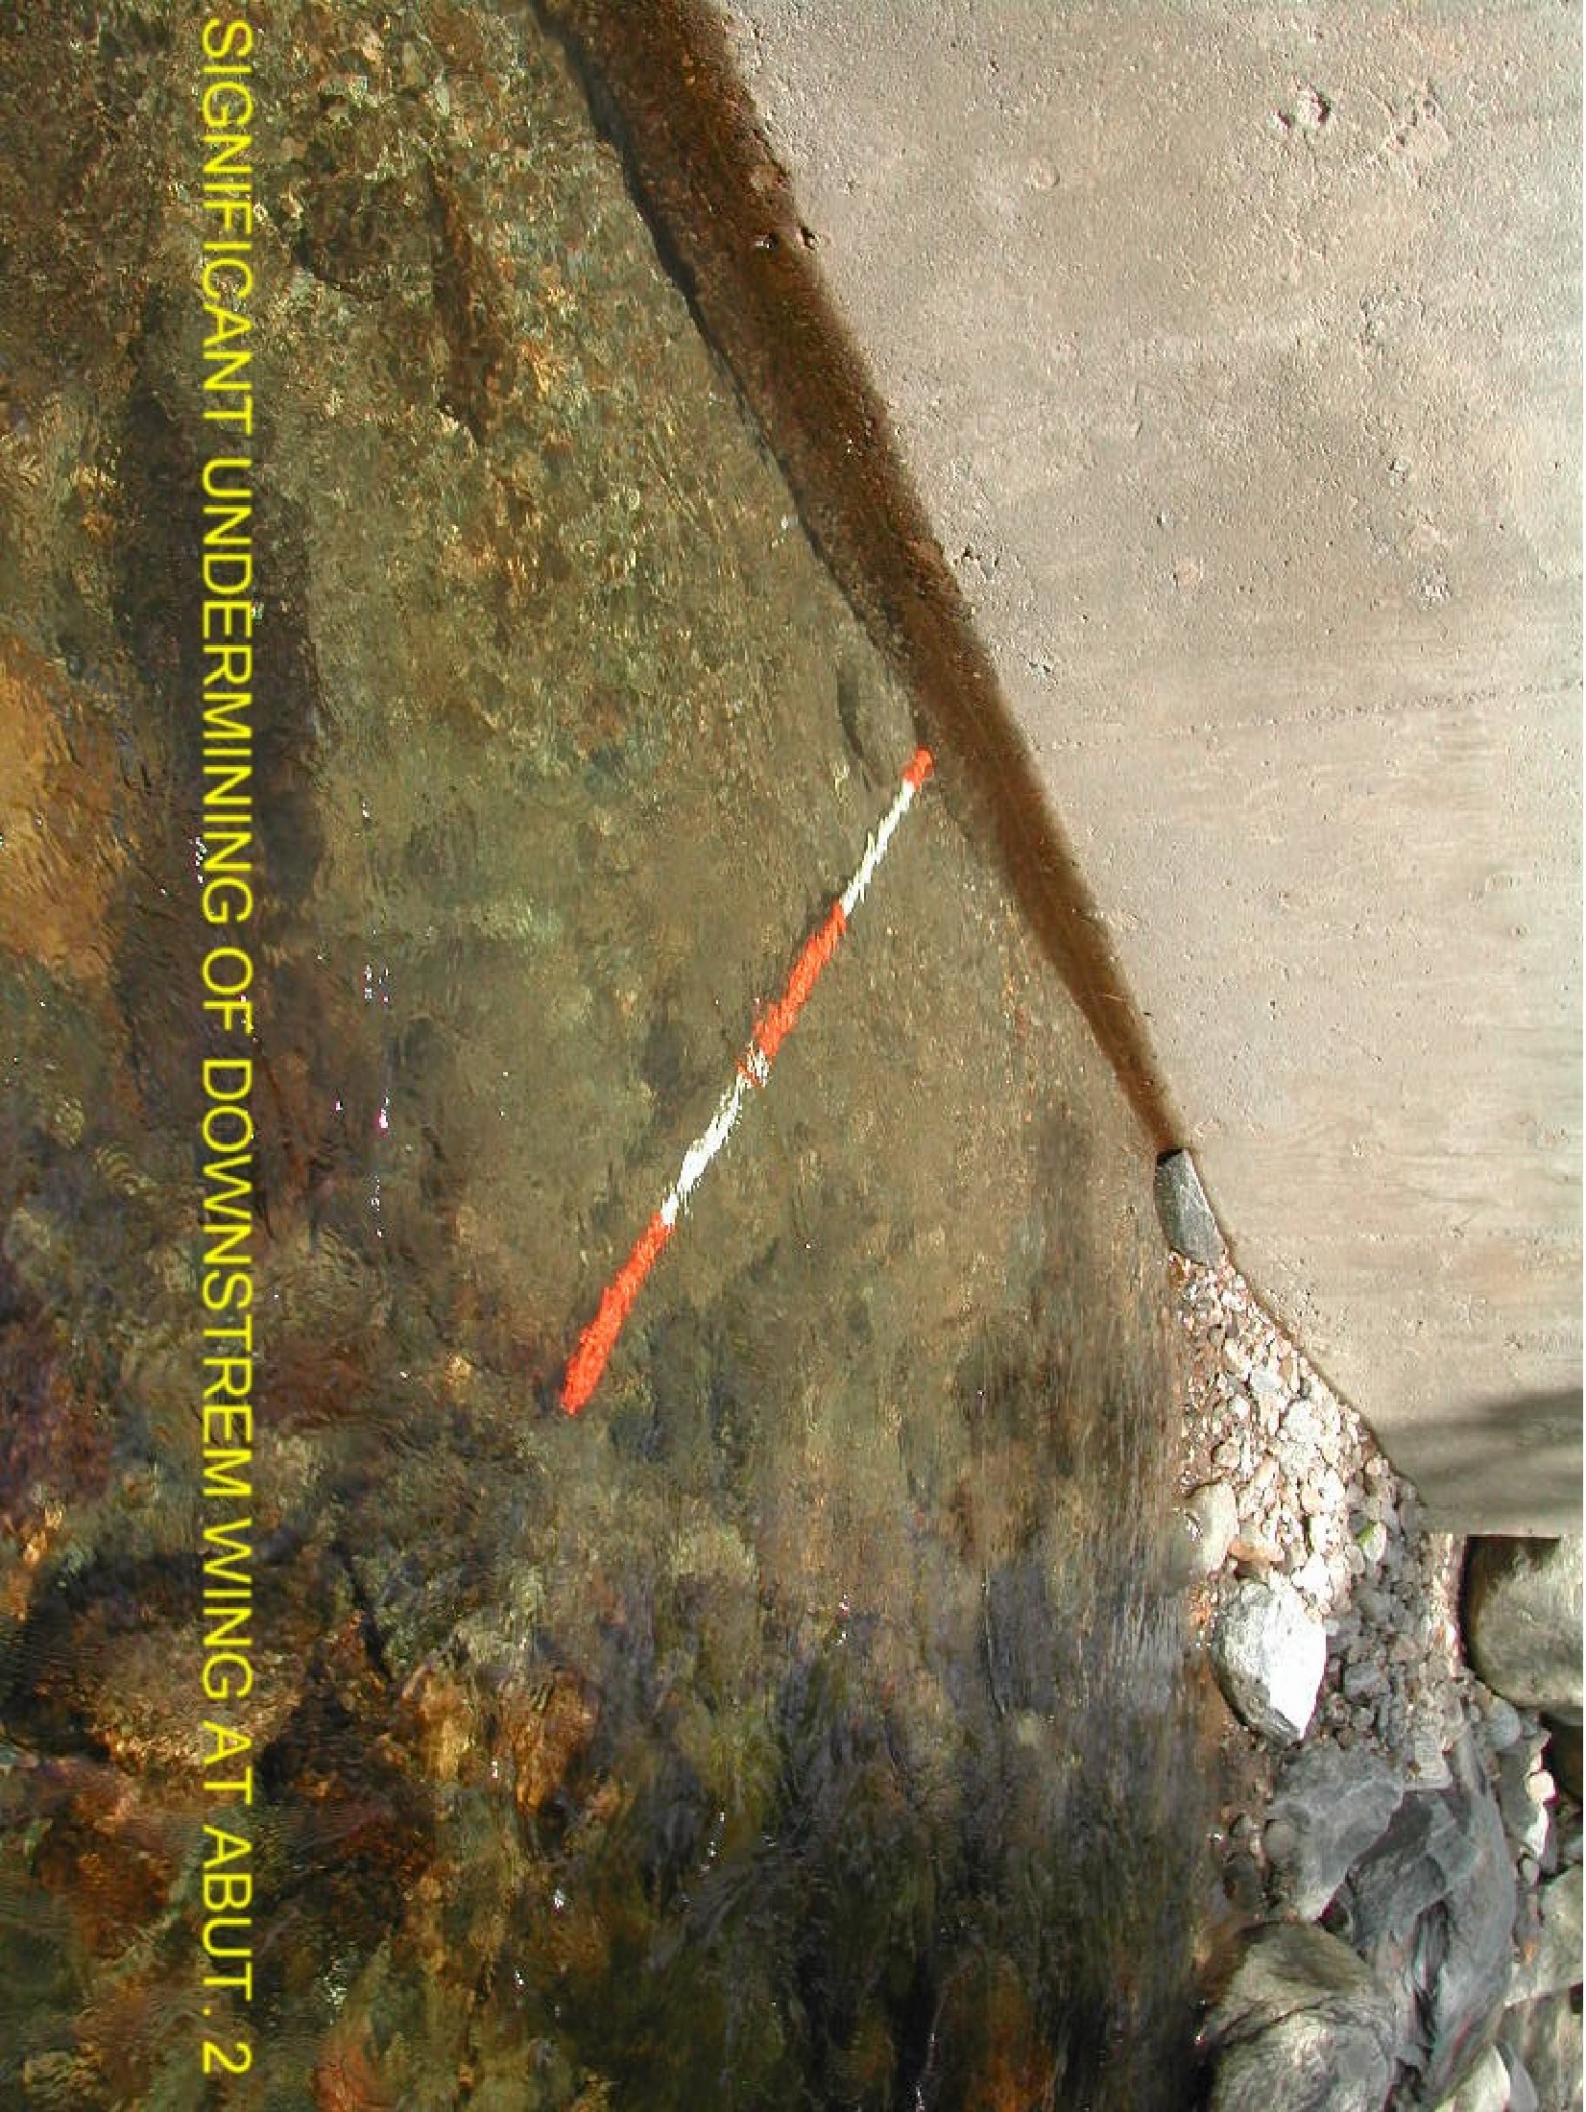
SIGNIFICANT UNDERMINING OF DOWNSTREAM WING AT ABUT. 2
