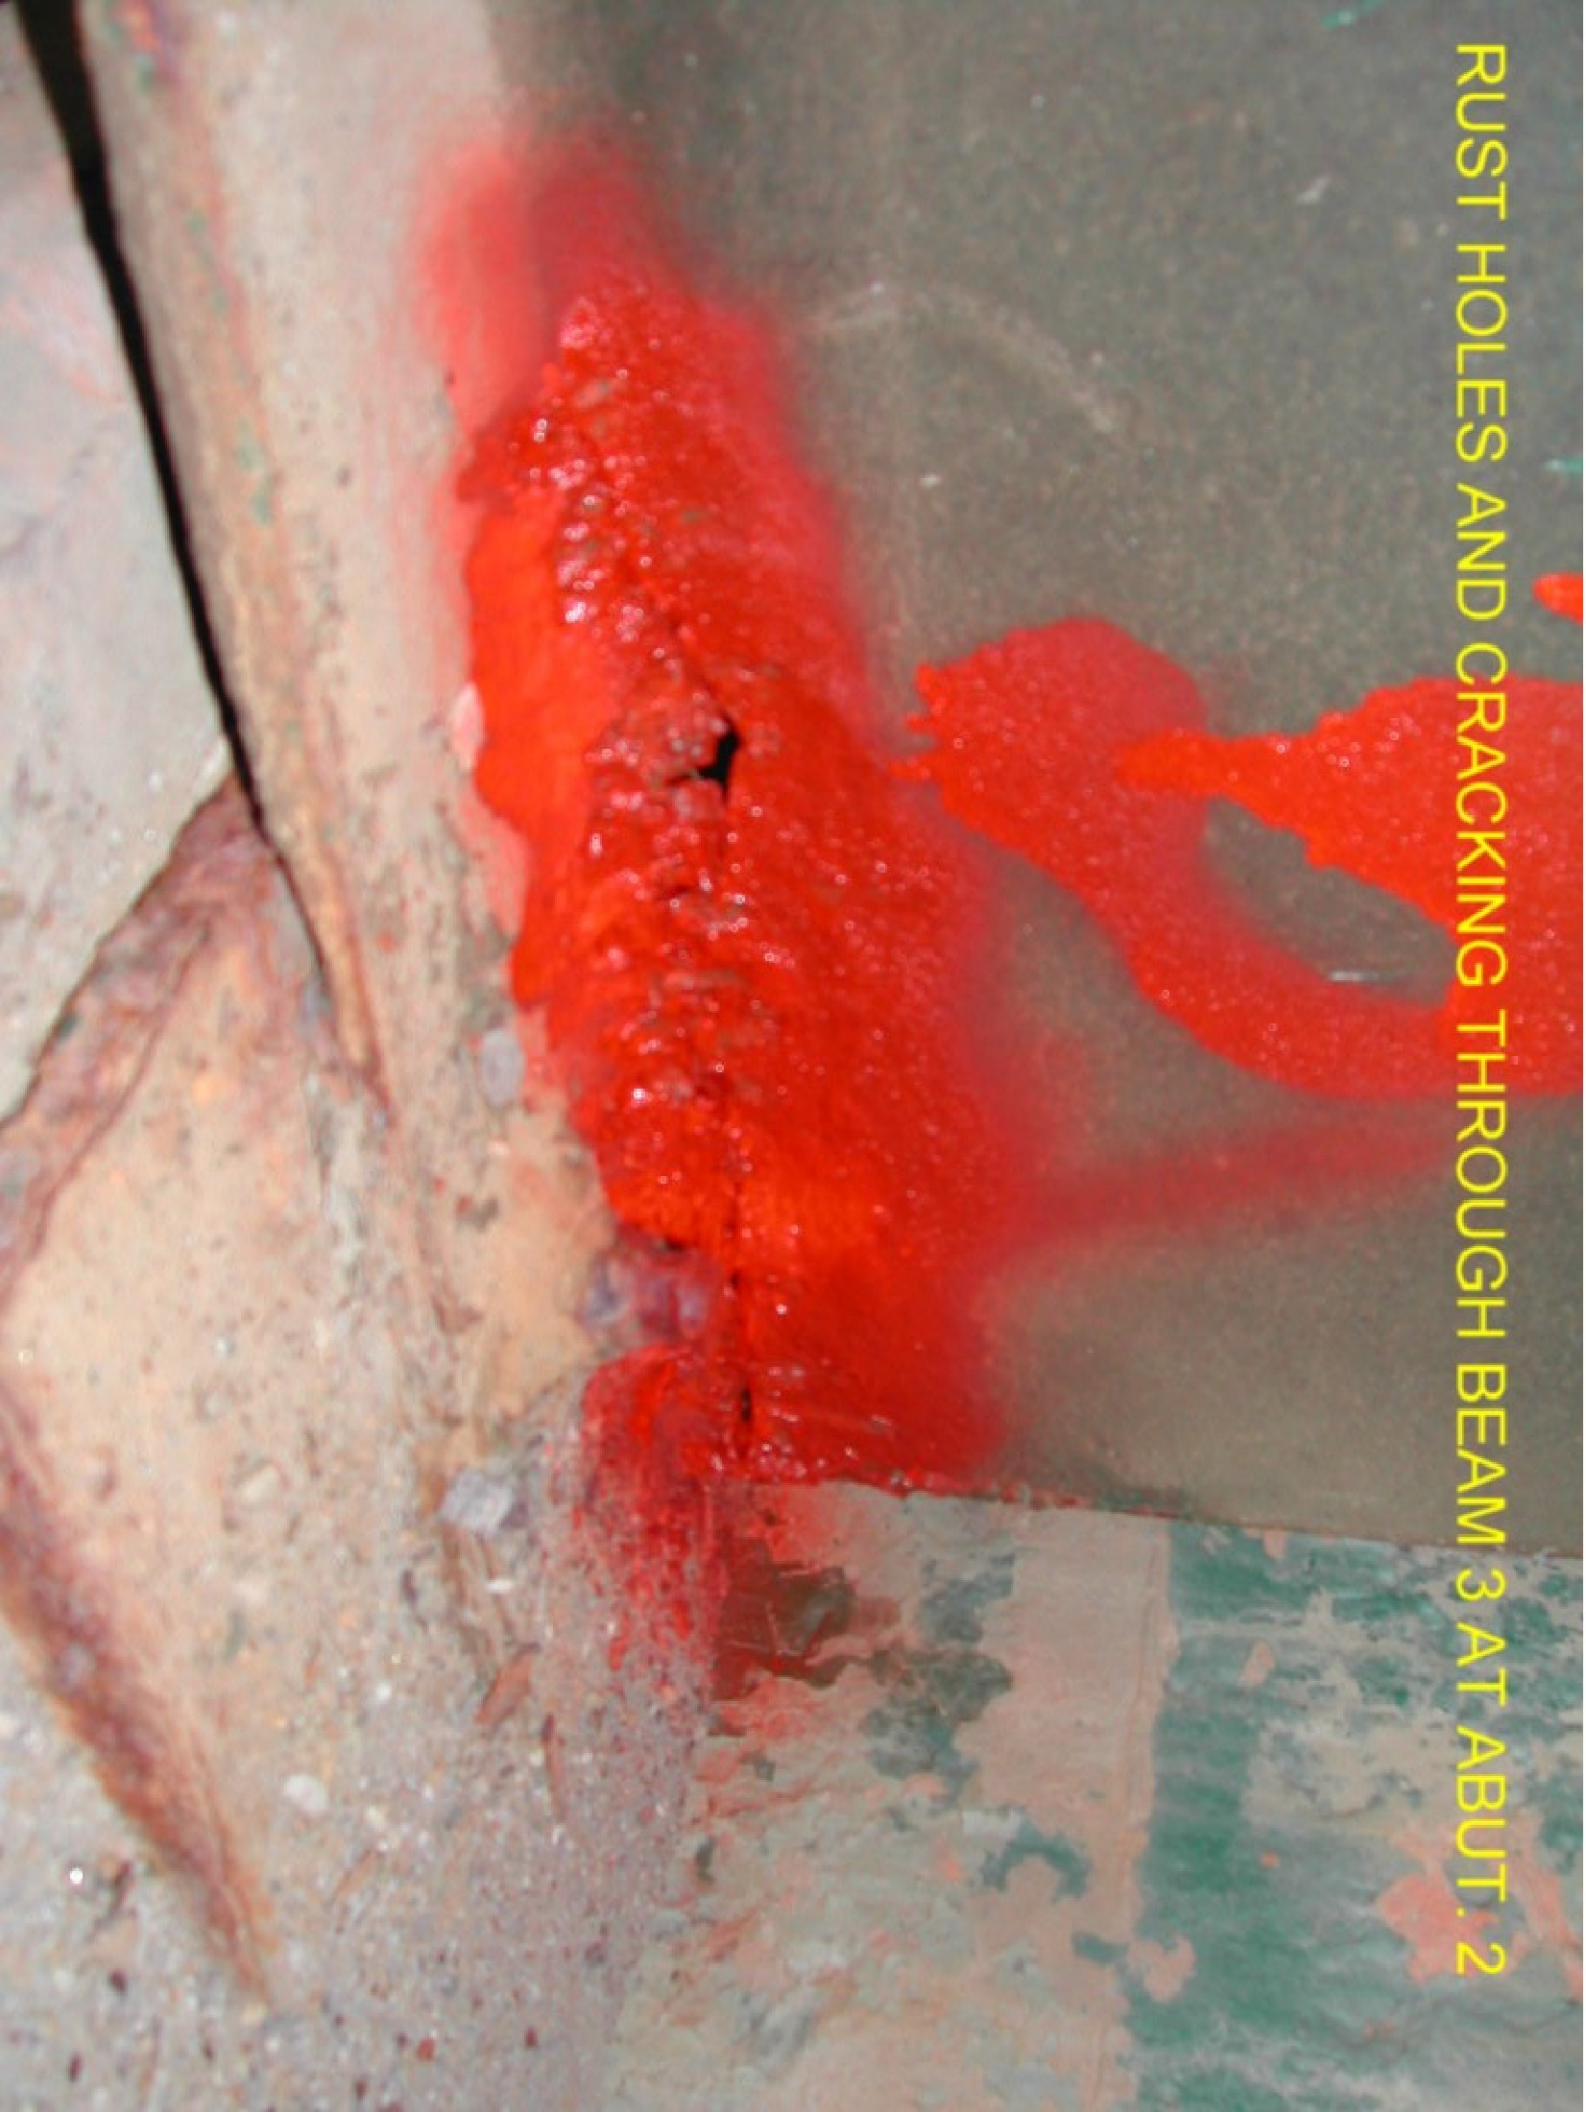
RUST HOLES AND CRACKING THROUGH BEAM 3 AT ABUT. 2
