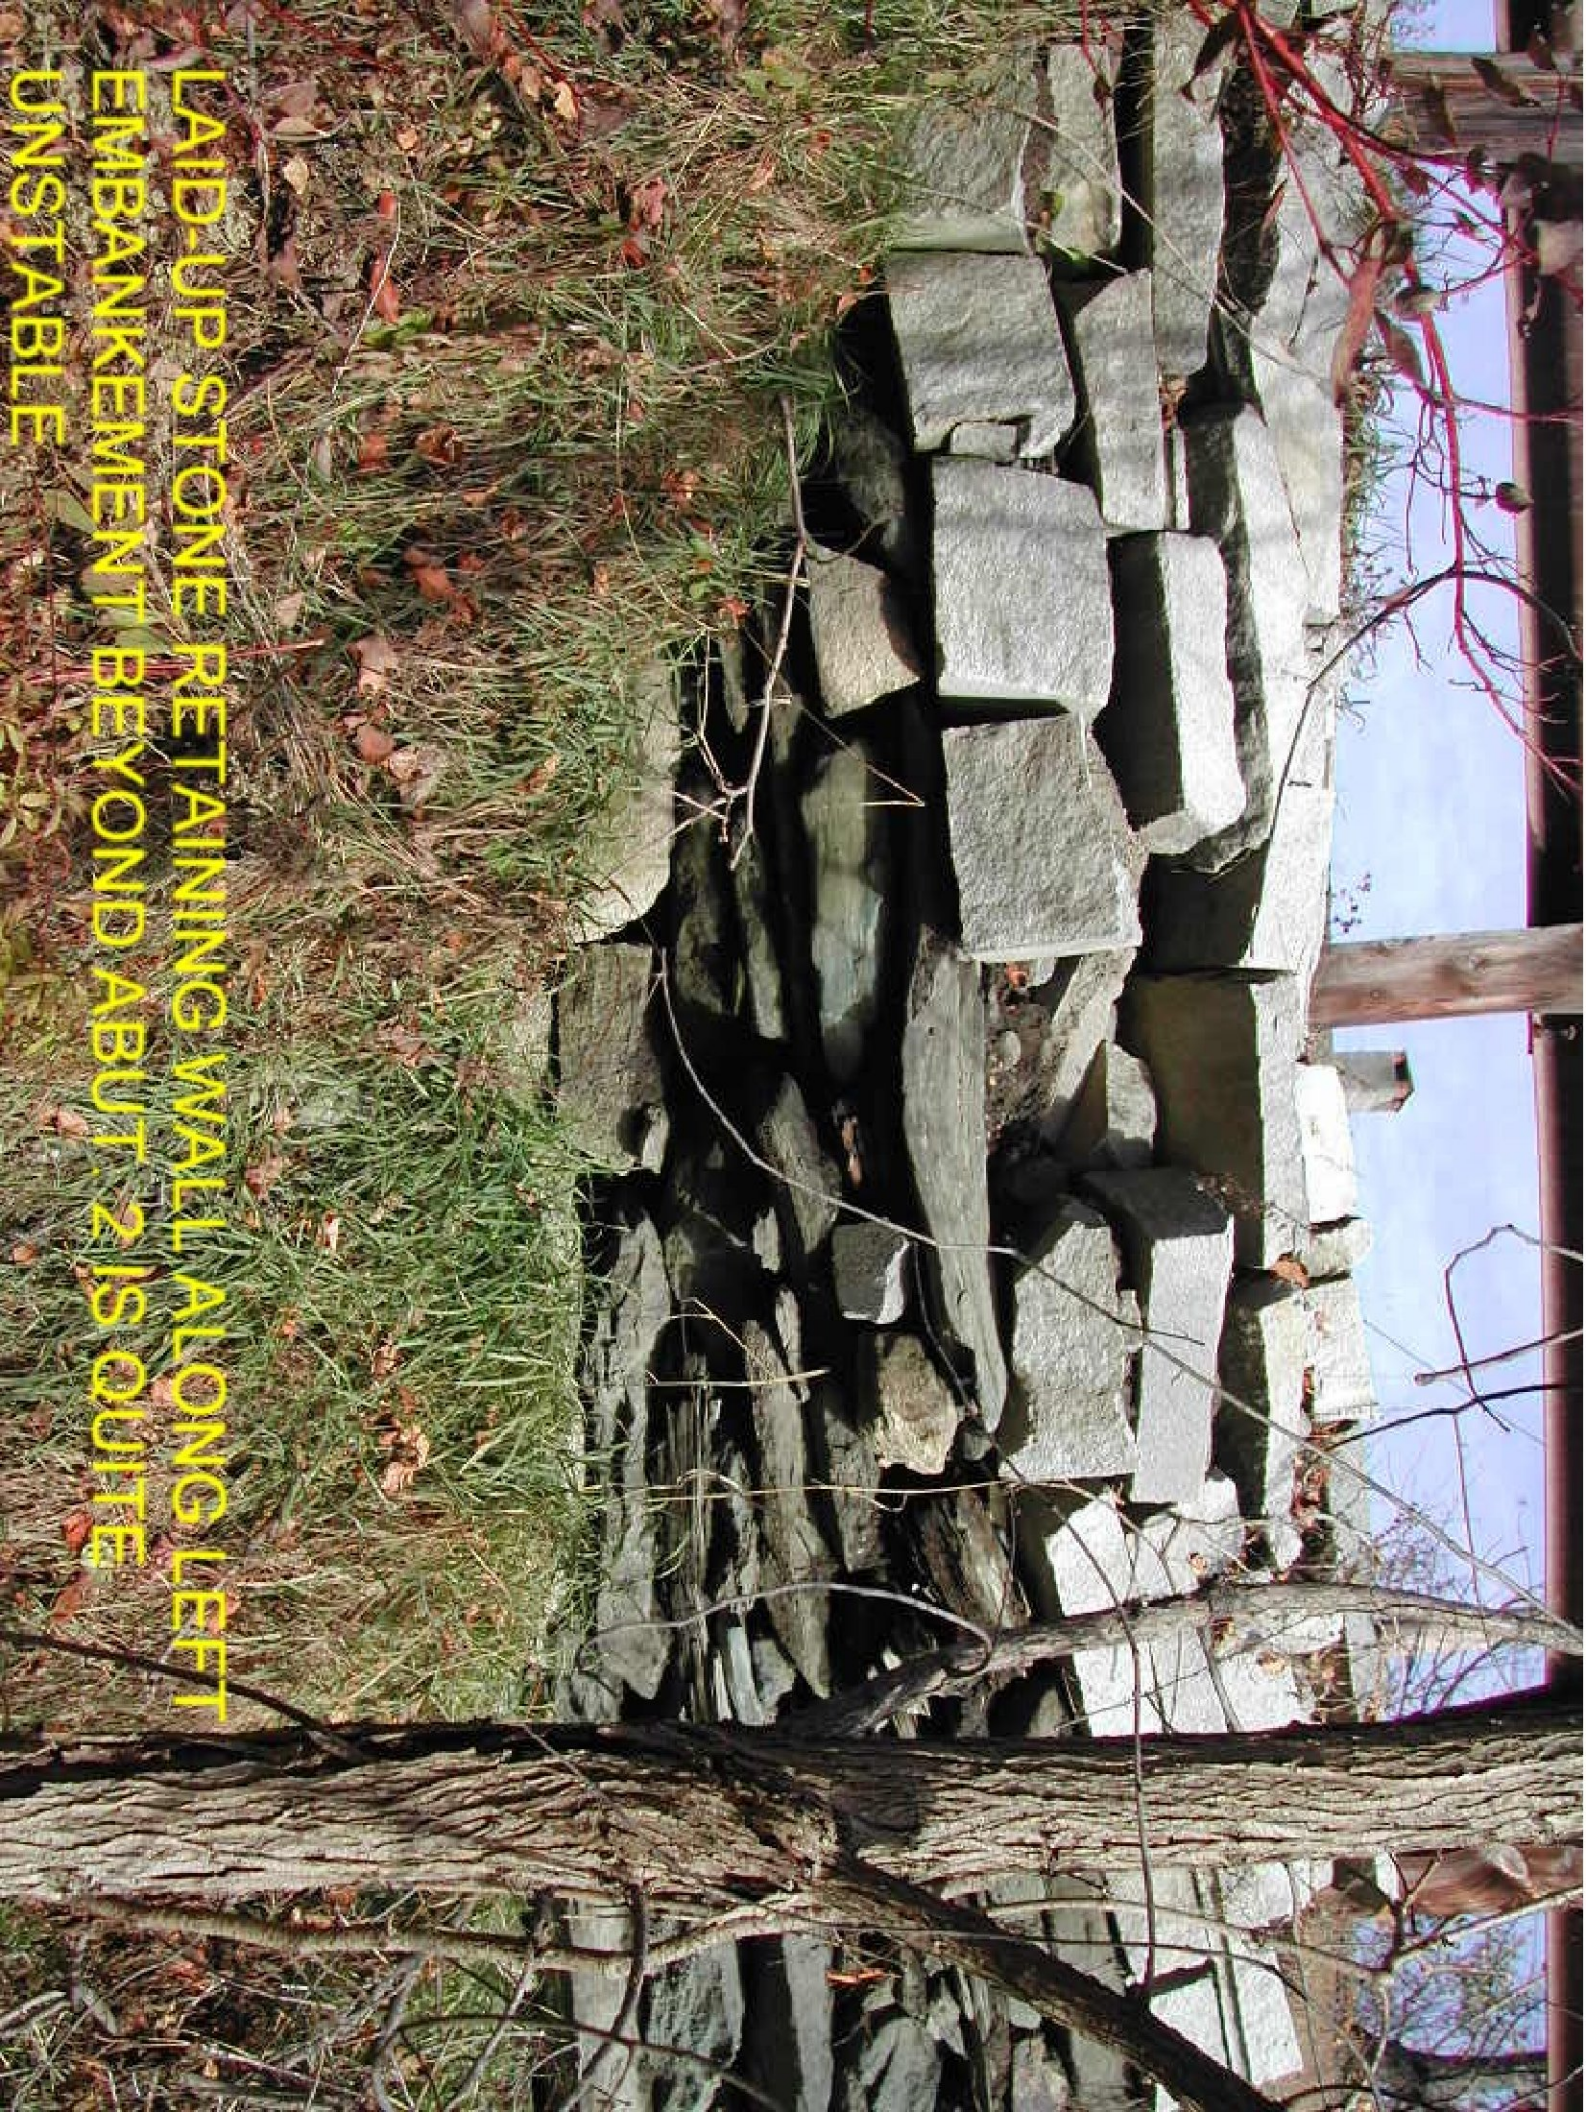
LAID-UP STONE RETAINING WALL ALONG LEFT  
EMBANKMENT BEYOND ABOUT 2 IS QUITE  
UNSTABLE
