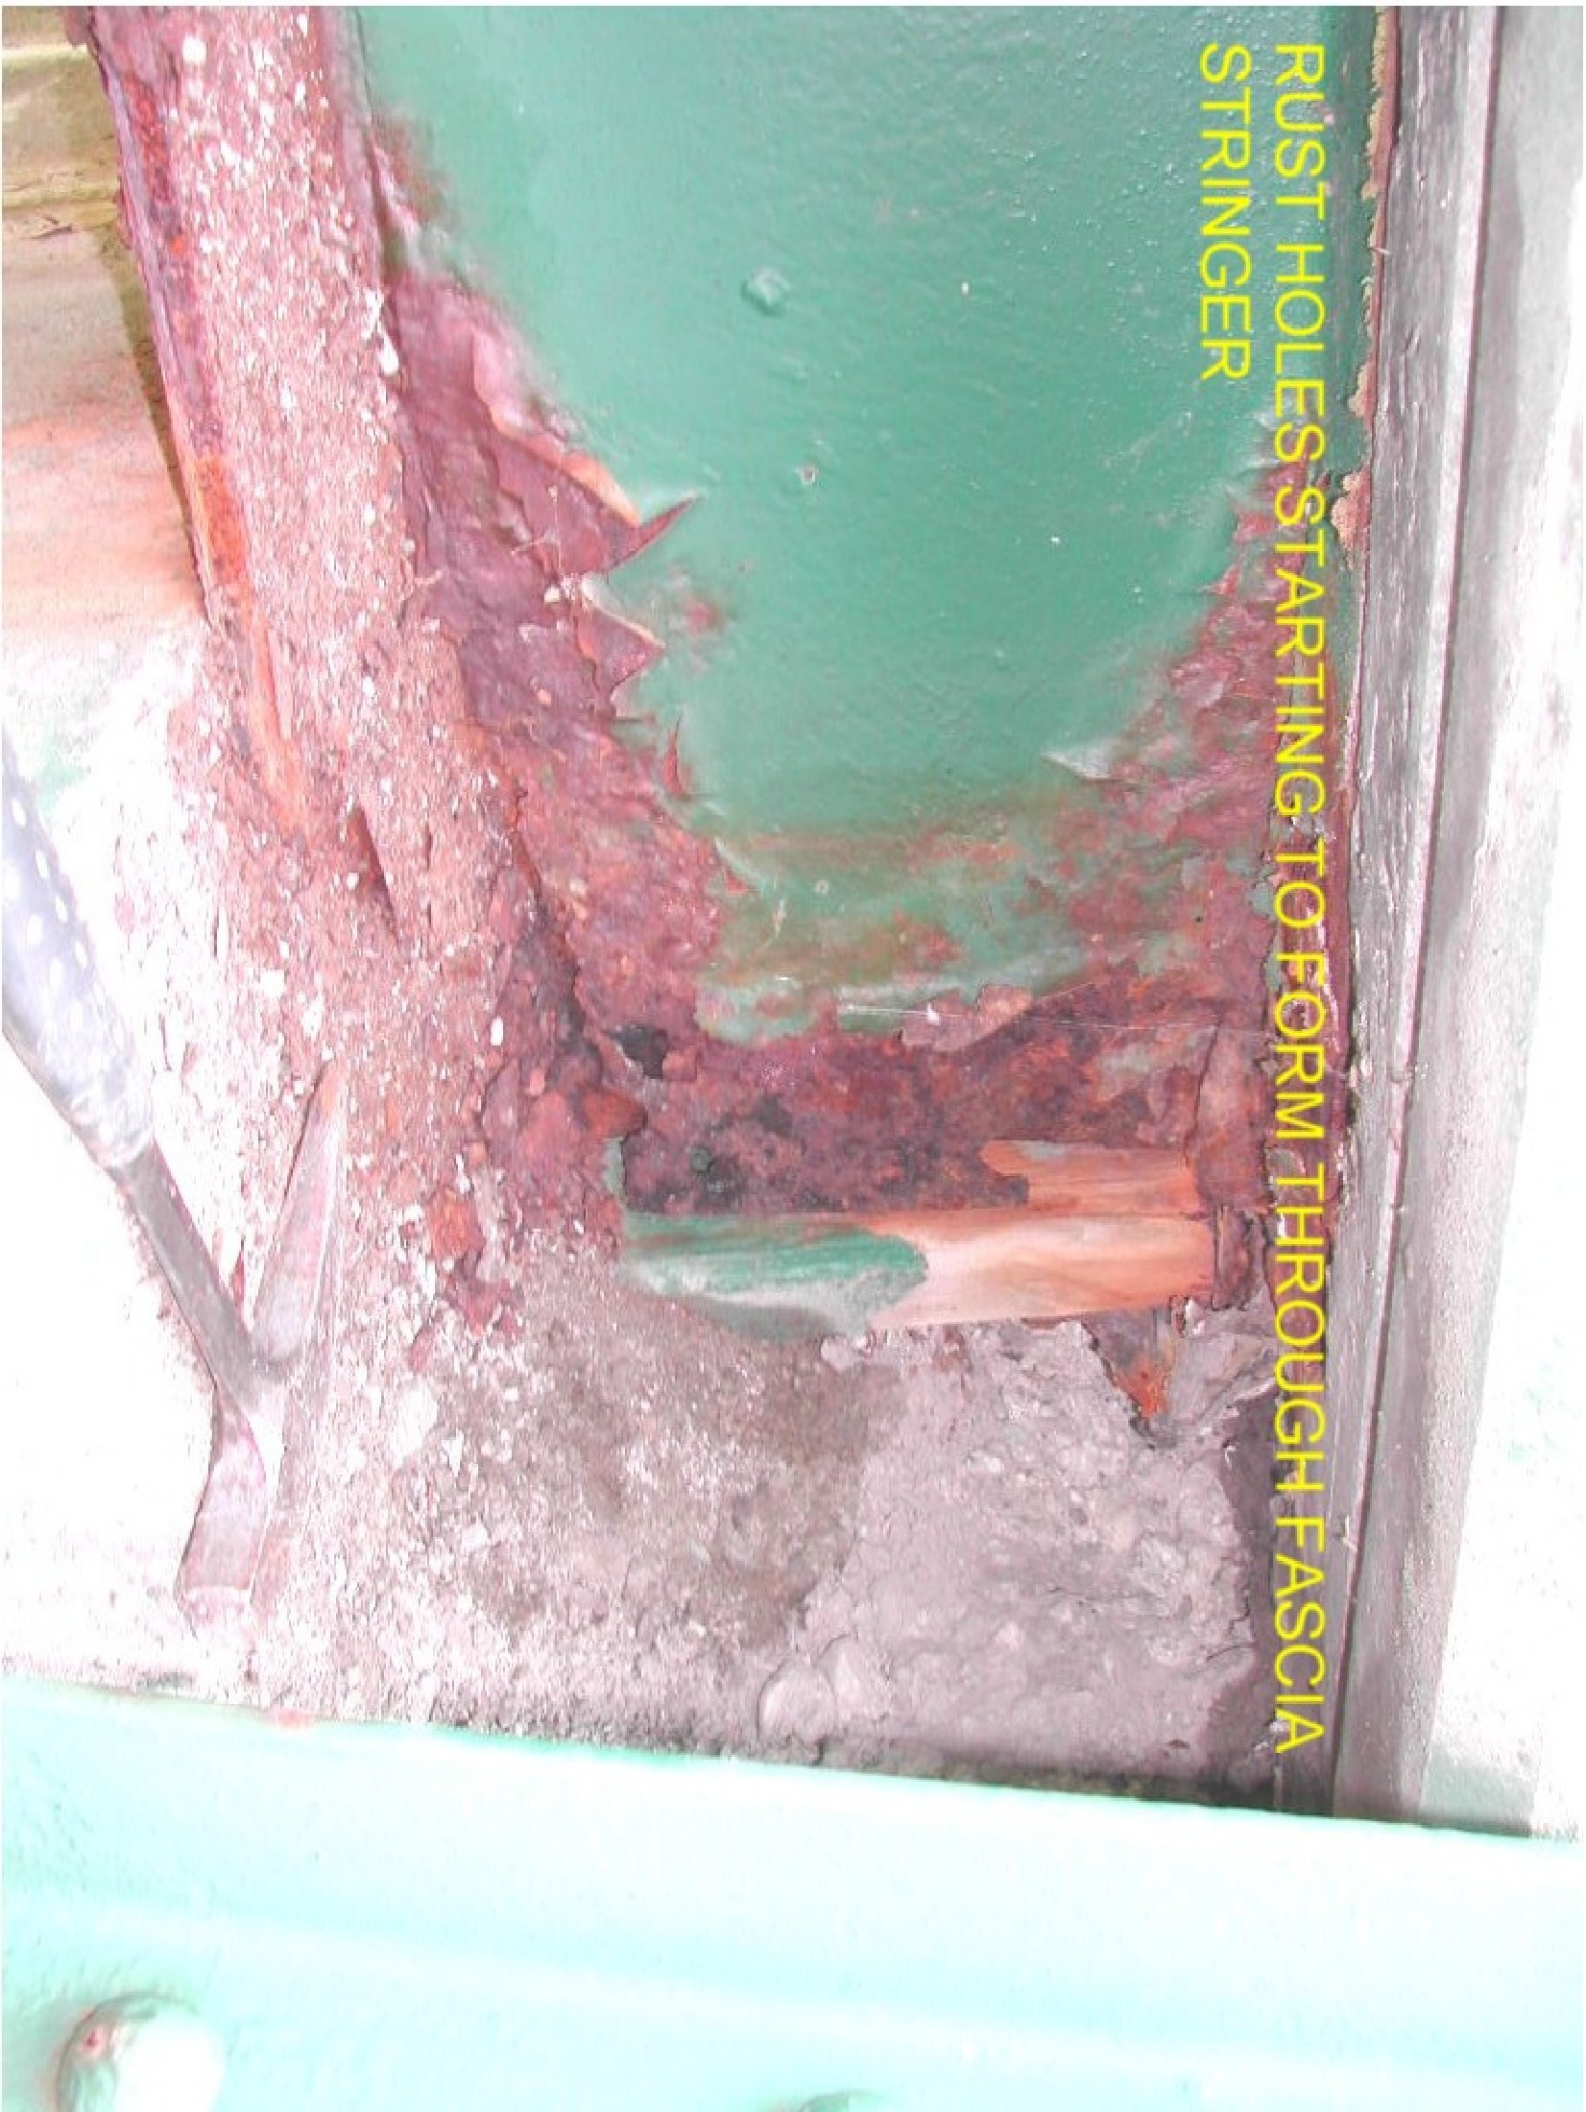
RUST HOLES STARTING TO FORM THROUGH FASCIA STRINGER
