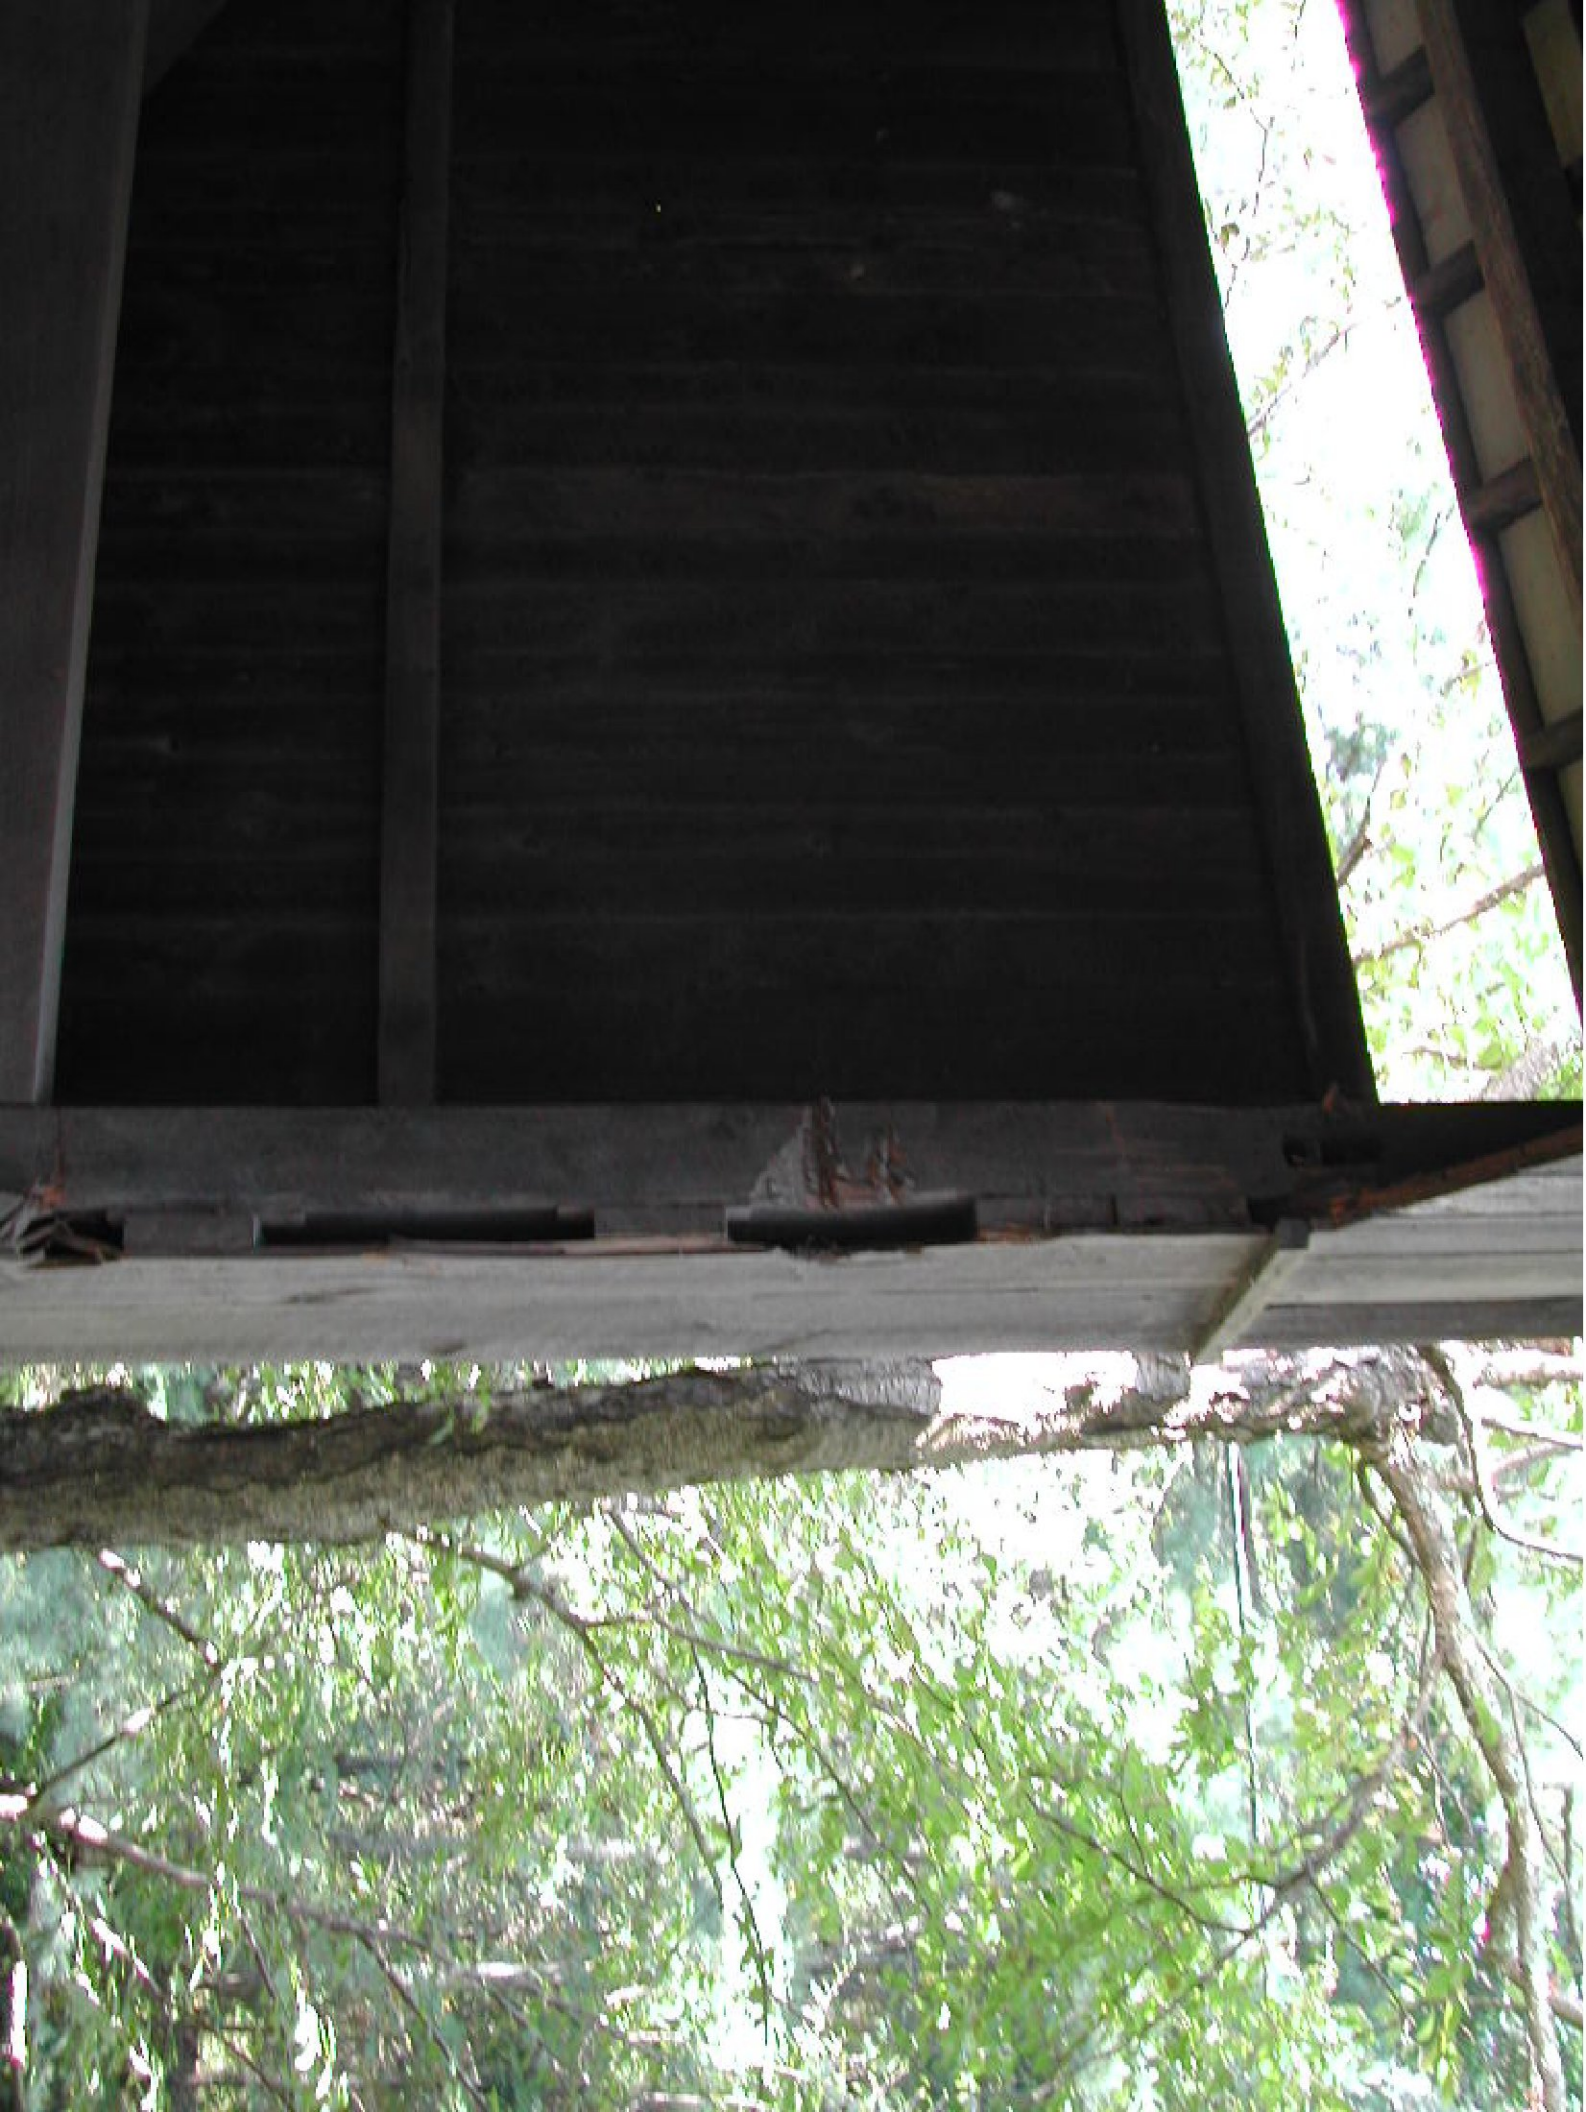
TIE BEAM 2 WAS HIT AND FRACTURED
2X6 SCAB SPLICE AS REPAIR

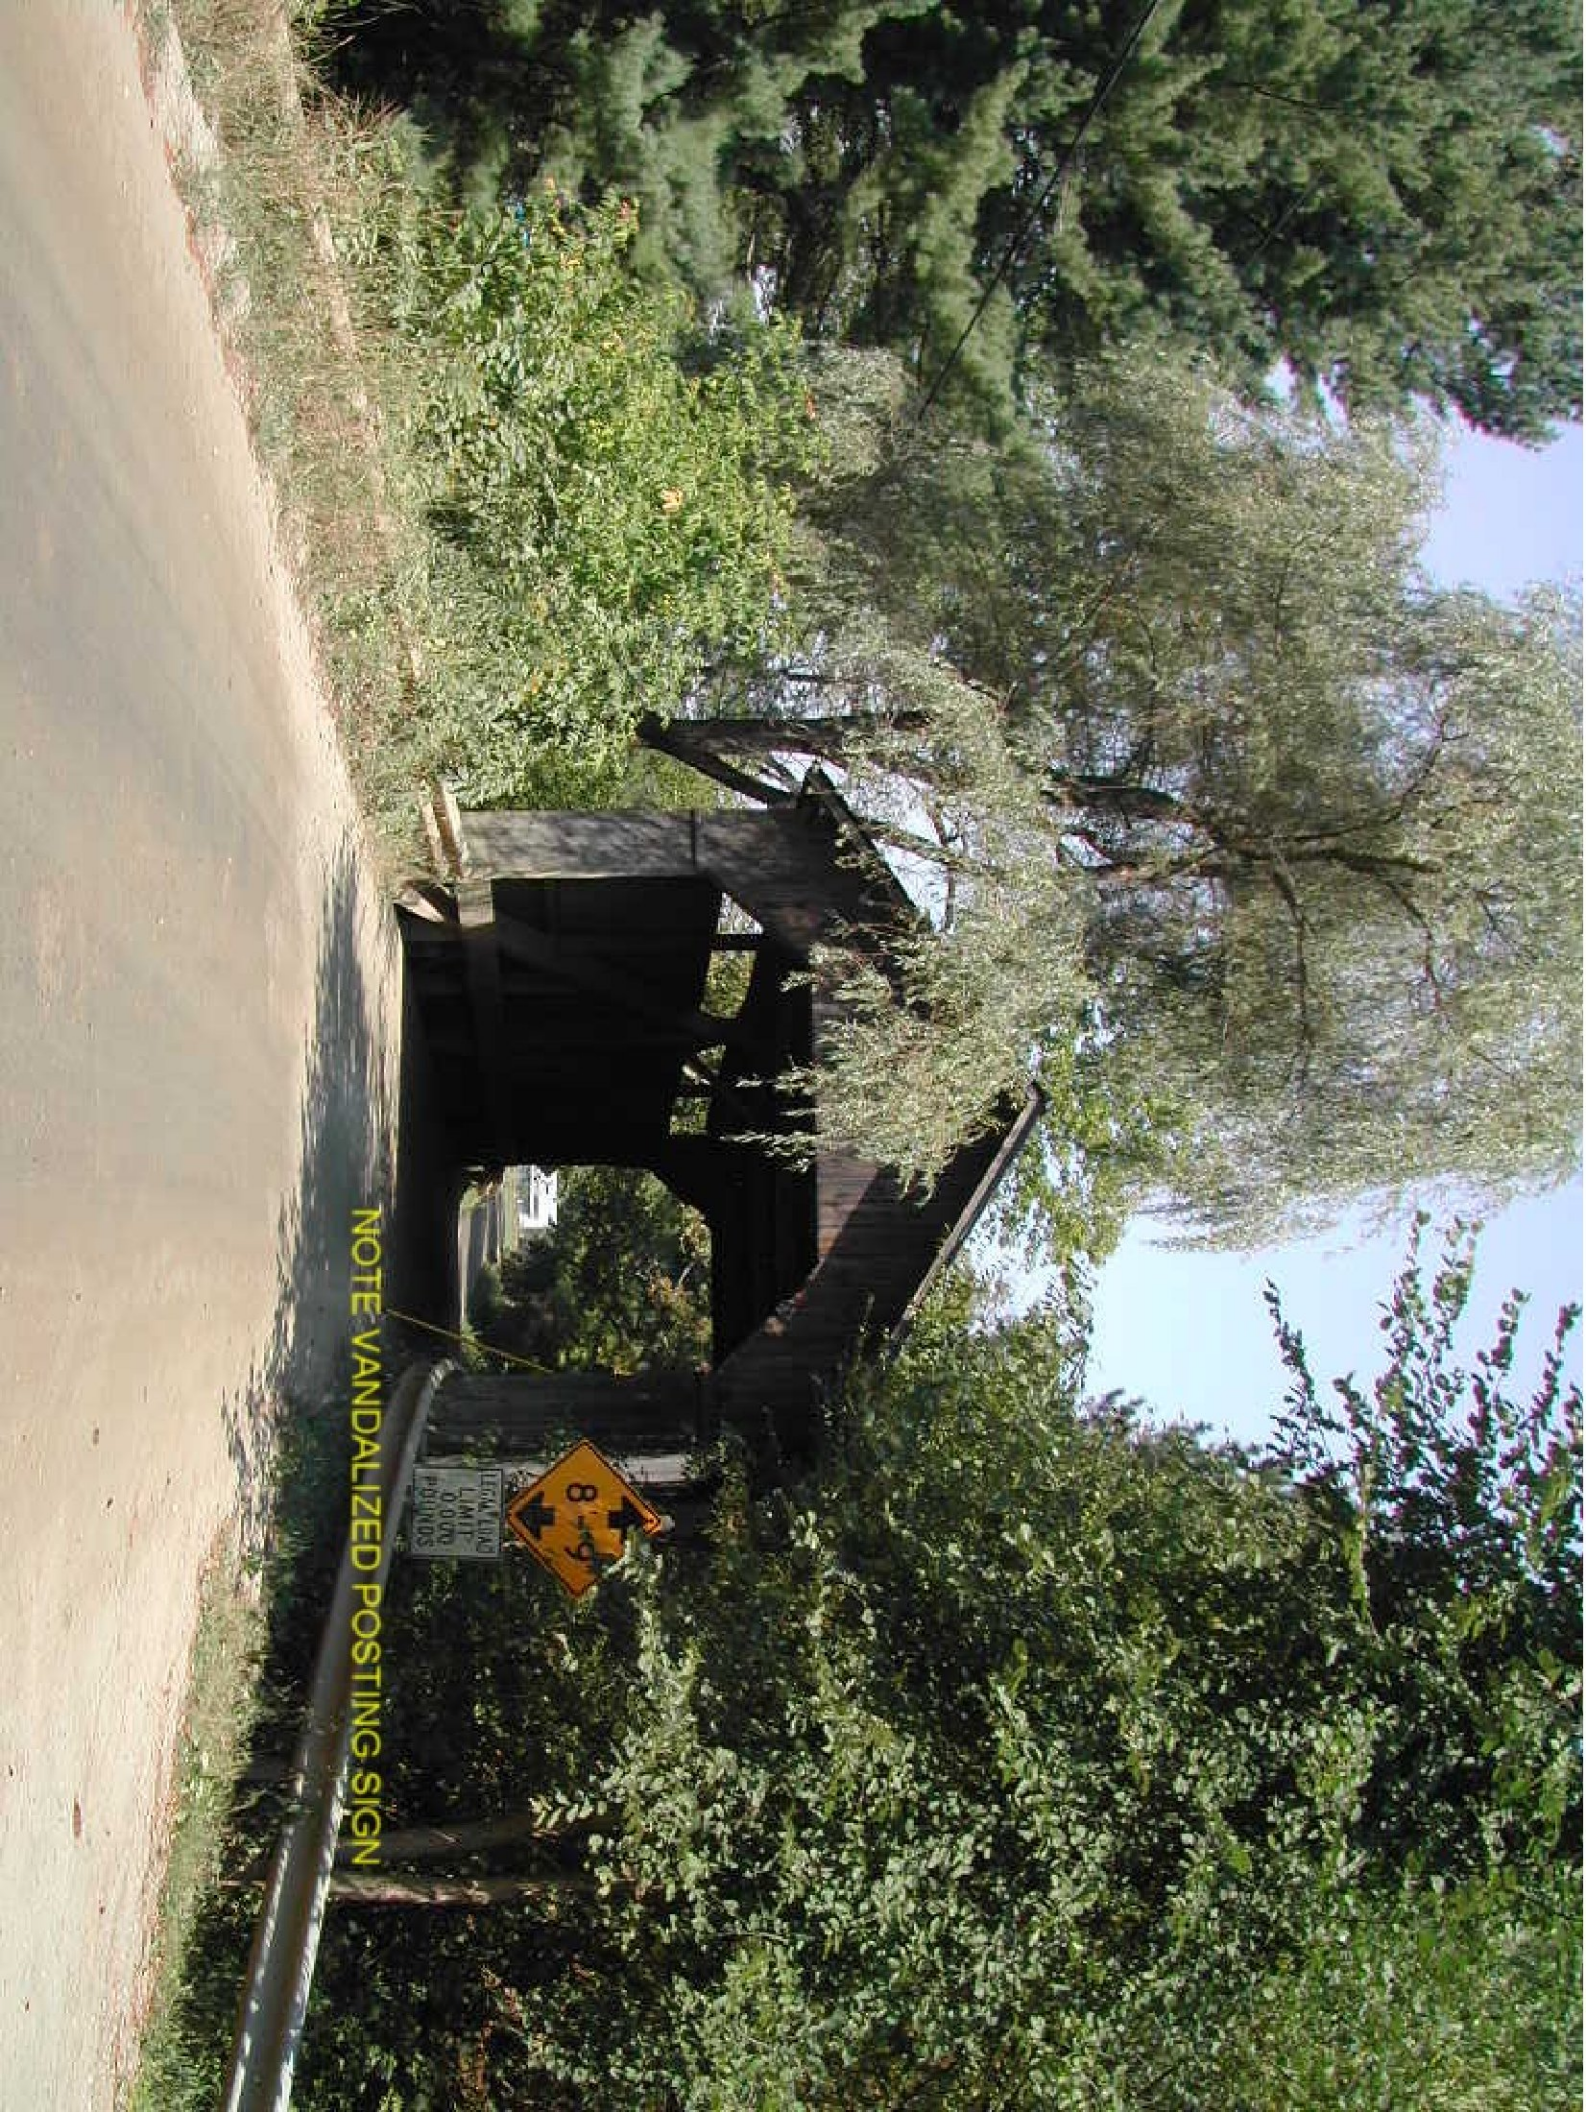
NOTE VANDALIZED POSTING SIGN
