LAMINATING A REPAIR ON BUOYANCY FOAM

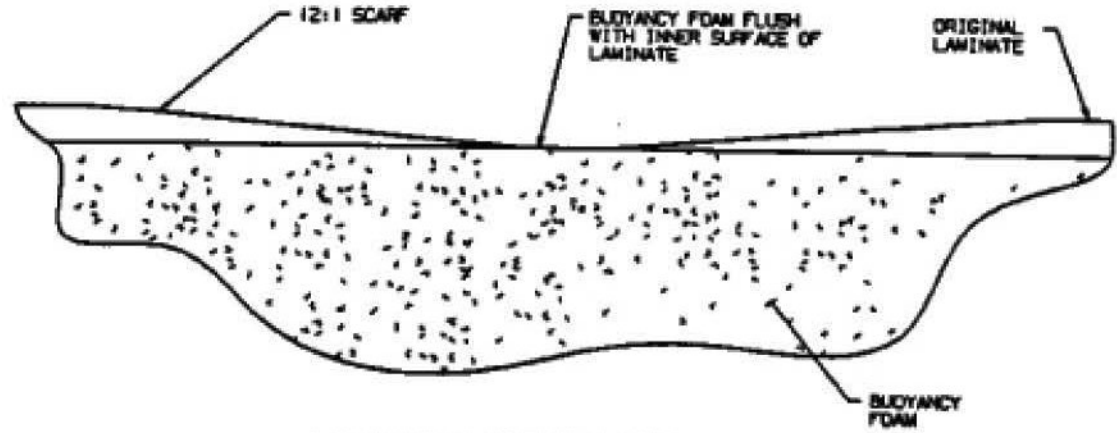
LAMINATE PREPARED FOR REPAIR

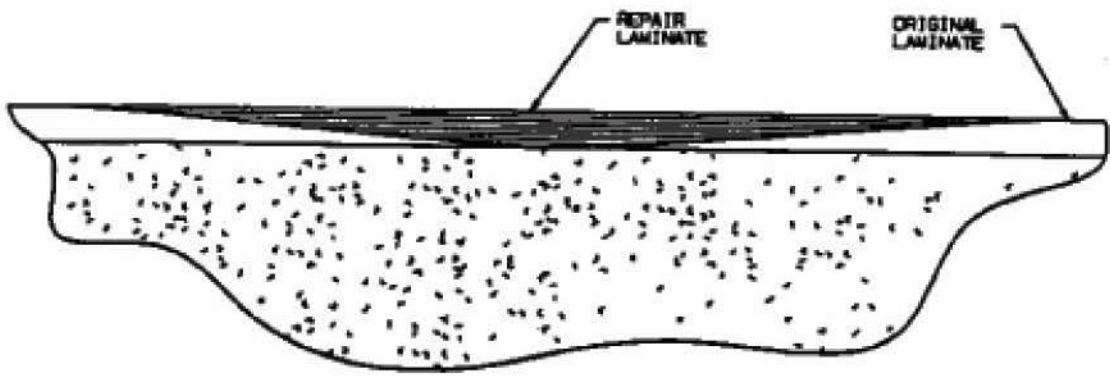
FIGURE 6.7

COMPLETED REPAIR
