Route Log and Progress Chart

DISTRICT	TOWN	ROUTE
1	BENNINGTON	US-7

DISTRICT	TOWN	Date: 12/02/19	ROUTE
1	BENNINGTON	1 of 1 TWN mileage: 3.876 to 7.292	US-7 ETE mileage: 11.864 to 15.28

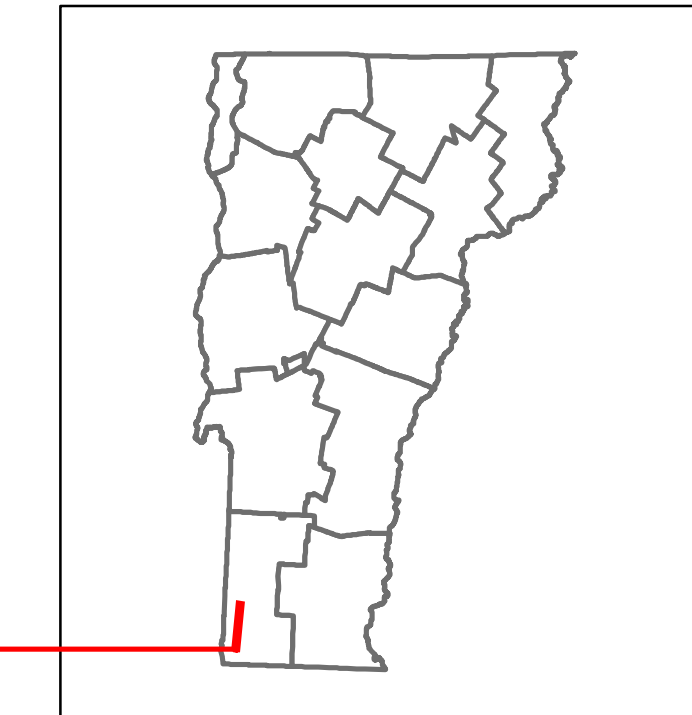
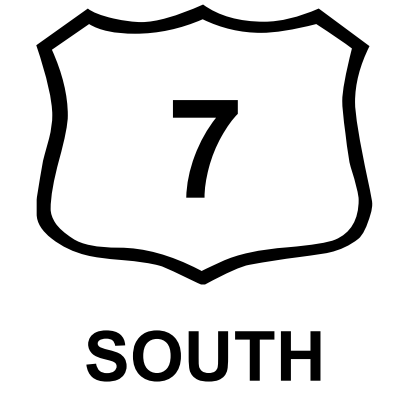
Stick Diagram

- Town Center
- Intersecting State Routes (excl. ramps/approaches)
- Other Intersecting Highways, Ramps, Approaches
- Railroad Crossings
- Primary Structures
- Secondary Structures
- Divided State Highway
- State Highway
- Divided Town Highway
- Town Highway
- Streams (Hydraulic Structure)
- Town Boundary
- Village/IC Boundaries
- District Boundaries
- State/Town Highway Change
- Divided Highway Limits
- Ghost Section Boundary
- Federal Urban Area Limits

Scale: 1 INCH = 2,000 FEET

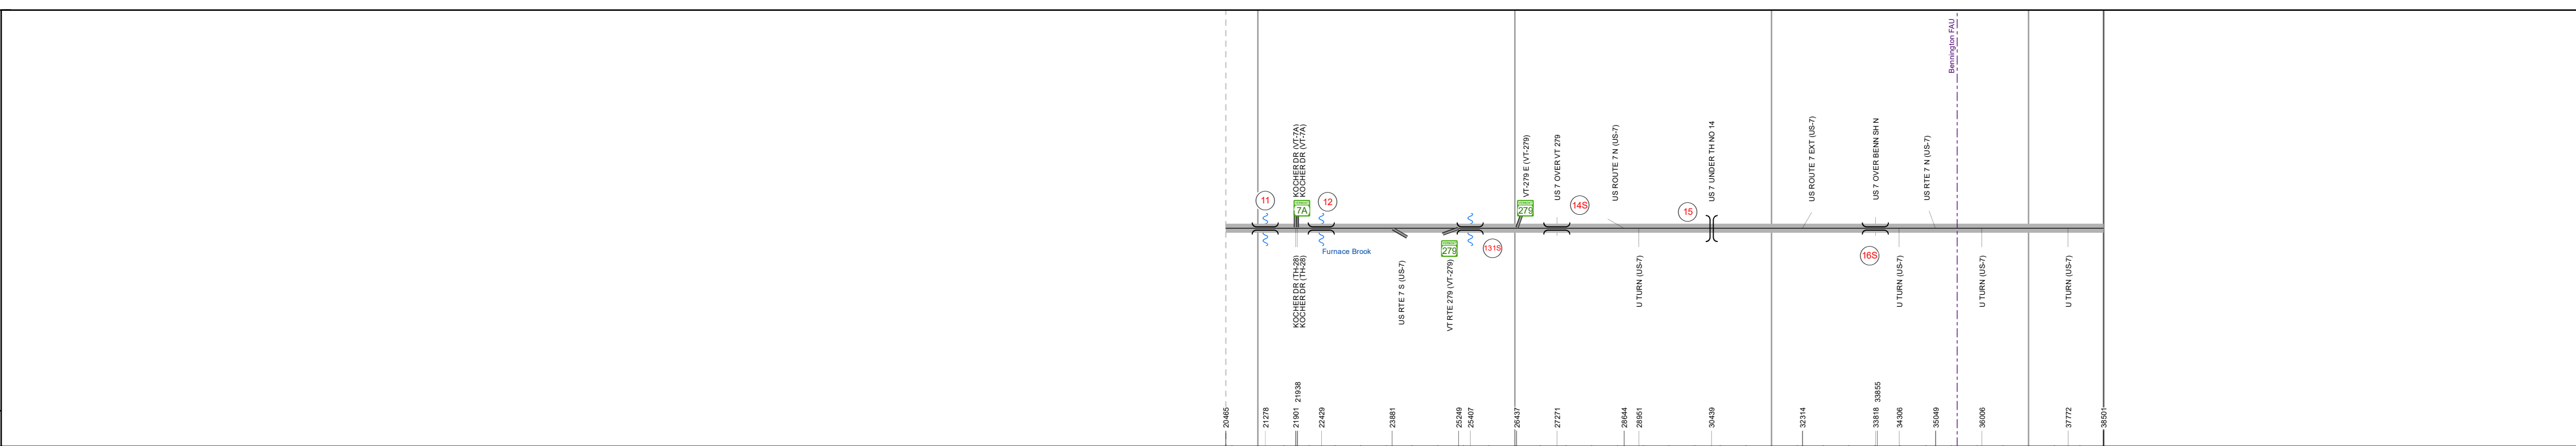
STRUCTURE DESCRIPTIONS

Bridge 11:
Stringer/multi-beam or girder - 1973
Structure No. 201000001102022
Length: 156'
Width: 84.2'
Facility Carried: US 07 ML
Structure Type: WELDED PLATE GIRDER
Features Intersected: ROARING BRANCH
Surface: Bituminous
Maintenance/Ownership: State

Culvert 12:
Culvert - 1973
Structure No. 200719001202022
Length: 25'
Facility Carried: US 07 ML
Structure Type: R.C. BOX
Features Intersected: FURNACE BROOK
Maintenance/Ownership: State

Culvert 131S:
Culvert - 1972
Structure No. 300019131502021
Length: 8'
Under Clearance: 8.0'
Facility Carried: US7
Structure Type: CGMPP
Features Intersected: BROOK
Maintenance: State

Bridge 14S:
Stringer/multi-beam or girder - 1973
Structure No. 200019014502022
Length: 232'
Width: 46.8'
Under Clearance: 20.67'
Facility Carried: US 07 ML
Structure Type: 2 SP CONT WLD CRV GR
Features Intersected: US 7 OVER VT 279
Surface: Bituminous
Maintenance/Ownership: State

Bridge 15:
Stringer/multi-beam or girder - 1973
Structure No. 2002020D1502021
Length: 234'
Facility Carried: TR 14
Structure Type: 2 SPAN CONT WLD GIRD
Features Intersected: US 7 UNDER TH NO 14

Bridge 16S:
Stringer/multi-beam or girder - 1973
Structure No. 200019016502022
Length: 140'
Width: 36.4'
Under Clearance: 19.67'
Facility Carried: US 07 ML
Structure Type: WELDED PLATE GIRDER
Features Intersected: US 7 OVER BENN SH N
Surface: Bituminous
Maintenance/Ownership: State
