PROJECT NAME: CORNWALL - MIDDLEBURY  
 PROJECT NUMBER: STP EH08(13)  
 FILE NAME: Z08F122BDR NU.DGN  
 PROJECT LEADER: MS  
 DESIGNED BY: CM  
 LAYOUT SHEET 14  
 PLOT DATE: 06/09/2010  
 DRAWN BY: CM  
 CHECKED BY: MS  
 SHEET 71 OF 133

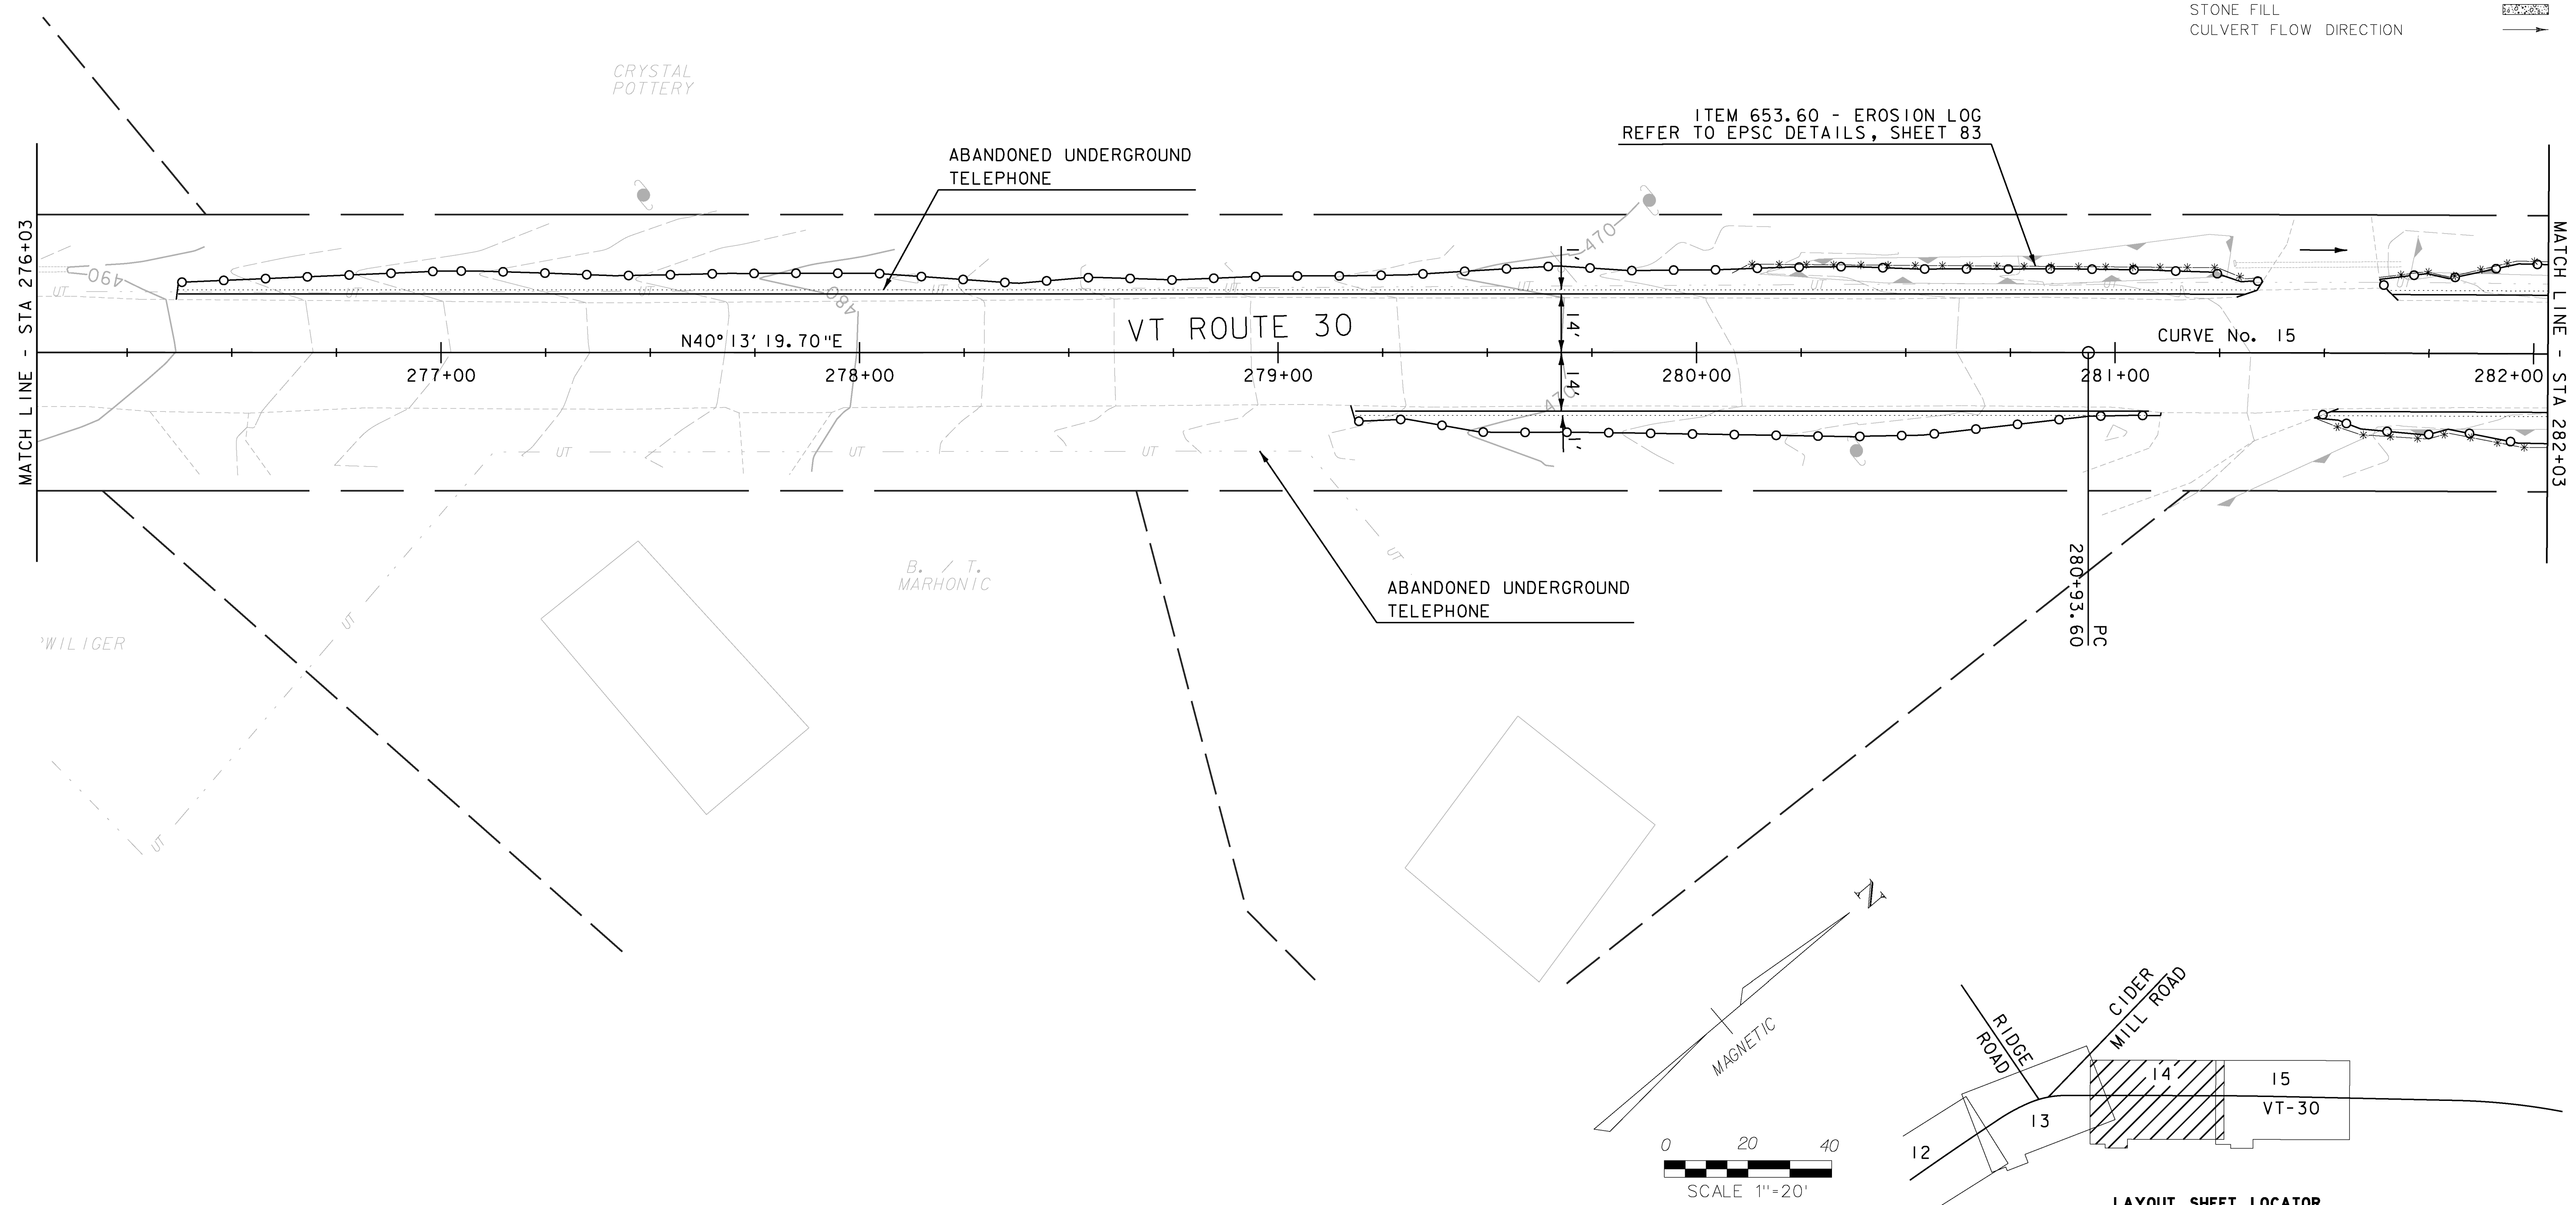
LIMITS OF WORK		
STA 276+12 - 281+35	LT	
STA 279+17 - 281+11	RT	
STA 281+48 - 282+03	RT	
STA 281+63 - 282+03	LT	
ITEM 653.60 - EROSION LOG		
STA 280+09 - 281+35	LT	
STA 281+48 - 282+03	RT	
STA 281+63 - 282+03	LT

CURVE No. 15 DATA  
 $\Delta = 1^\circ 10' 27''$  RT  
 $R = 20000$  FT  
 $T = 204.96$  FT  
 $L = 409.90$  FT  
 $E = 1.05$  FT  
 $D = 0^\circ 17' 11''$
