PROJECT NAME: CORNWALL - MIDDLEBURY  
 PROJECT NUMBER: STP EH08(13)  
 FILE NAME: Z08F122BDR NU.DGN  
 PROJECT LEADER: MS  
 DESIGNED BY: CM  
 LAYOUT SHEET 18

PLOT DATE: 06/09/2010  
 DRAWN BY: CM  
 CHECKED BY: MS  
 SHEET 75 OF 133

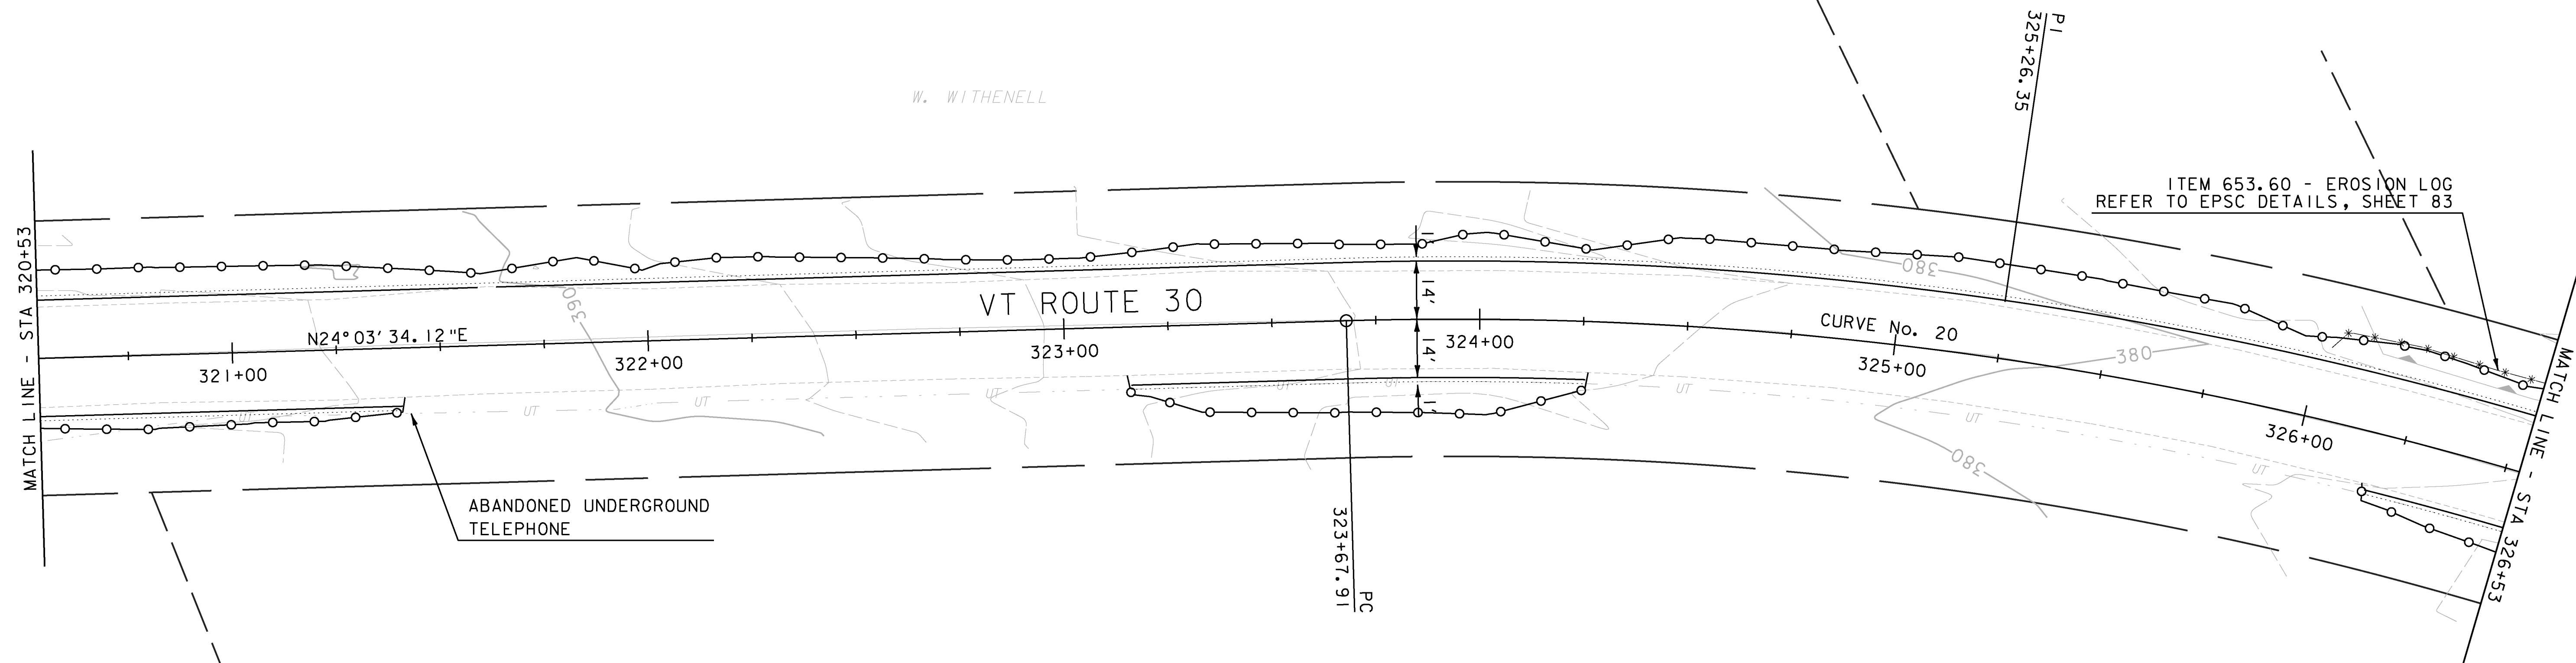
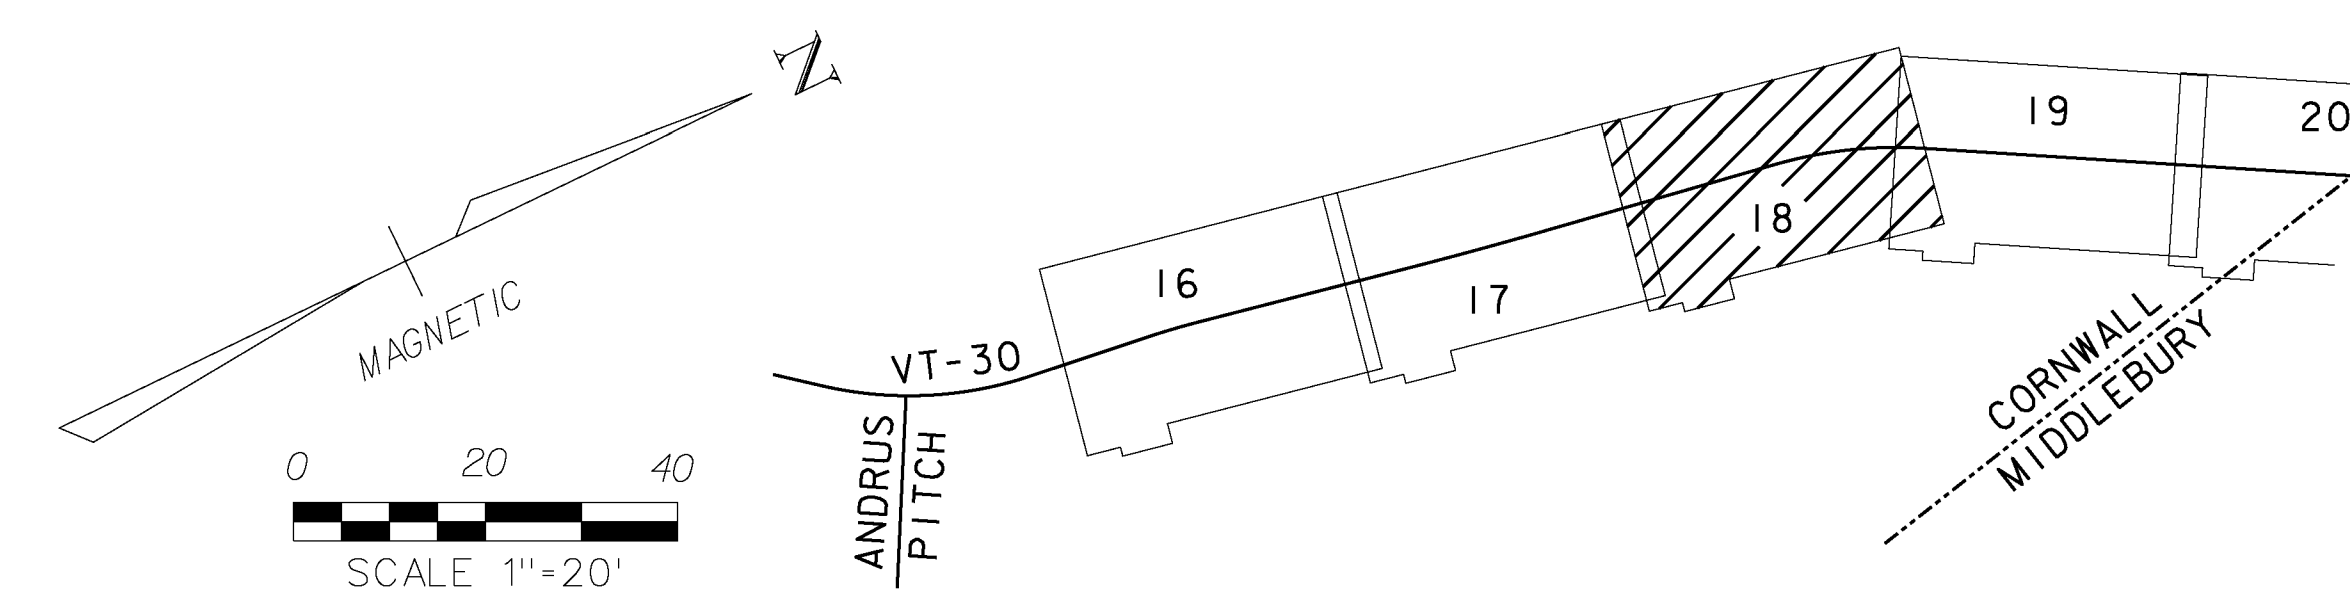
LIMITS OF WORK		
STA 320+53 - 326+53	LT	
STA 320+53 - 321+41	RT	
STA 323+15 - 324+26	RT	
STA 326+17 - 326+53	RT	
ITEM 653.60 - EROSION LOG		
STA 326+03 - 326+53	LT

ITEM 653.60 - EROSION LOG  
REFER TO EPSC DETAILS, SHEET 83

CURVE No. 20 DATA  
 $\Delta = 19^\circ 45' 12''$  RT  
 R = 910 FT  
 T = 158.44 FT  
 L = 312.18 FT  
 E = 13.69 FT  
 D = 6° 17' 46"
