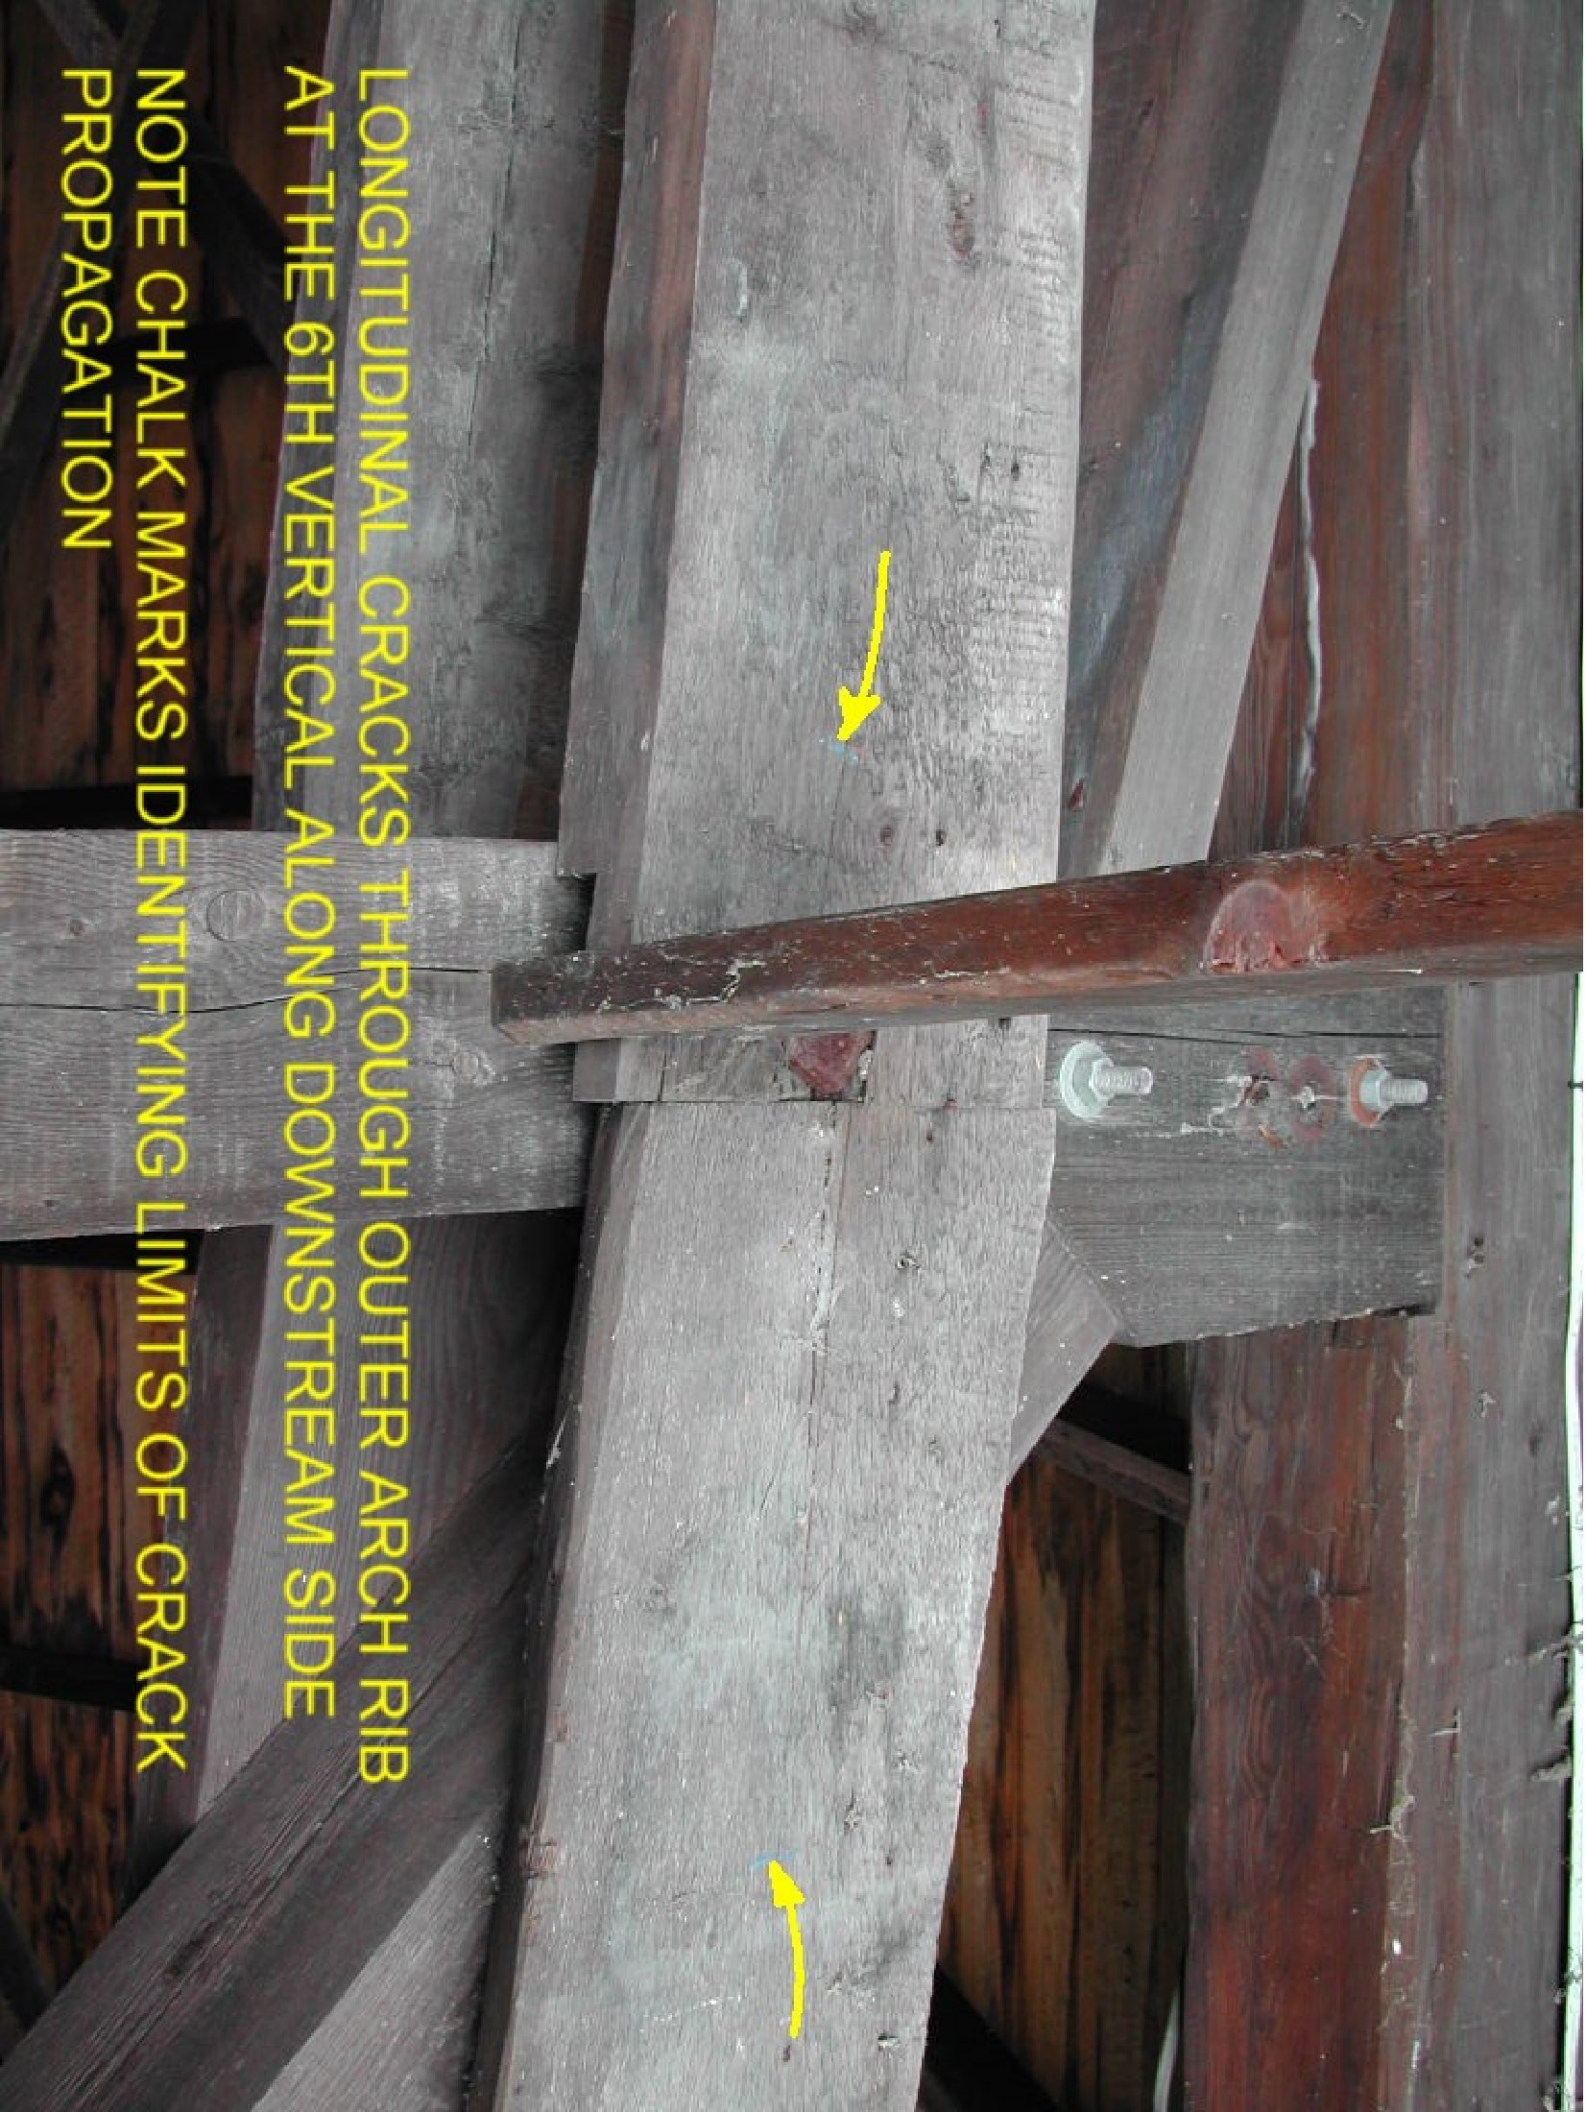
LONGITUDINAL CRACKS THROUGH OUTER ARCH RIB  
AT THE 6TH VERTICAL ALONG DOWNSTREAM SIDE  
NOTE CHALK MARKS IDENTIFYING LIMITS OF CRACK  
PROPAGATION
