SHEAR FAILURE OF TENON AT TOP POST

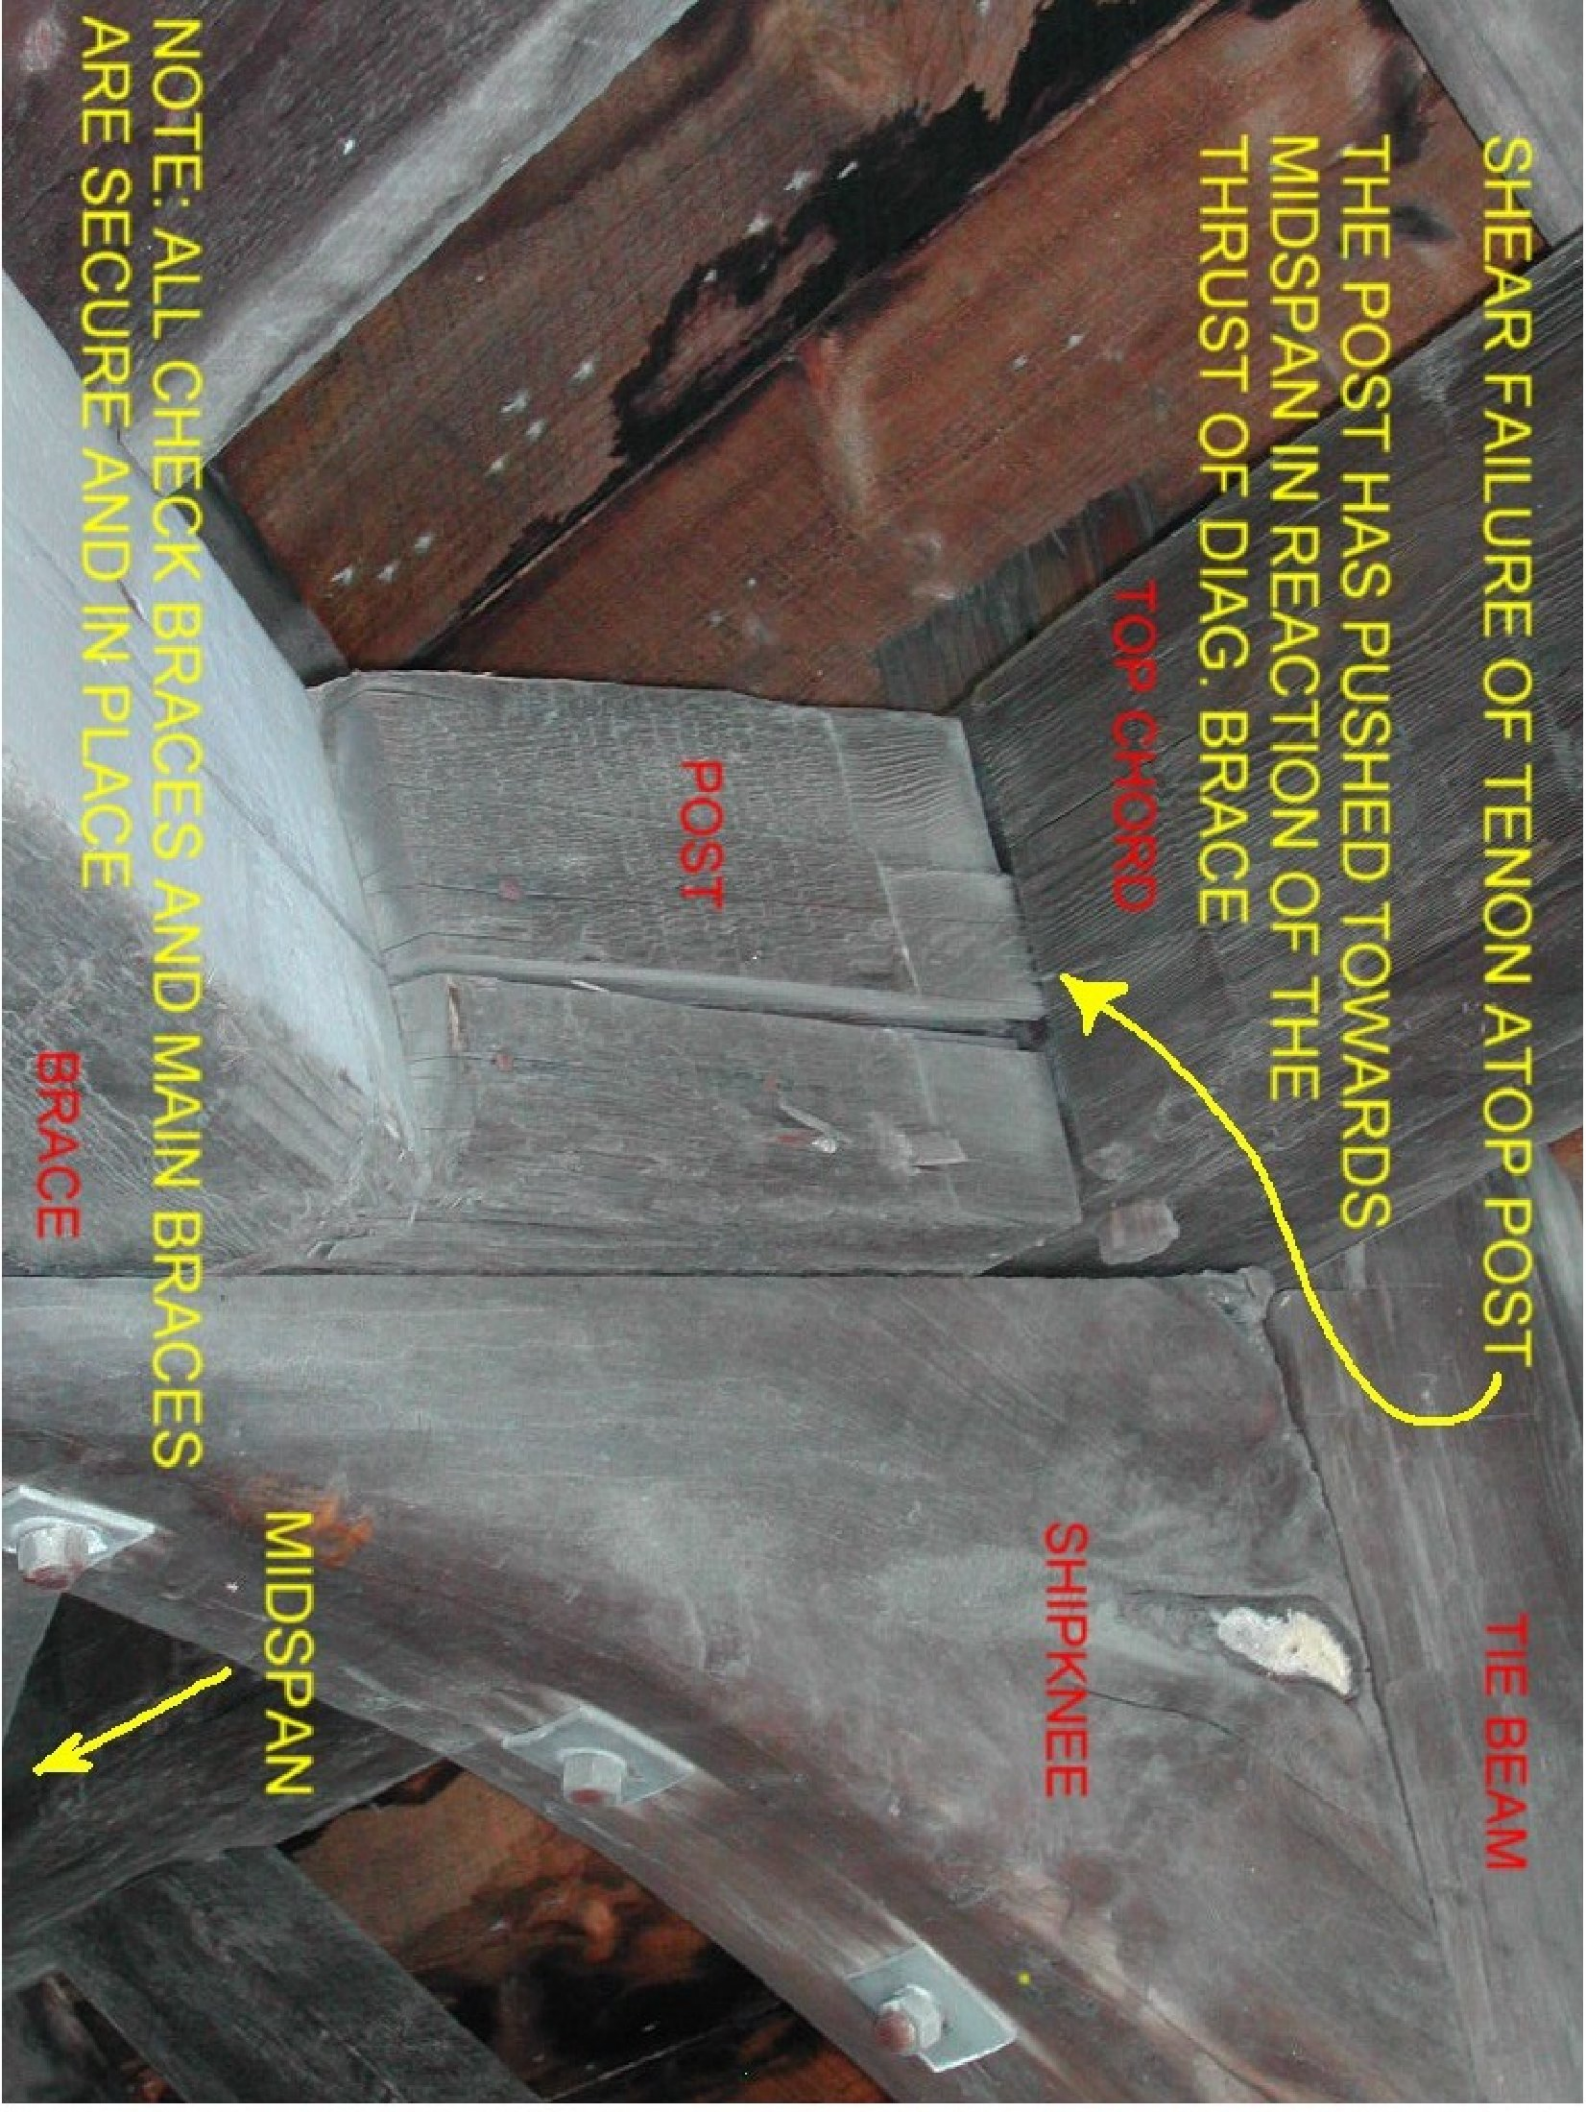
THE POST HAS PUSHED TOWARDS
MIDSPAN IN REACTION OF THE
THRUST OF DIAG. BRACE

NOTE: ALL CHECK BRACES AND MAIN BRACES
ARE SECURE AND IN PLACE
