JOB NO. 127-50N | DRG. NO. J2A

PROJECT NO. IM-089-2(26) STATE BRIDGE NO. 50N
MATERIAL AASHTO M270 Gr 36 ELECTRODES: PER PROC HOLES: AS NOTED SHOP BOLTS:
SURFACE PREP. & PAINT:
GALVANIZED AFTER FAB

DESCRIPTION: EXP. JOINT-ABUT. 2
JOB: BRIDGE 50N
I 89 OVER U.S. ROUTE 2
MIDDLESEX-BOLTON VT
CUSTOMER: WINTERSET INC.

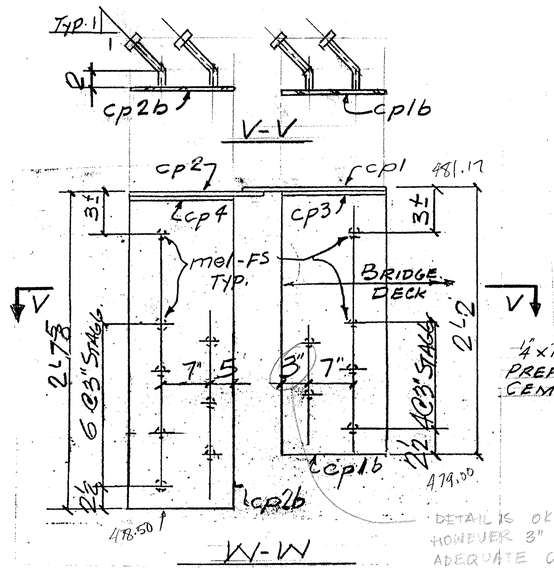
DETAIL IS OK @ SOUTH FACE HOWEVER 3" WILL NOT PROVIDE ADEQUATE COVER @ NORTH FACE
