SHEET 36

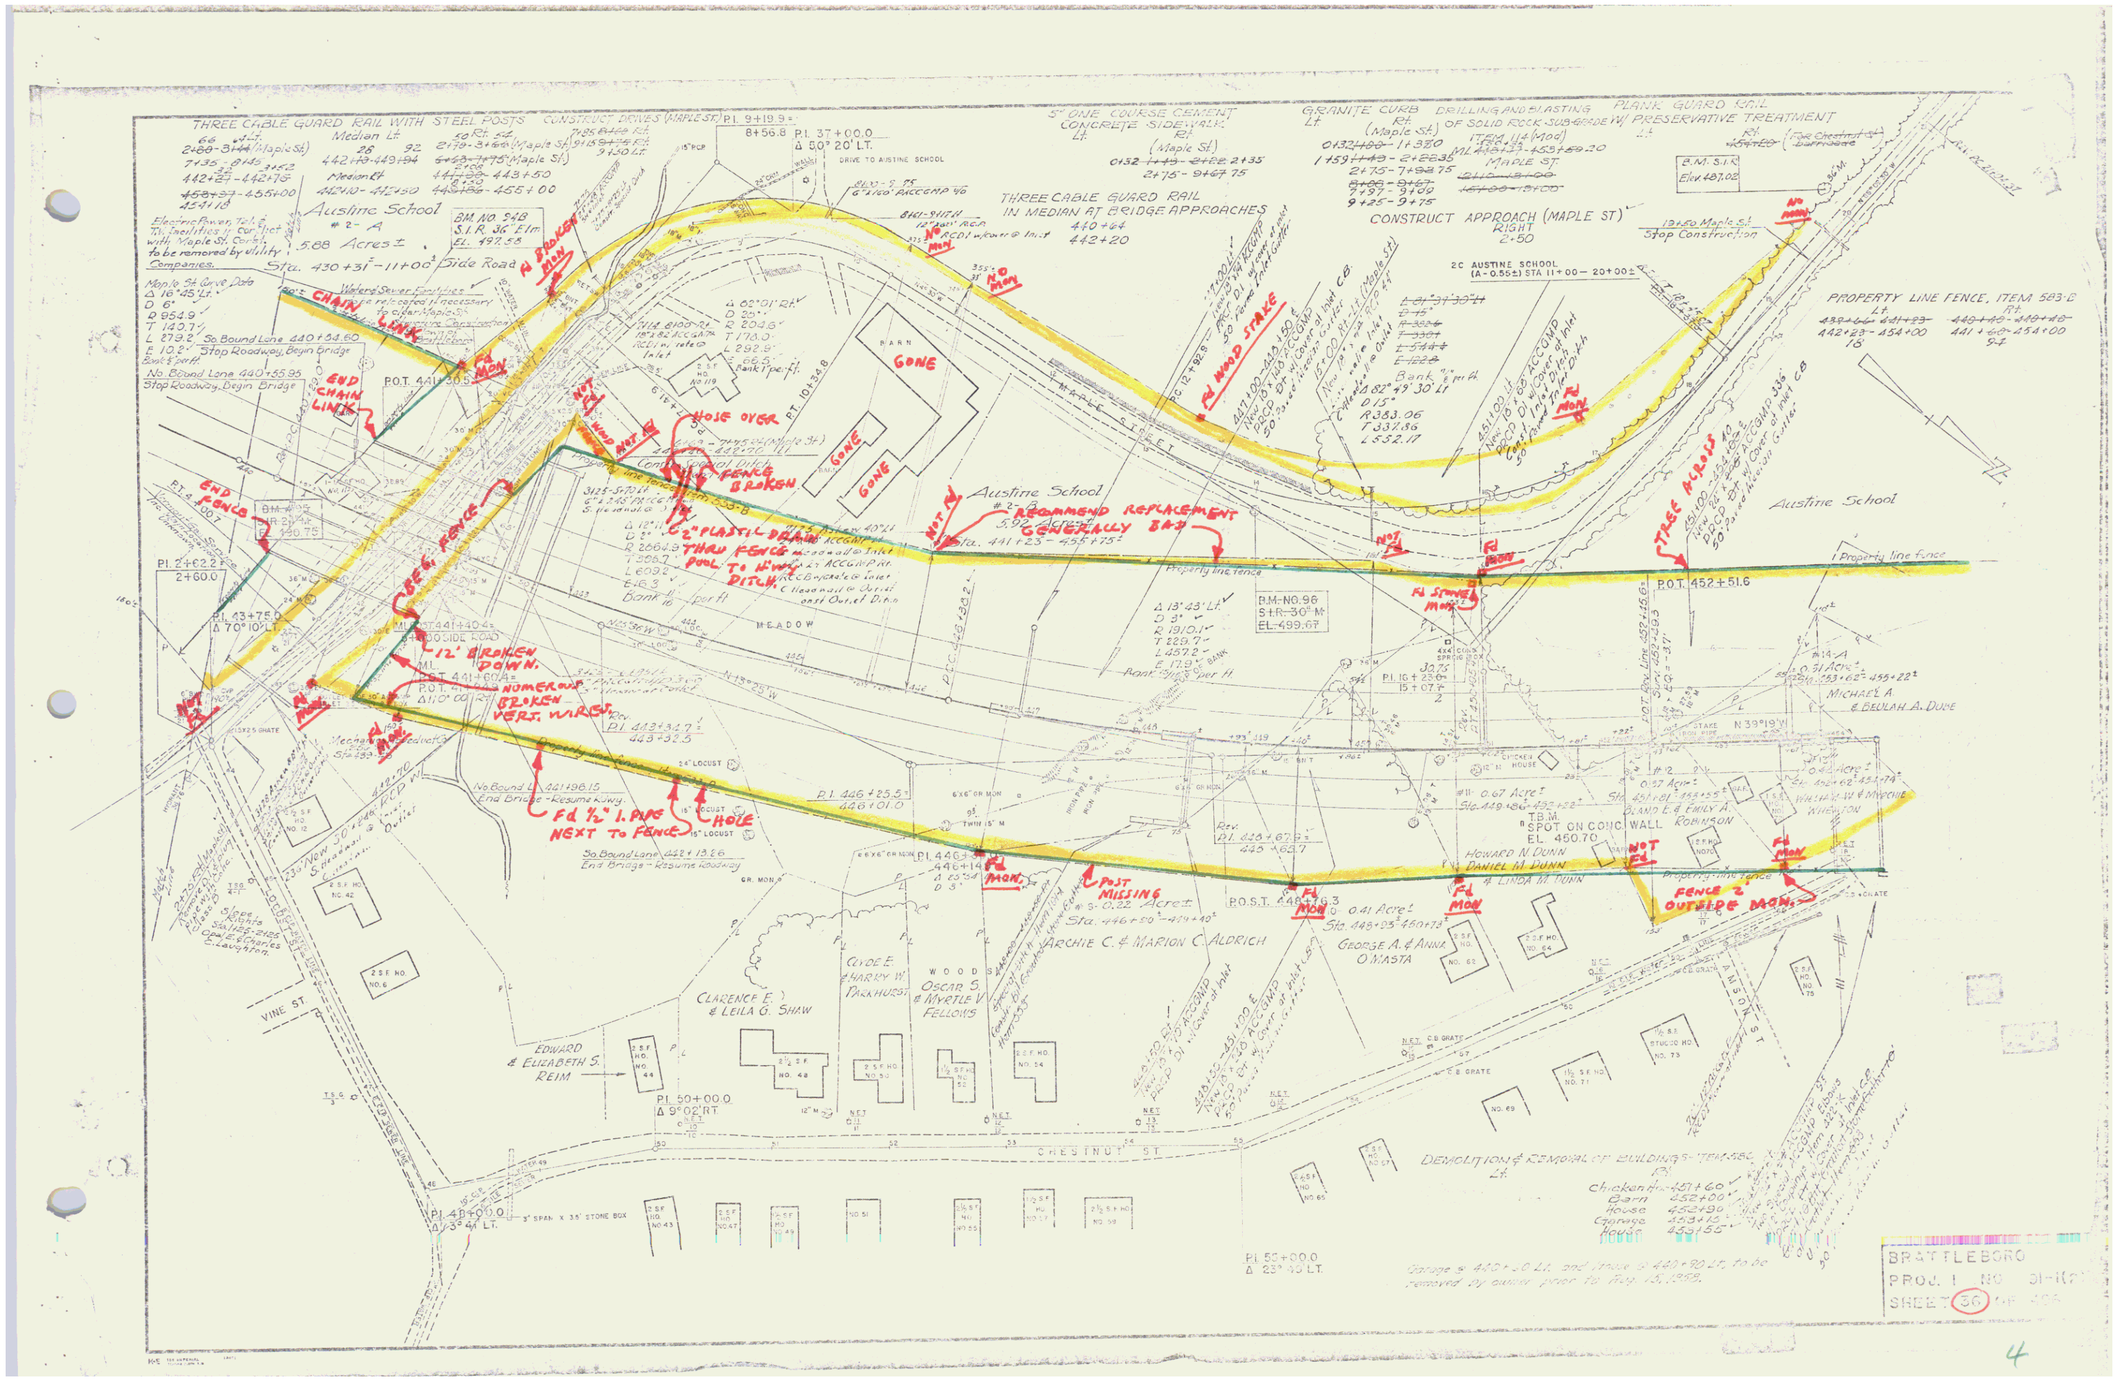
5.88 Acres ±
Sta. 430+31' - 11+00' Side Road
CHAIN LINK
END CHAIN LINK
END FENCE
HOSE OVER
FENCE BROKEN
RECOMMEND REPLACEMENT
GENERALLY BAD
12" PLASTIC DRAIN
THRU FENCE TO H'WAY DITCH
BEG. FENCE
12" BROKEN DOWN.
NUMEROUS BROKEN VERT. WIRES
Fd 1/2" I. PIPE NEXT TO FENCE
HOLE
POST MISSING
FENCE 2' OUTSIDE MON.
TILE ALREADY
Fd WOOD STAKE
Fd STONE MON.
BARN
GONE
MEADOW
Austine School
Property line fence
P.O.T. 452+51.6
B.M. NO. 96
S.I.R. 30" M
EL. 499.67
MICHAEL A. & BEULAH A. DUDE
HOWARD N. DUNN
DANIEL H. DUNN & LINDA M. DUNN
ARCHIE C. & MARION C. ALDRICH
GEORGE A. & ANNA O. MASTA
CLYDE E. & HARRY W. PARKHURST
OSCAR S. & MYRTLE V. FELLOWS
CLARENCE E. & LEILA G. SHAW
EDWARD & ELIZABETH S. REIM
VINE ST.
CHESTNUT ST.
DEMOLITION & REMOVAL OF BUILDINGS, ITEM 206.1
Garage & 440+-0 Lt. and House @ 440+90 Lt. to be removed by owner prior to Aug. 15, 1968.
BRATTLEBORO
PROJ. I NO
