PROJECT NAME: RYEGATE	
PROJECT NUMBER: STP CULV(10)	
FILE NAME:	PLOT DATE:
PROJECT LEADER:	DRAWN BY:
DESIGNED BY:	CHECKED BY:
Abandoned Structures	SHEET 7 OF 8

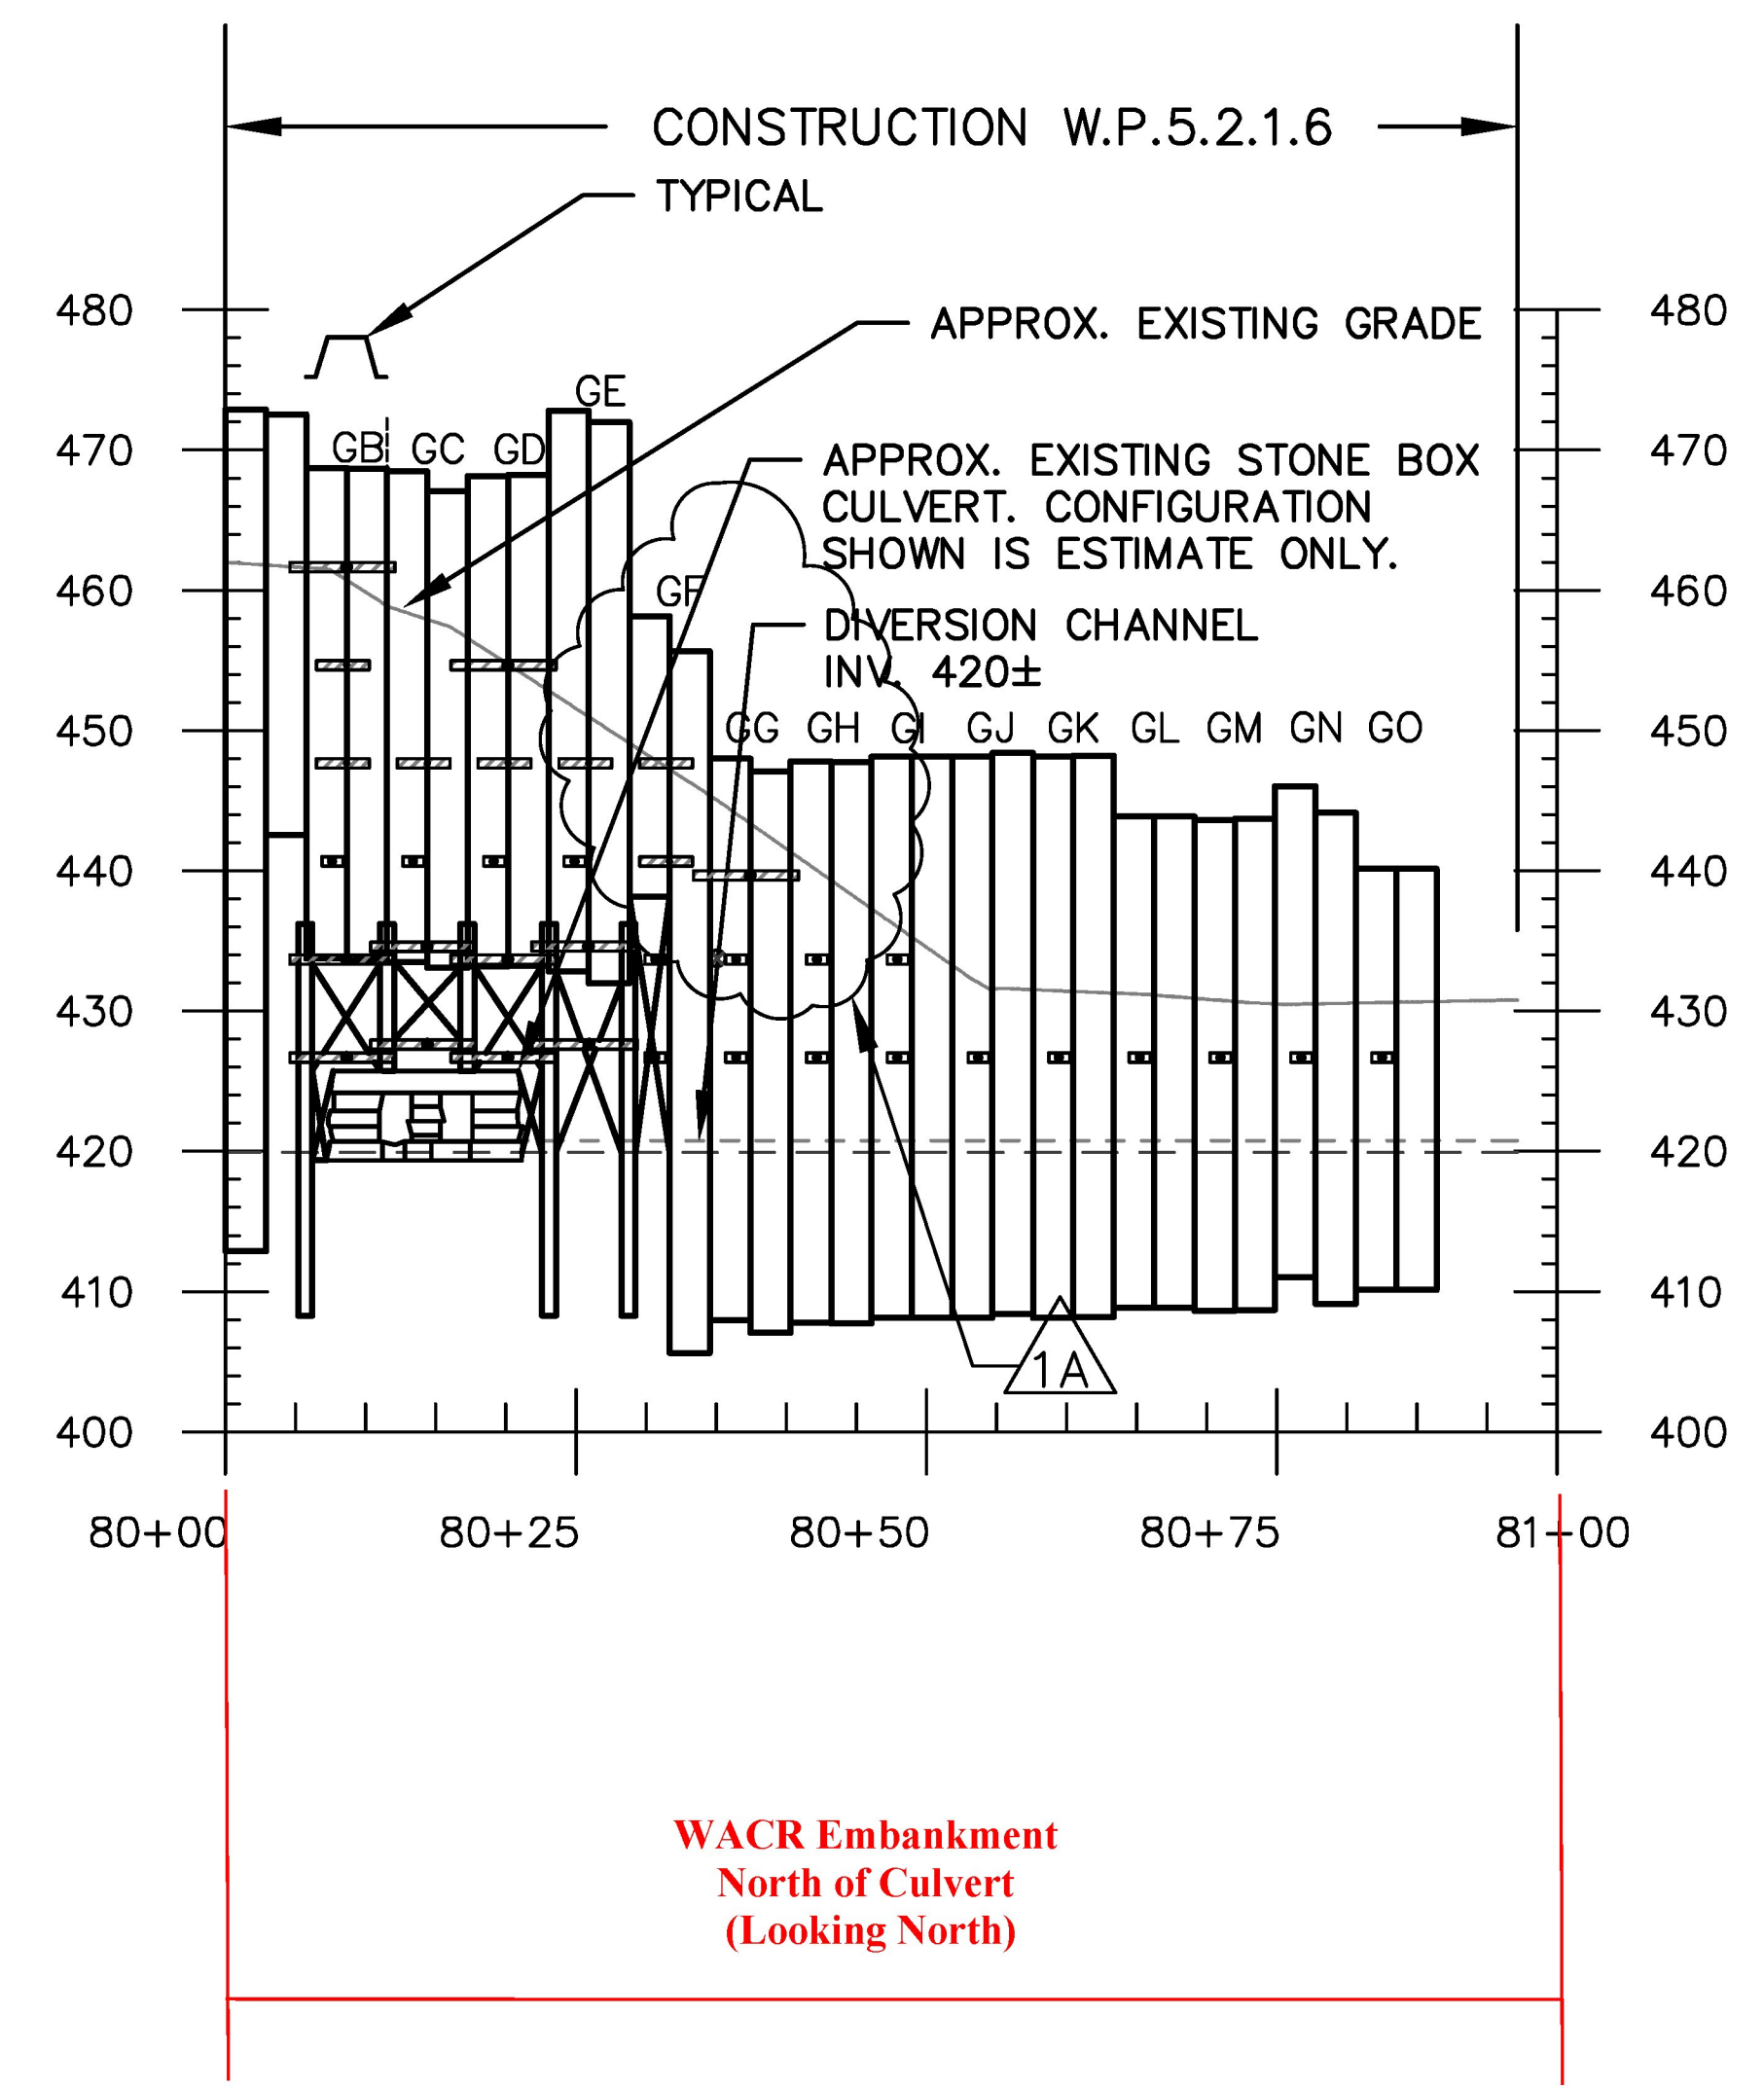
- Wales and Soil Anchor Heads Removed  
 - Sheet Piles Removed Except As Shown In Plan View

**(For Reference Only)**
