| PROJECT NAME: RYEGATE | |
| PROJECT NUMBER: STP CULV(10) | |
| Abandoned Structures | SHEET 8 OF 8 |

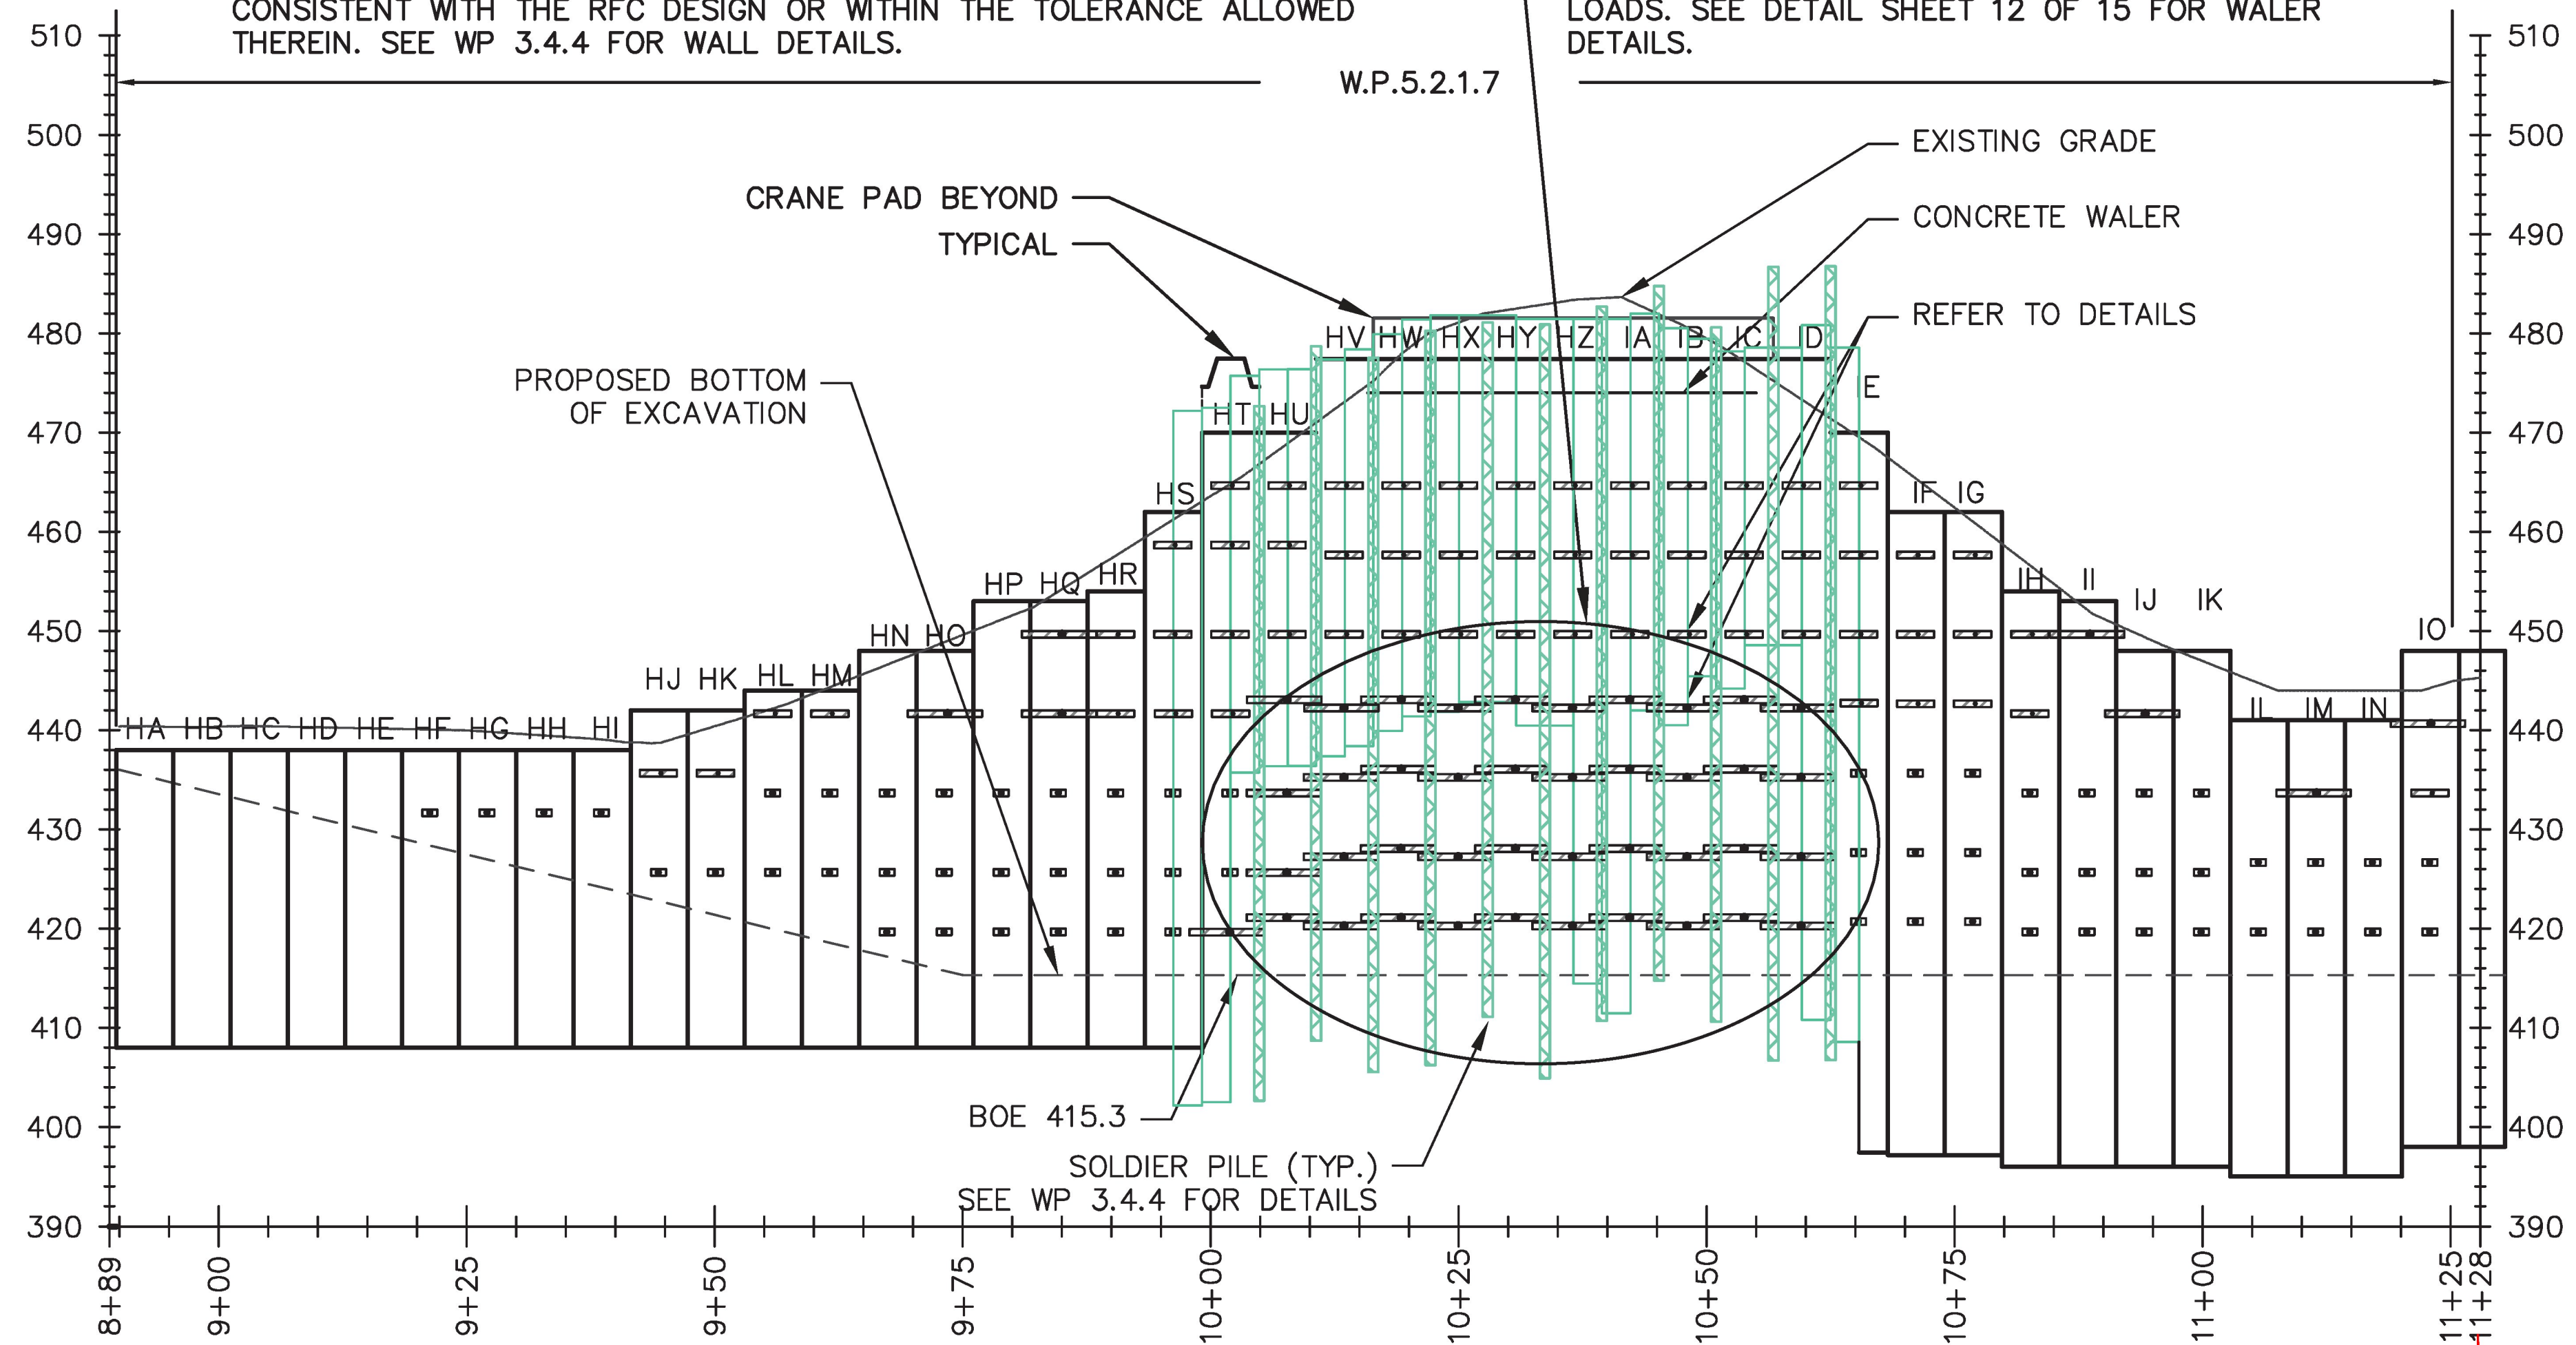
**WACR Embankment
South of Culvert
(Looking South)**

- SOIL NAIL WITH PLATE
TIEBACK OR SOIL NAIL
WITH WALER BEAM OR
BRACKET
- ⊙ TEST SOIL NAIL

SHEETPILES AND SOLDIER PILES SHOWN FROM 10+00 TO 10+63
REPRESENT AS-BUILT CONDITION. SHEETPILES SHOWN OUTSIDE THIS AREA
ARE DEPICTED AS DESIGNED BECAUSE THOSE SHEETS ARE INSTALLED
CONSISTENT WITH THE RFC DESIGN OR WITHIN THE TOLERANCE ALLOWED
THEREIN. SEE WP 3.4.4 FOR WALL DETAILS.

SOLDIER PILES ADDED TO THIS AREA. CHANGES WILL
BE SHOWN ON AMENDED WP 3.4.4. NO CHANGE IN
TIEBACK OR SOIL NAIL LOCATIONS, DIMENSIONS OR
LOADS. SEE DETAIL SHEET 12 OF 15 FOR WALER
DETAILS.

- Wales and Soil Anchor Heads Removed
- Sheet Piles Removed Except As Shown In Plan View
