PROJECT NAME: BURKE
PROJECT NUMBER: BRF 0269(13)

FILE NAME: z10c412rall.dgn
PROJECT LEADER: J. BYATT
DESIGNED BY: S. BEAUMONT
APPROACH RAIL DETAILS (3 OF 4)

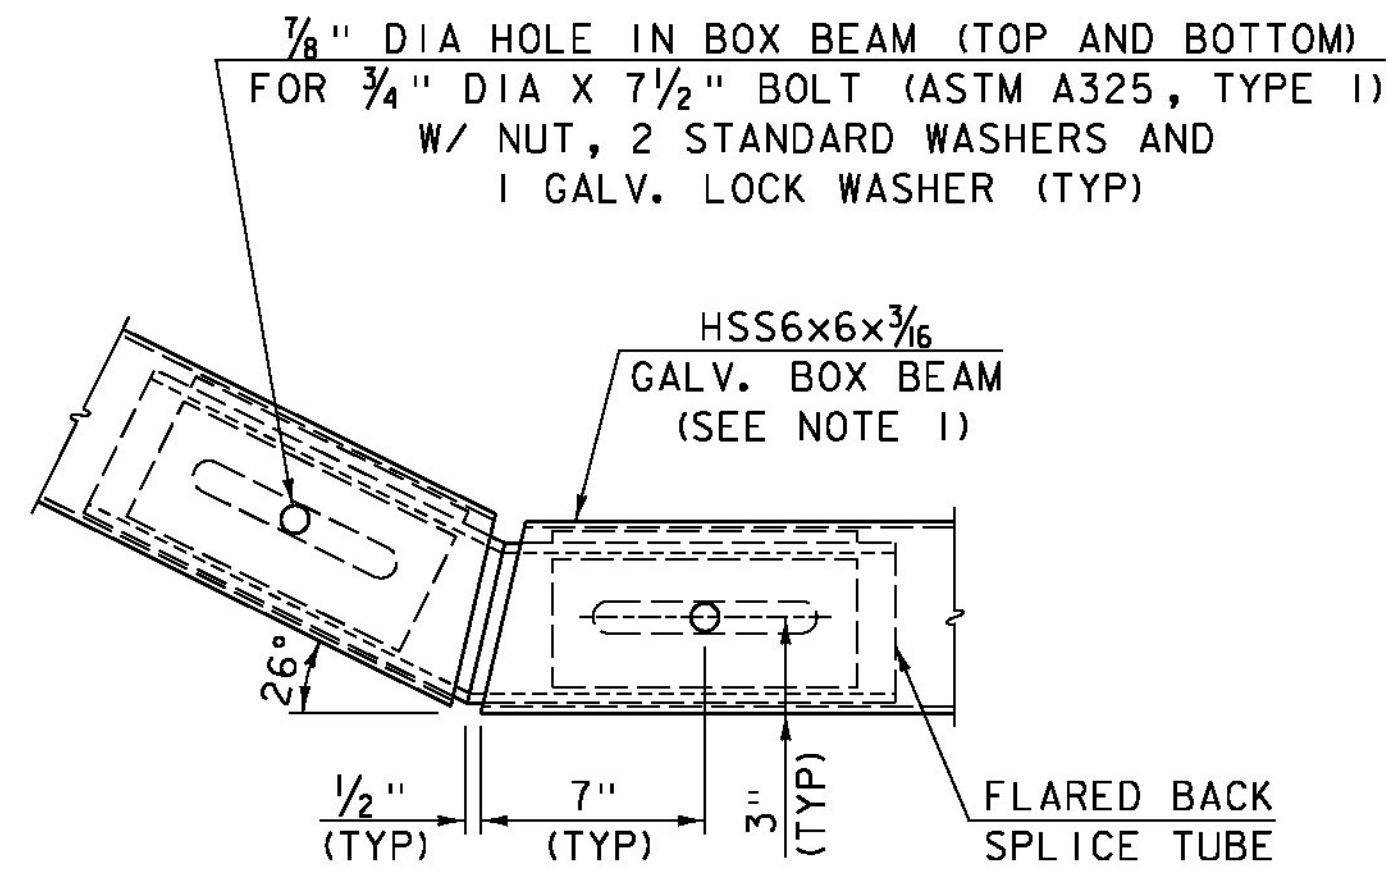
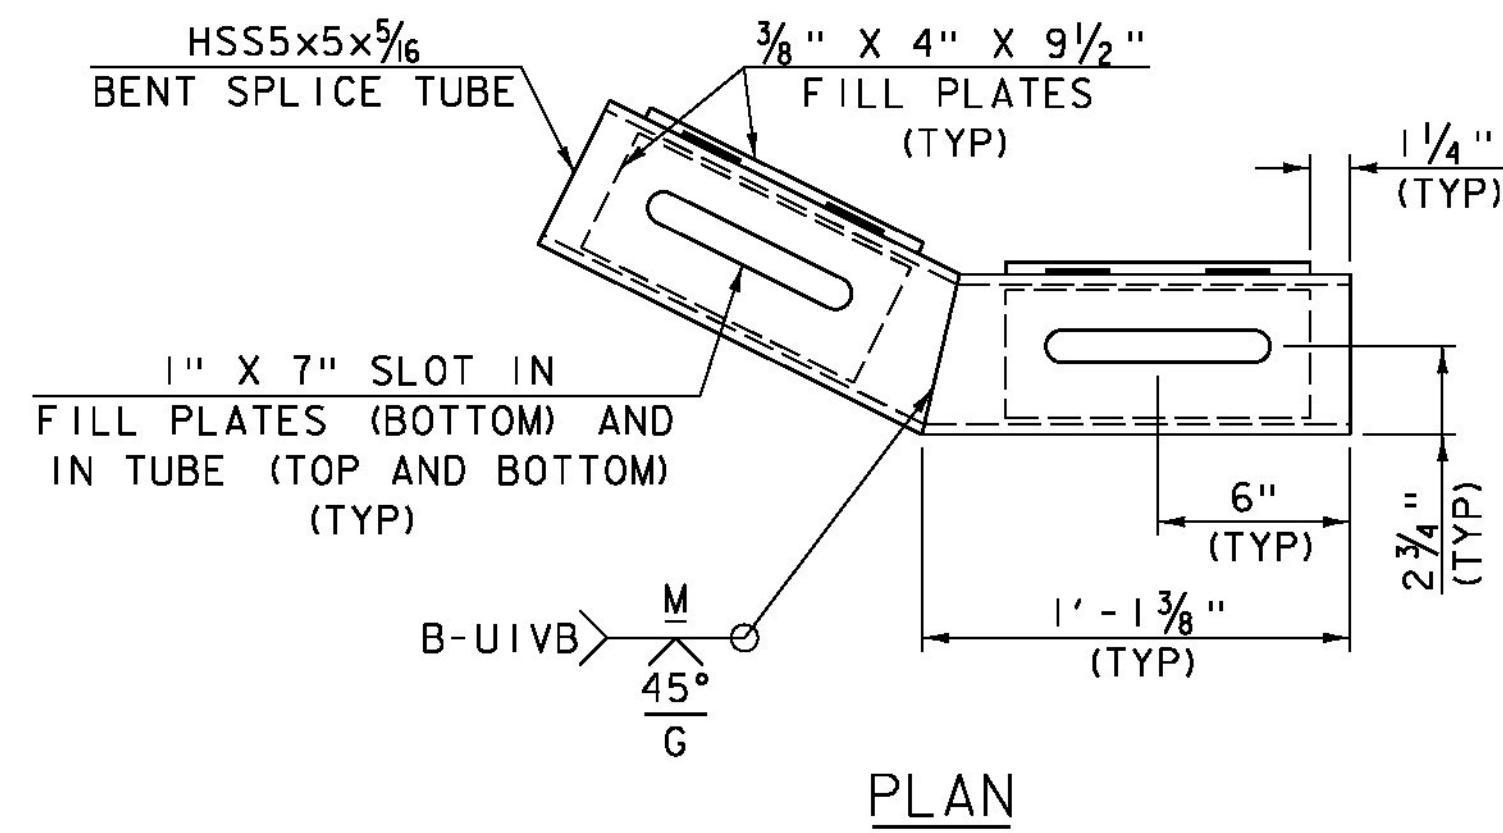
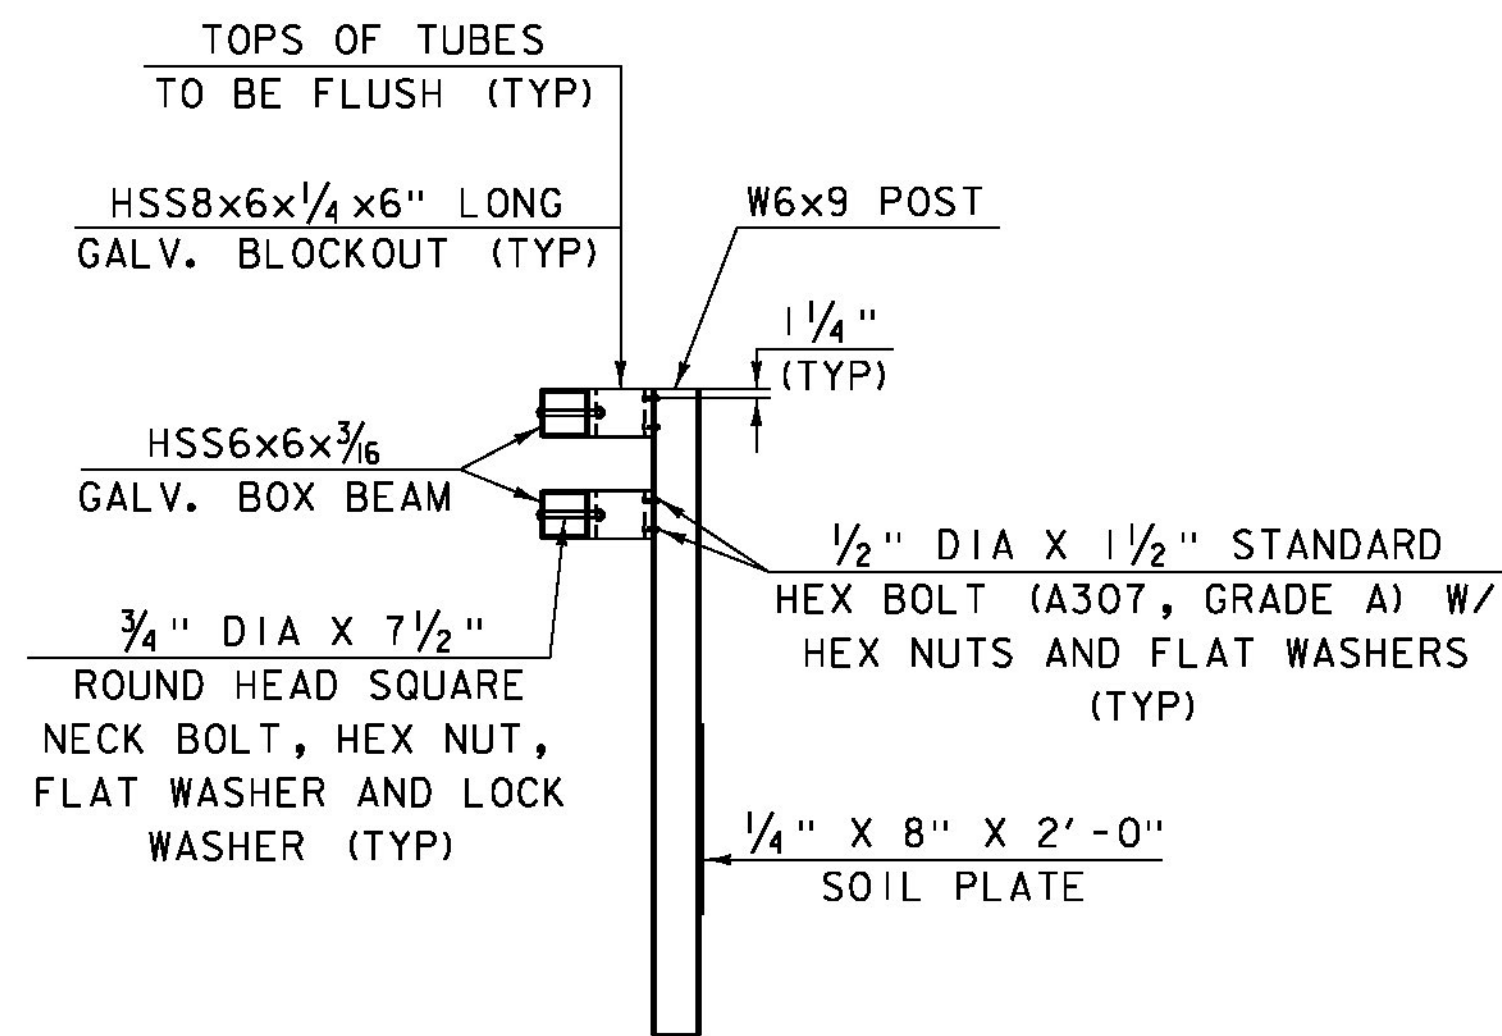
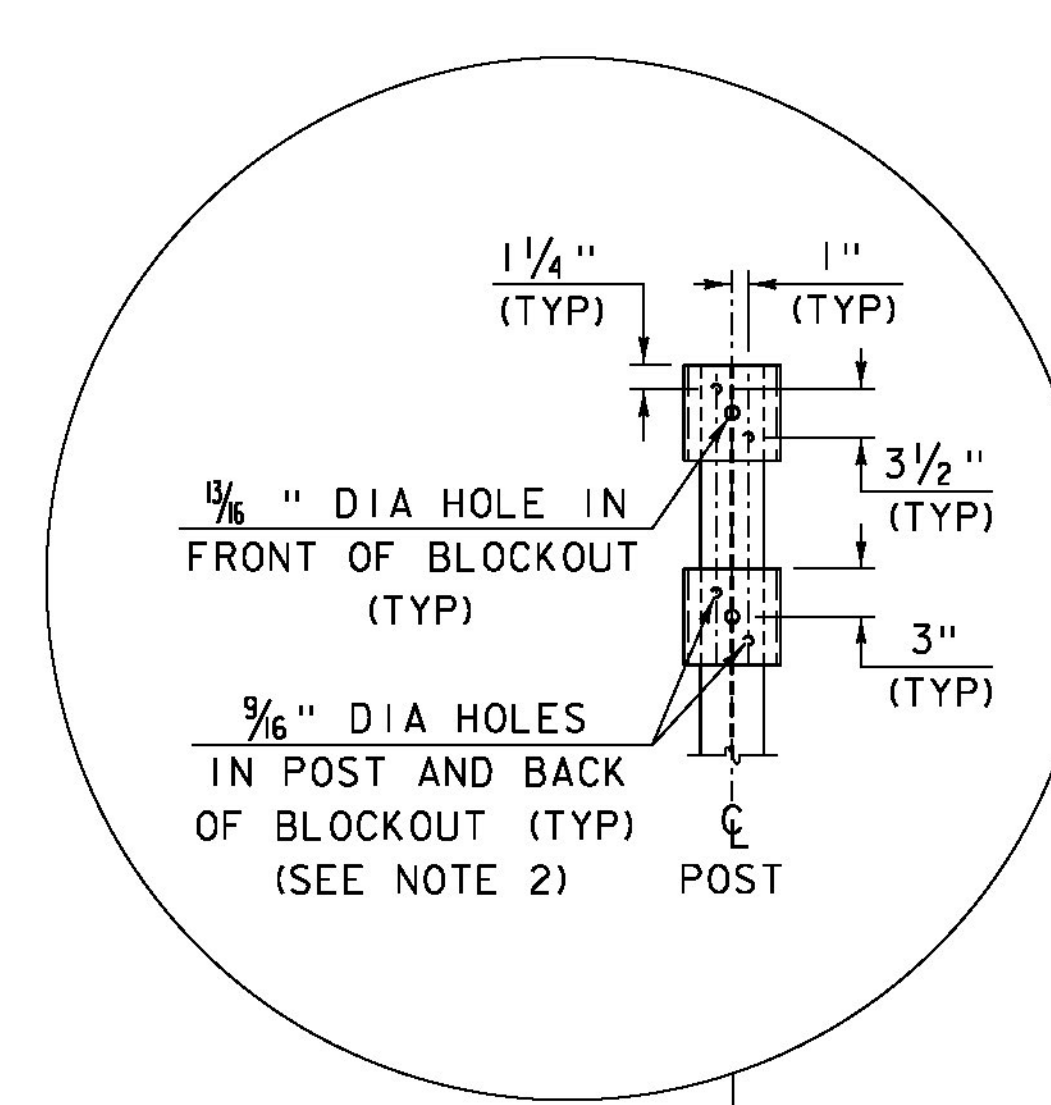
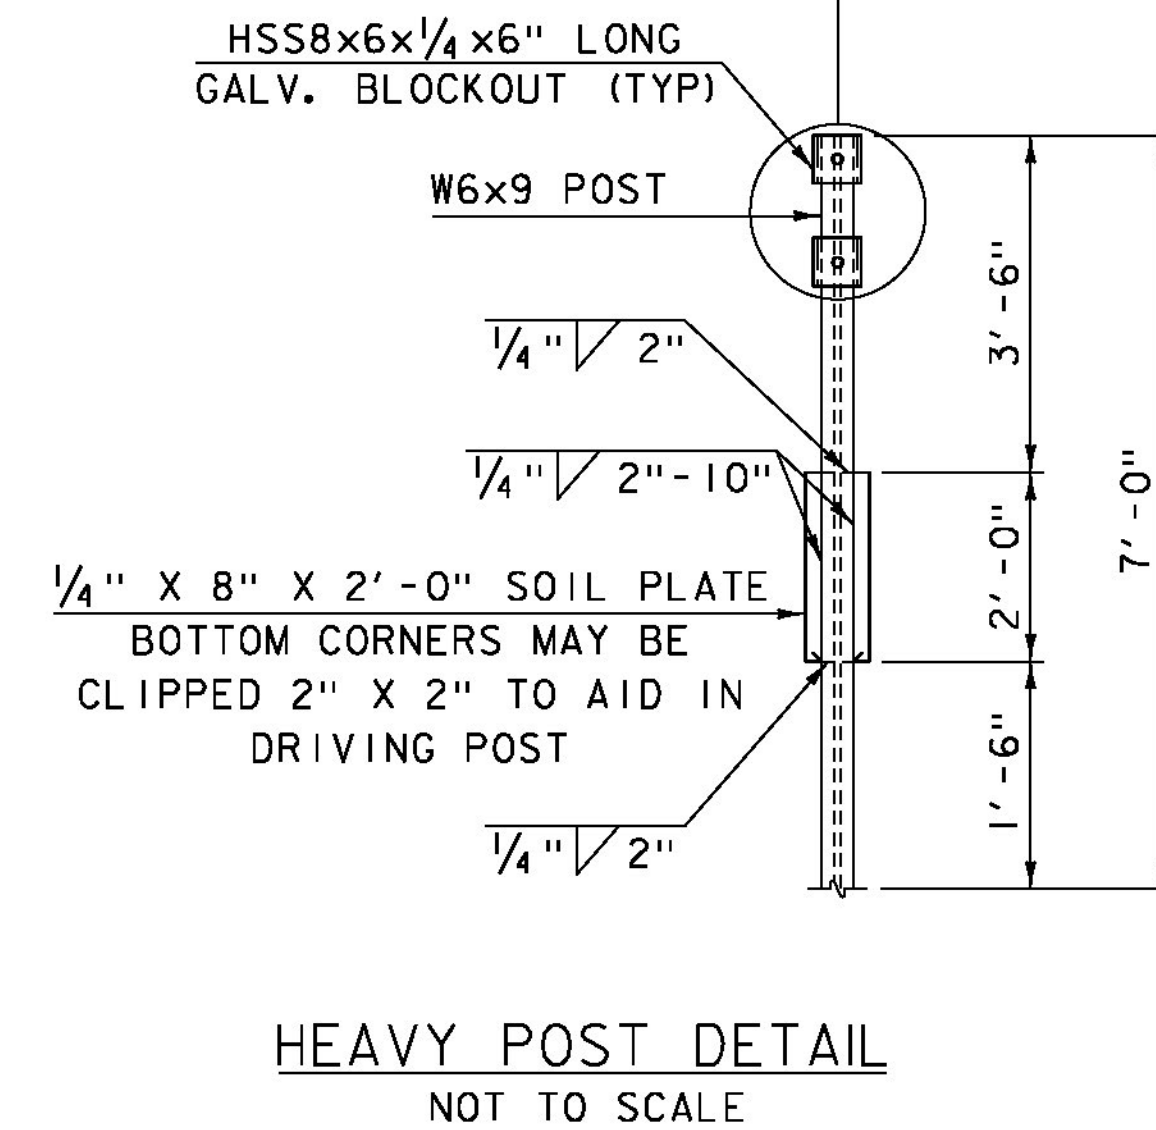
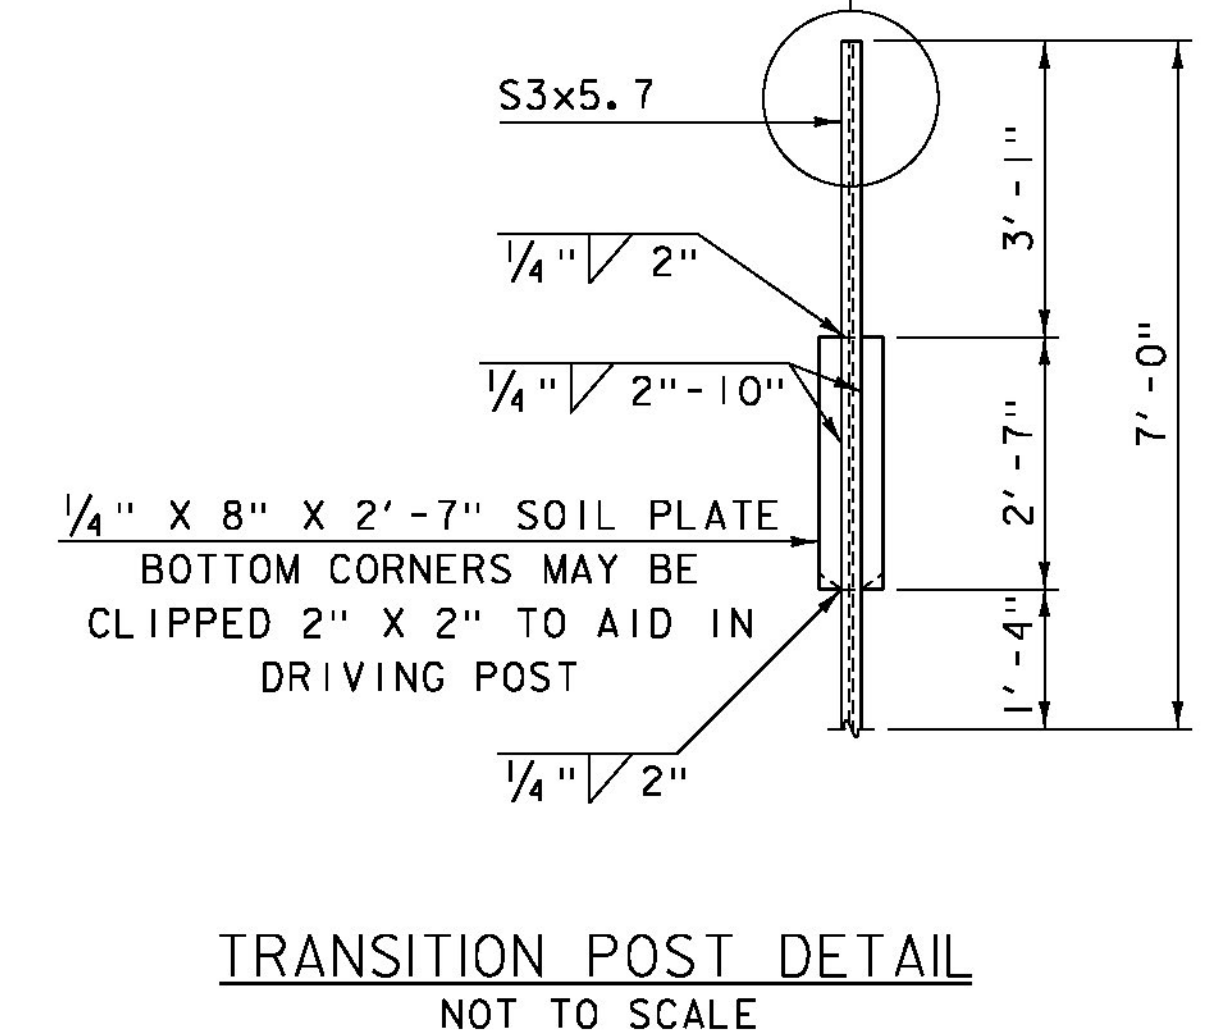
1. PROTRUSIONS CAUSED BY WELDING OR GALVANIZING ARE NOT PERMITTED ON THE ADJOINING SURFACES OF THE BOX BEAM RAILS, SPLICE TUBES AND FILL PLATES.
2. HOLES IN POST FOR LOWER RAIL MAY BE LOCATED AND DRILLED IN THE FIELD. IF SO, GALVANIZING SHALL BE REPAIRED.
