GUARDRAIL REPLACEMENT GUIDELINES

PROJECT NAME:	MONTPELIER-WATERBURY
PROJECT NUMBER:	IM SURF(59)
FILE NAME: pl6v098 Montpelier-Water.dgn	PLOT DATE: 20-MAR-2018
PROJECT LEADER: M. BOGACZYK	DRAWN BY: N. PAPPAS
DESIGNED BY: N. PAPPAS	CHECKED BY: M. BOGACZYK
GUARDRAIL REPLACEMENT DETAIL 2	SHEET 14 OF 34

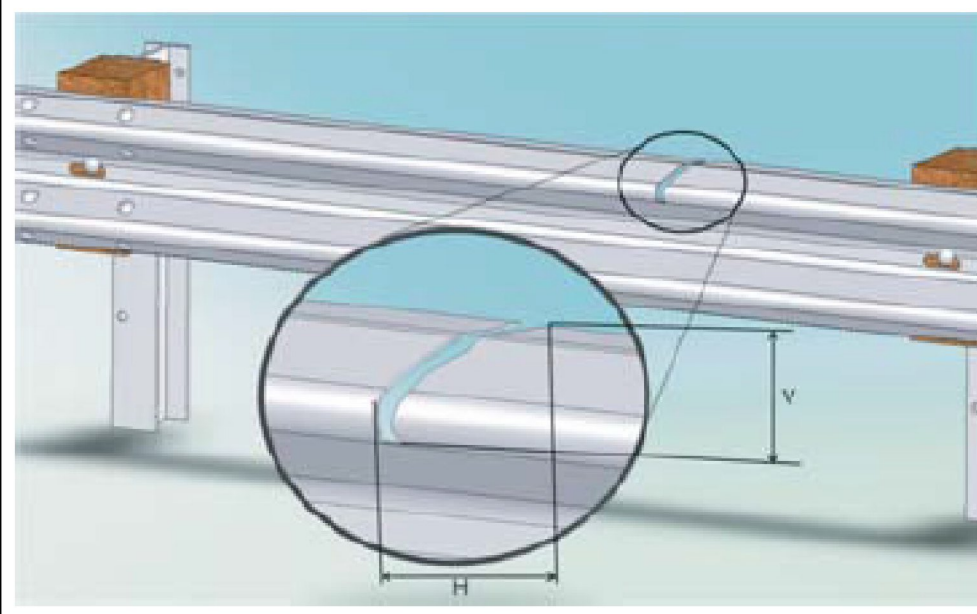
DAMAGE TYPE	REPAIR THRESHOLD	RELATIVE PRIORITY	MEASUREMENT
VERTICAL TEAR	ANY LENGTH VERTICAL (TRANSVERSE) TEAR	HIGH

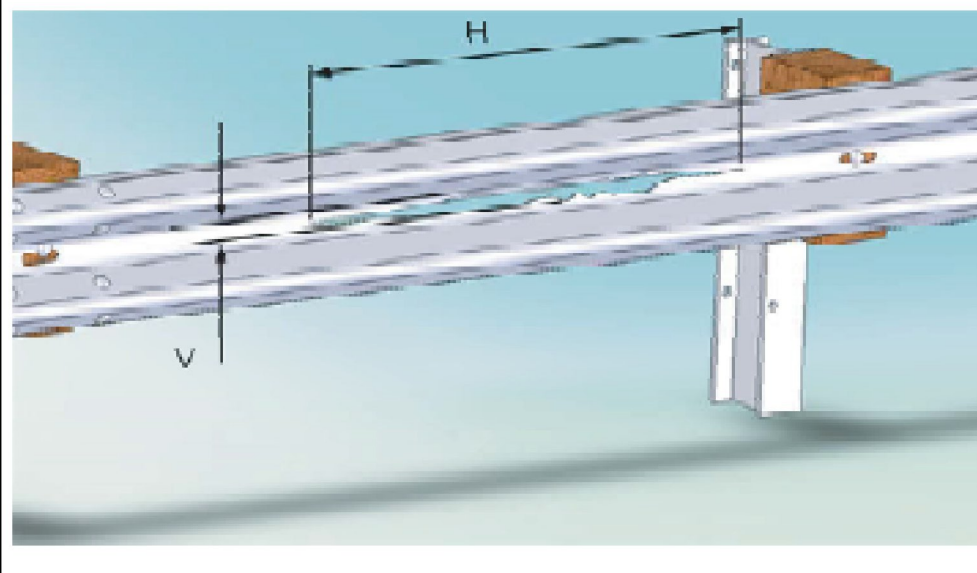
HORIZONTAL TEAR	HORIZONTAL (LONGITUDINAL) GREATER THAN 12 IN. LONG AND GREATER THAN 0.5 IN. WIDE NOTE: FOR HORIZONTAL TEARS LESS THAN 12 IN. IN LENGTH OR LESS THAN 0.5 IN. IN HEIGHT, USE THE NON-MANUFACTURED HOLES GUIDELINES	MEDIUM

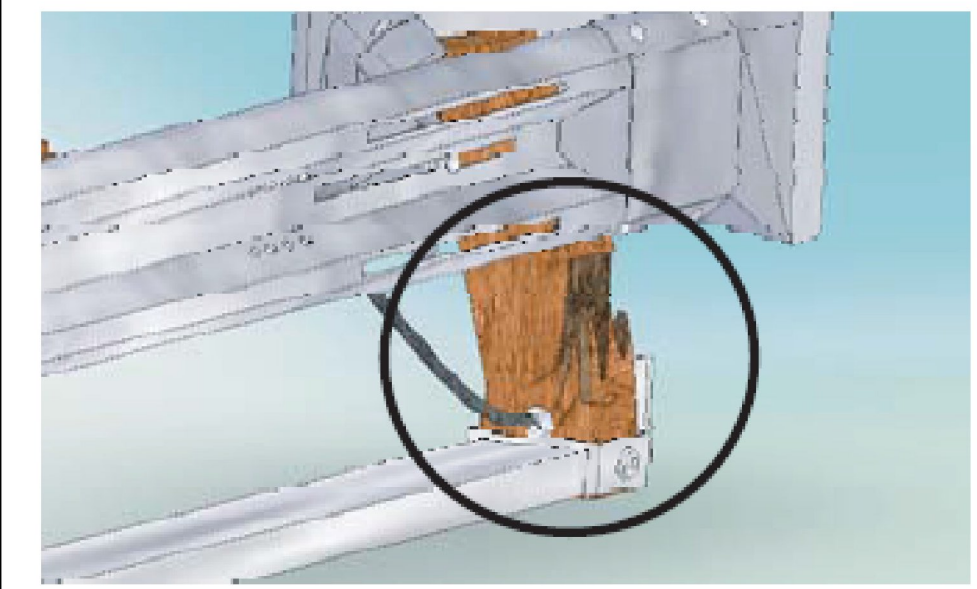
DAMAGE TYPE	REPAIR THRESHOLD	RELATIVE PRIORITY	MEASUREMENT
DAMAGED END POST	NOT FUNCTIONAL (SHEARED, ROTTED CRACKED ACROSS THE GRAIN)	HIGH

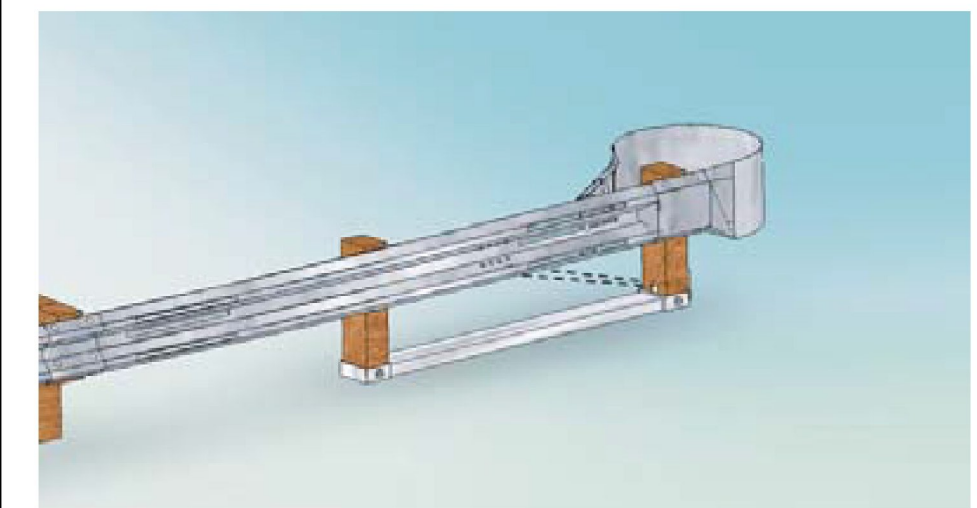
ANCHOR CABLE	MISSING	HIGH

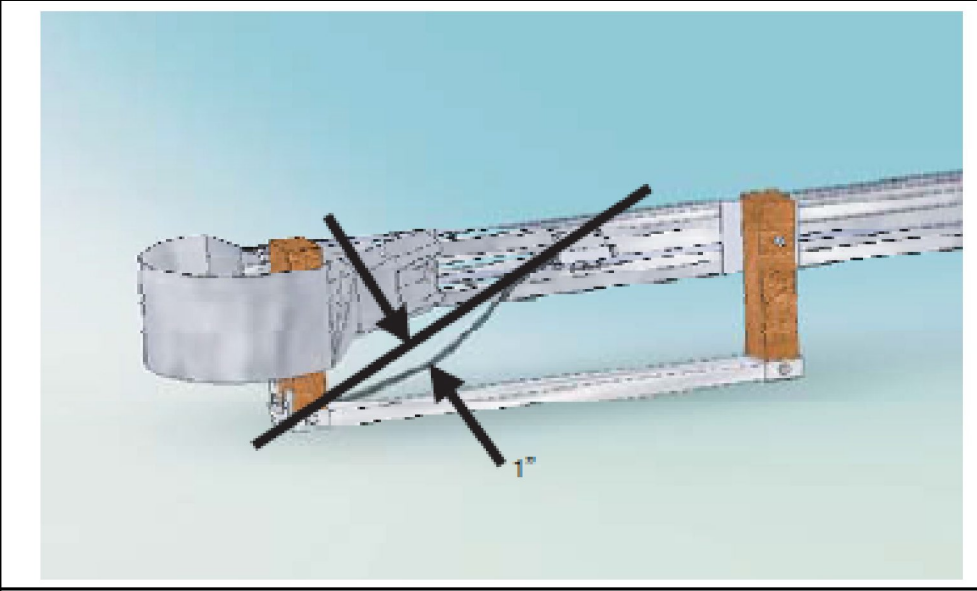
ANCHOR CABLE	LOOSE - MORE THAN 1 IN. OF MOVEMENT WHEN PUSHED DOWN BY HAND	MEDIUM

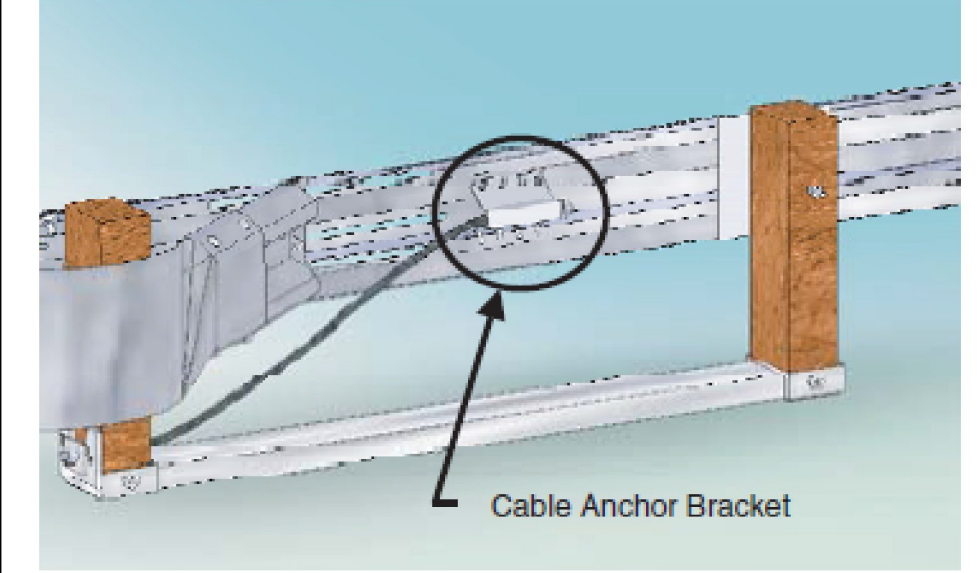
CABLE ANCHOR BRACKET	LOOSE OR NOT FIRMLY SEATED IN RAIL	MEDIUM

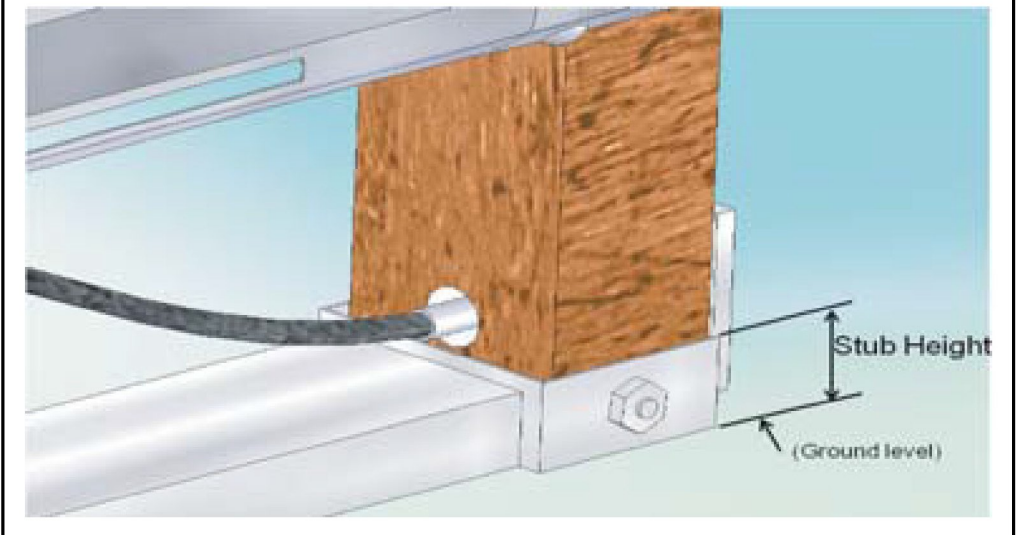
DAMAGE TYPE	REPAIR THRESHOLD	RELATIVE PRIORITY	MEASUREMENT
STUB HEIGHT	HEIGHT WHICH EXCEEDS 4 IN.	MEDIUM

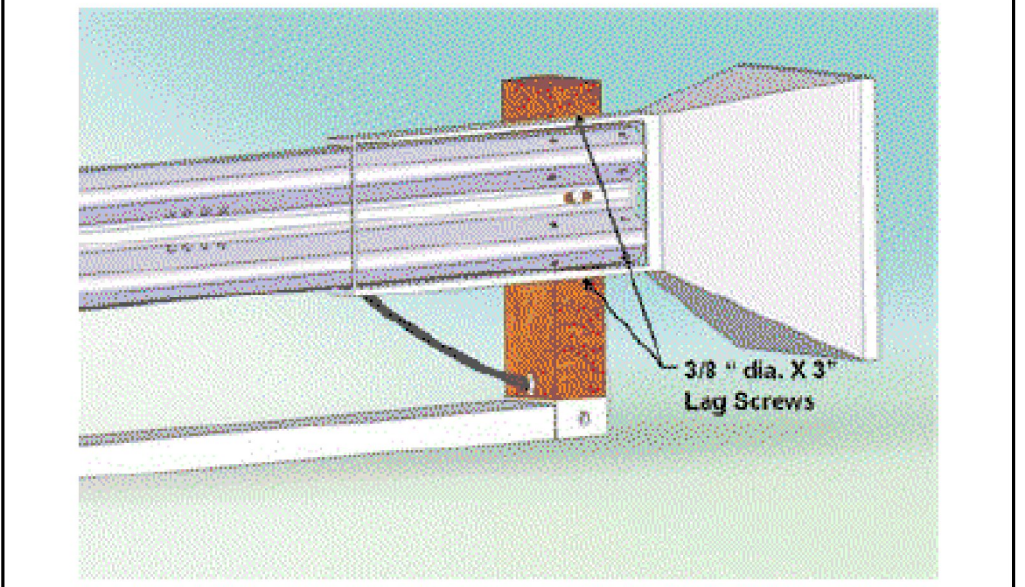
LAG SCREWS (ENERGY ABSORBING TERMINALS ONLY)	HEIGHT WHICH EXCEEDS 4 IN.	MEDIUM

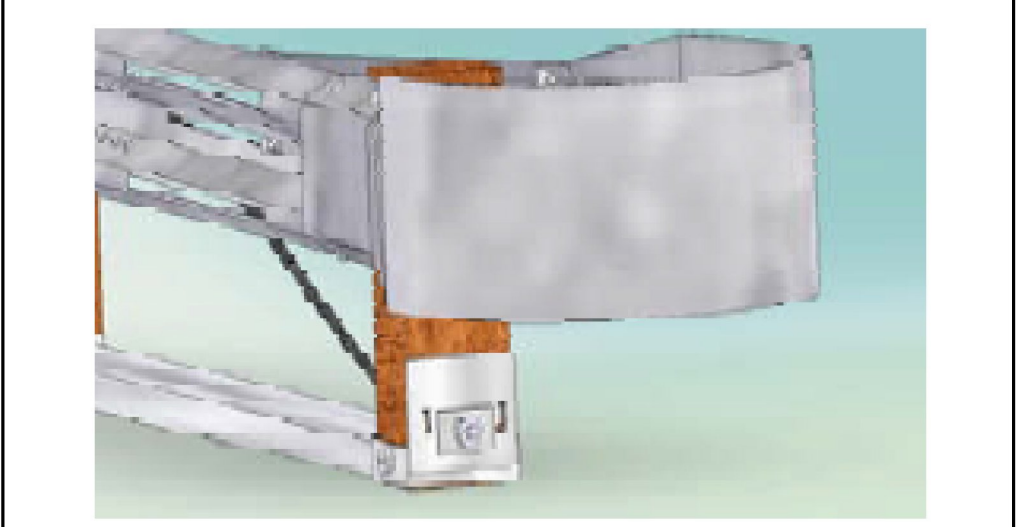
(CORRECT BEARING PLATE)

BEARING PLATE	LOOSE OR MISALIGNED	MEDIUM

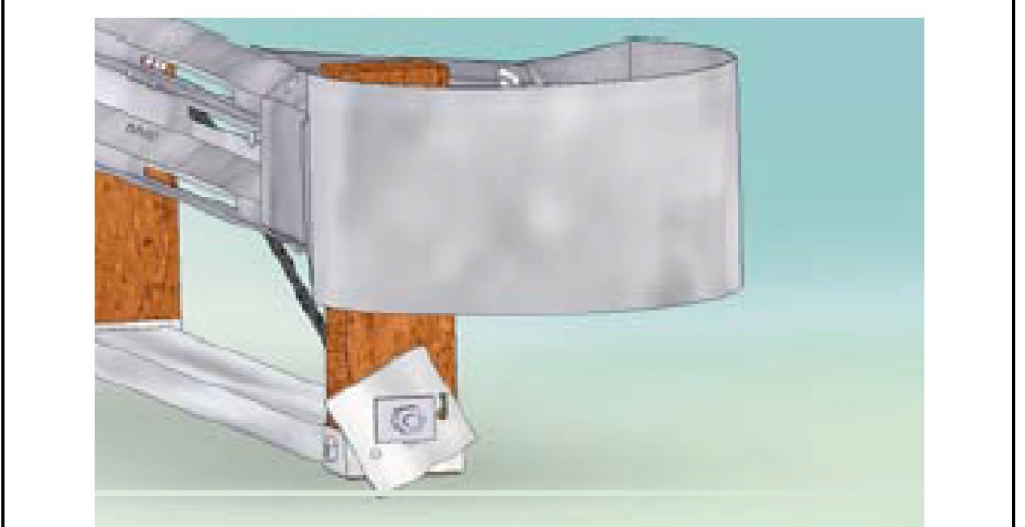
(MISALIGNED BEARING PLATE)
	MISSING BEARING PLATE	HIGH
