GUARDRAIL REPLACEMENT GUIDELINES

PROJECT NAME: ENOSBURGH-RICHFORD
PROJECT NUMBER: STP 2969(1)

FILE NAME: z16v104detail.dgn
PROJECT LEADER: G. EDWARDS
DESIGNED BY: G. BURGMEIER
GUARDRAIL DETAIL SHEET 5

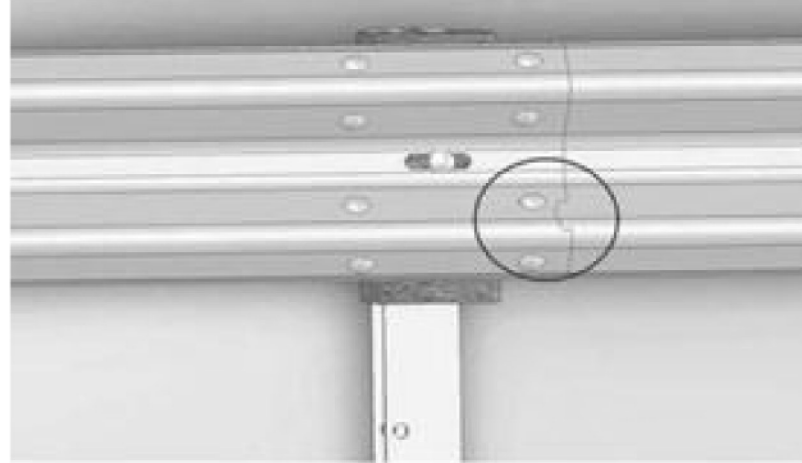
DAMAGE AT A RAIL SPLICE	MORE THAN 1 SPLICE BOLT: <ul style="list-style-type: none"> MISSING DAMAGED VISIBLY MISSING ANY UNDERLYING RAIL TORN THROUGH RAIL 	HIGH
