VERMONT AGENCY OF TRANSPORTATION

STANDARD

D-4

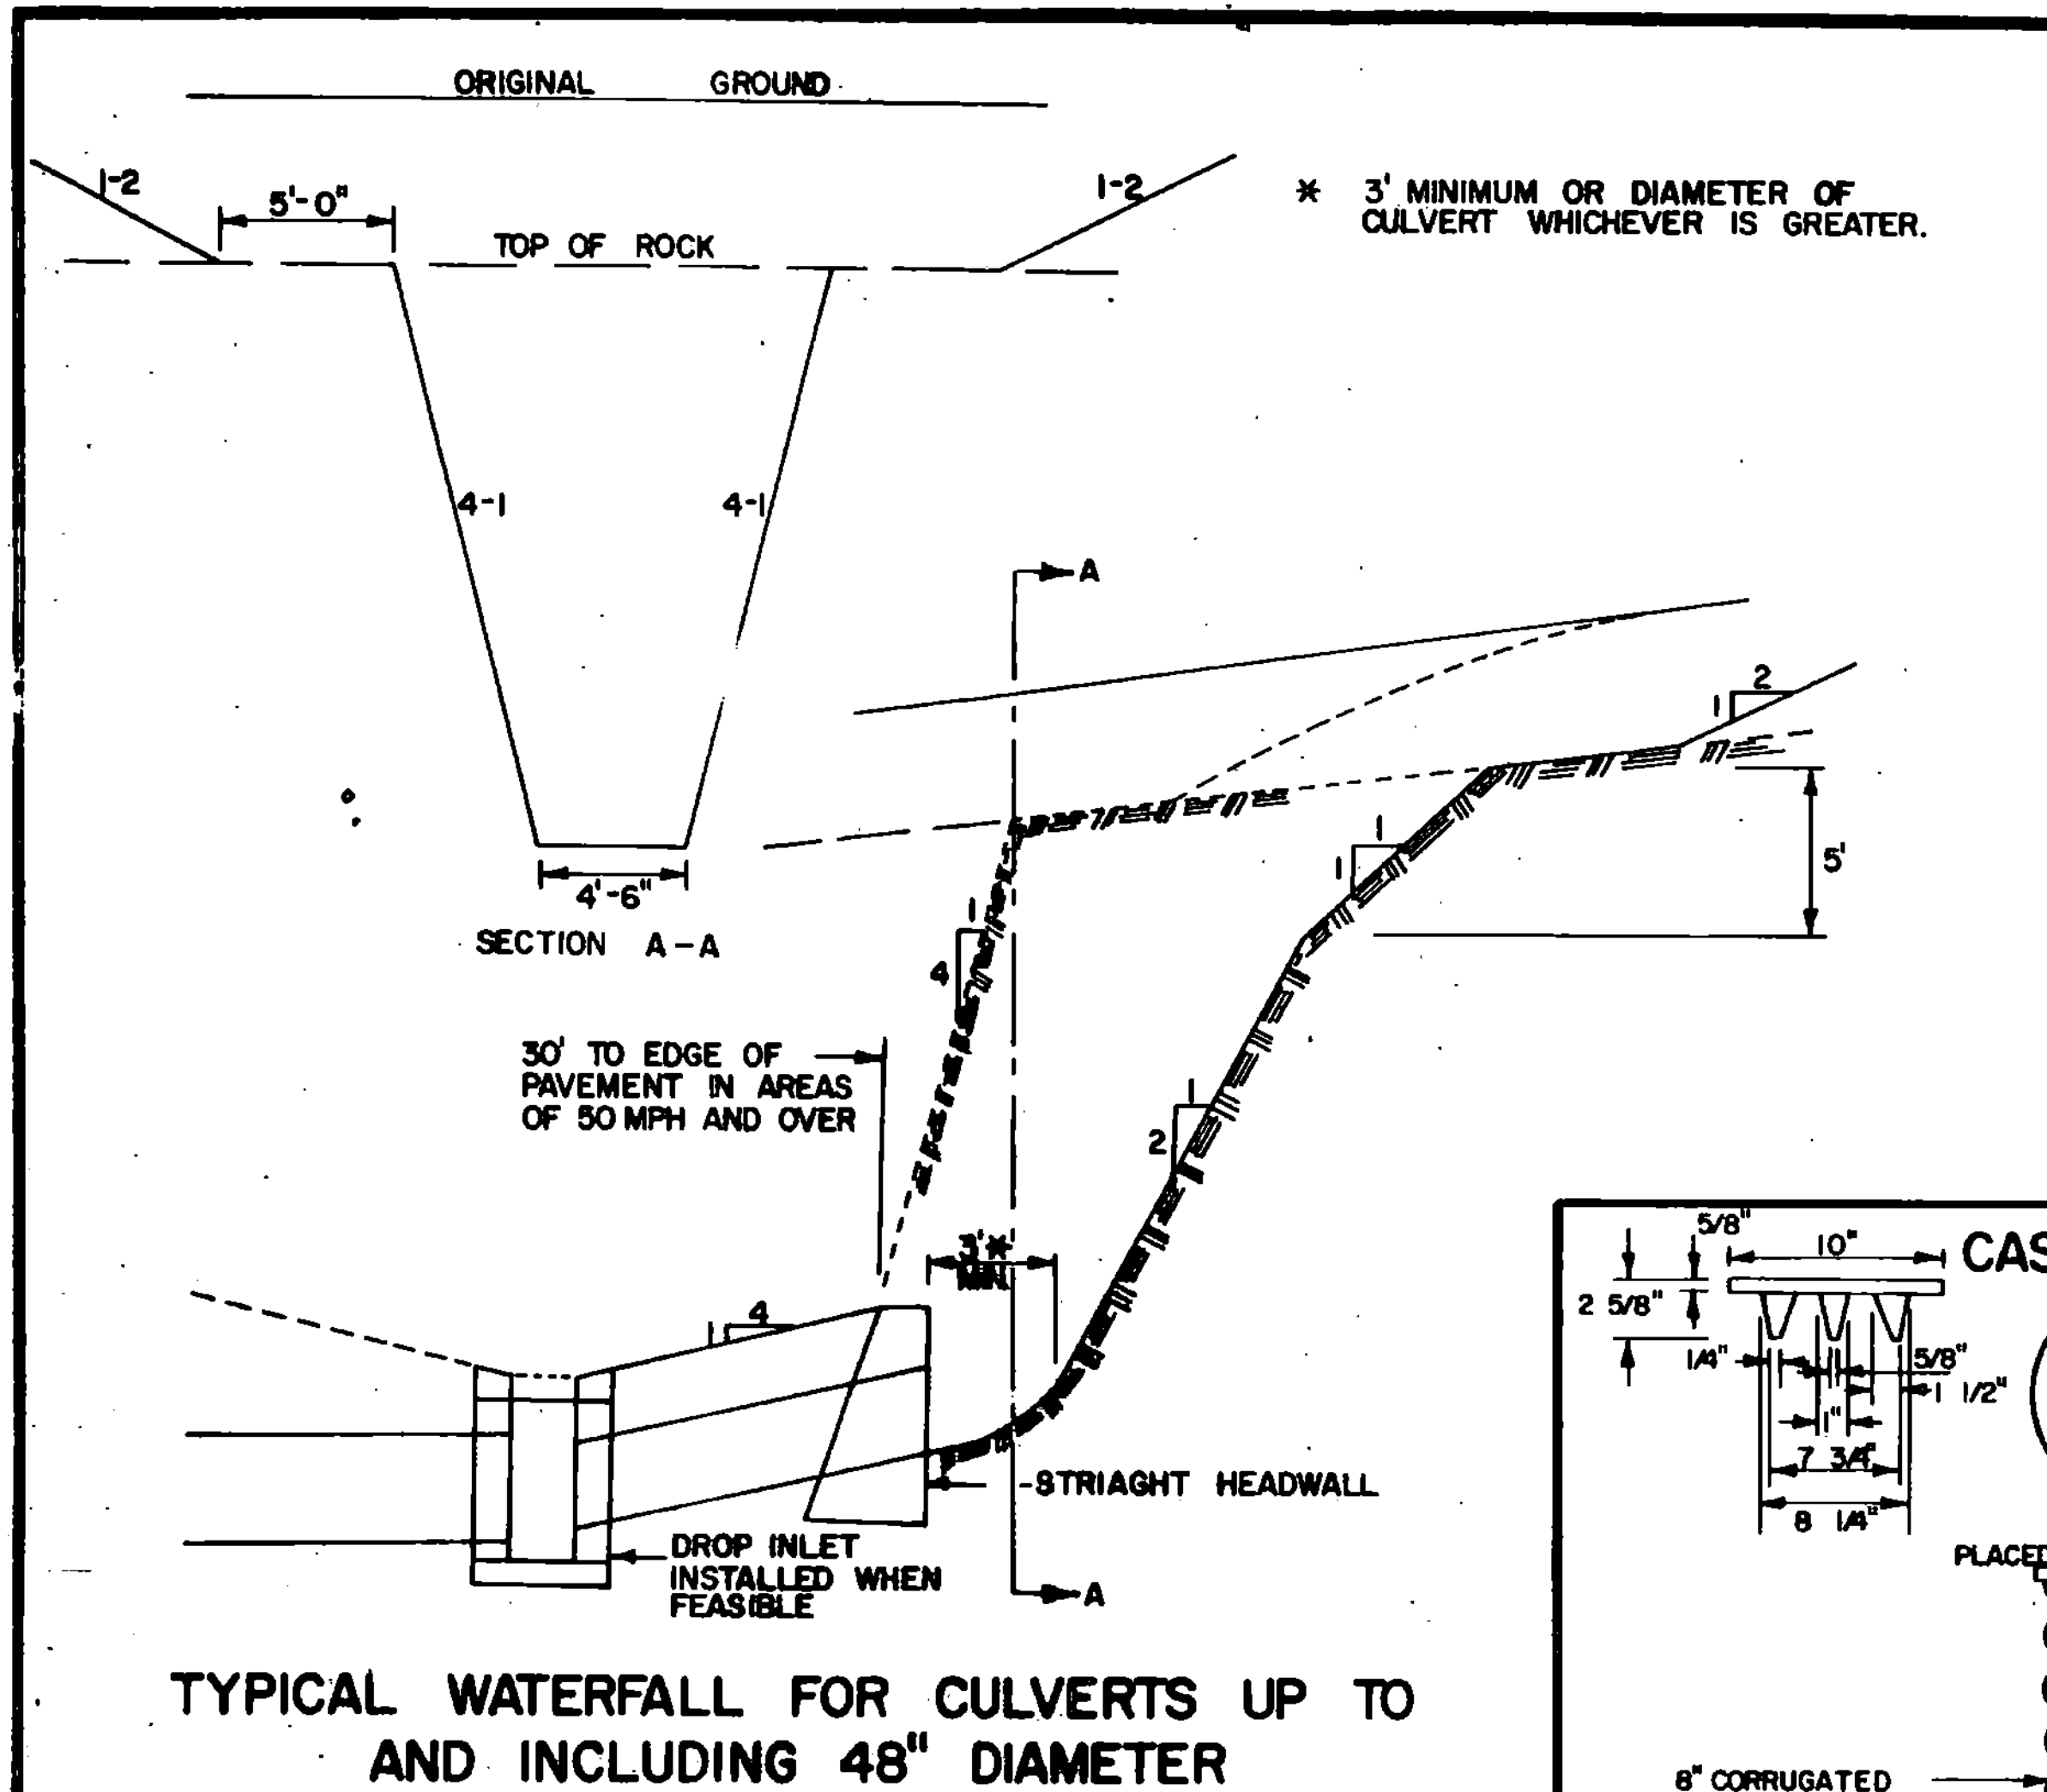
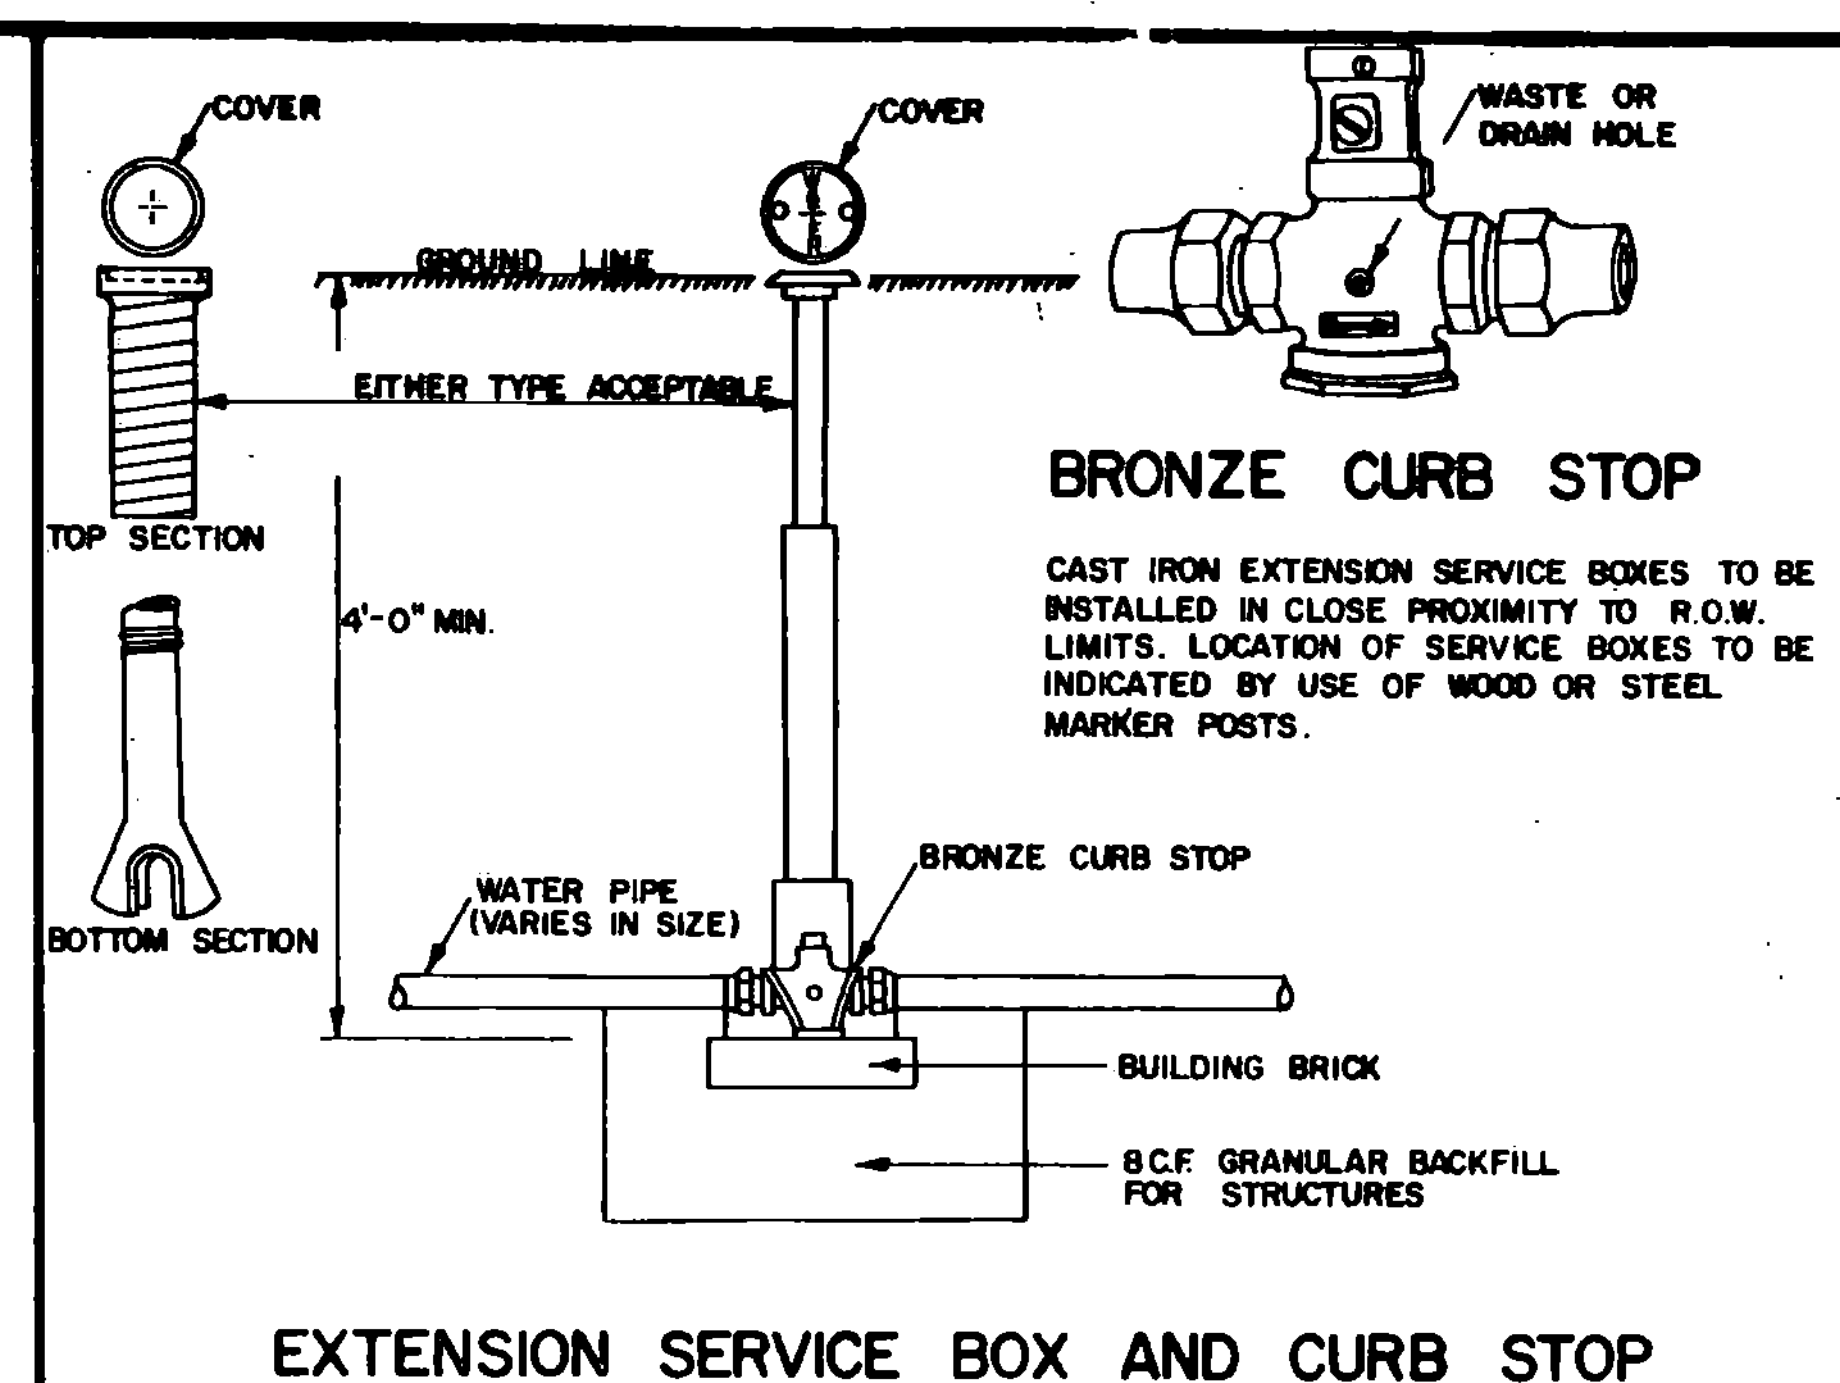
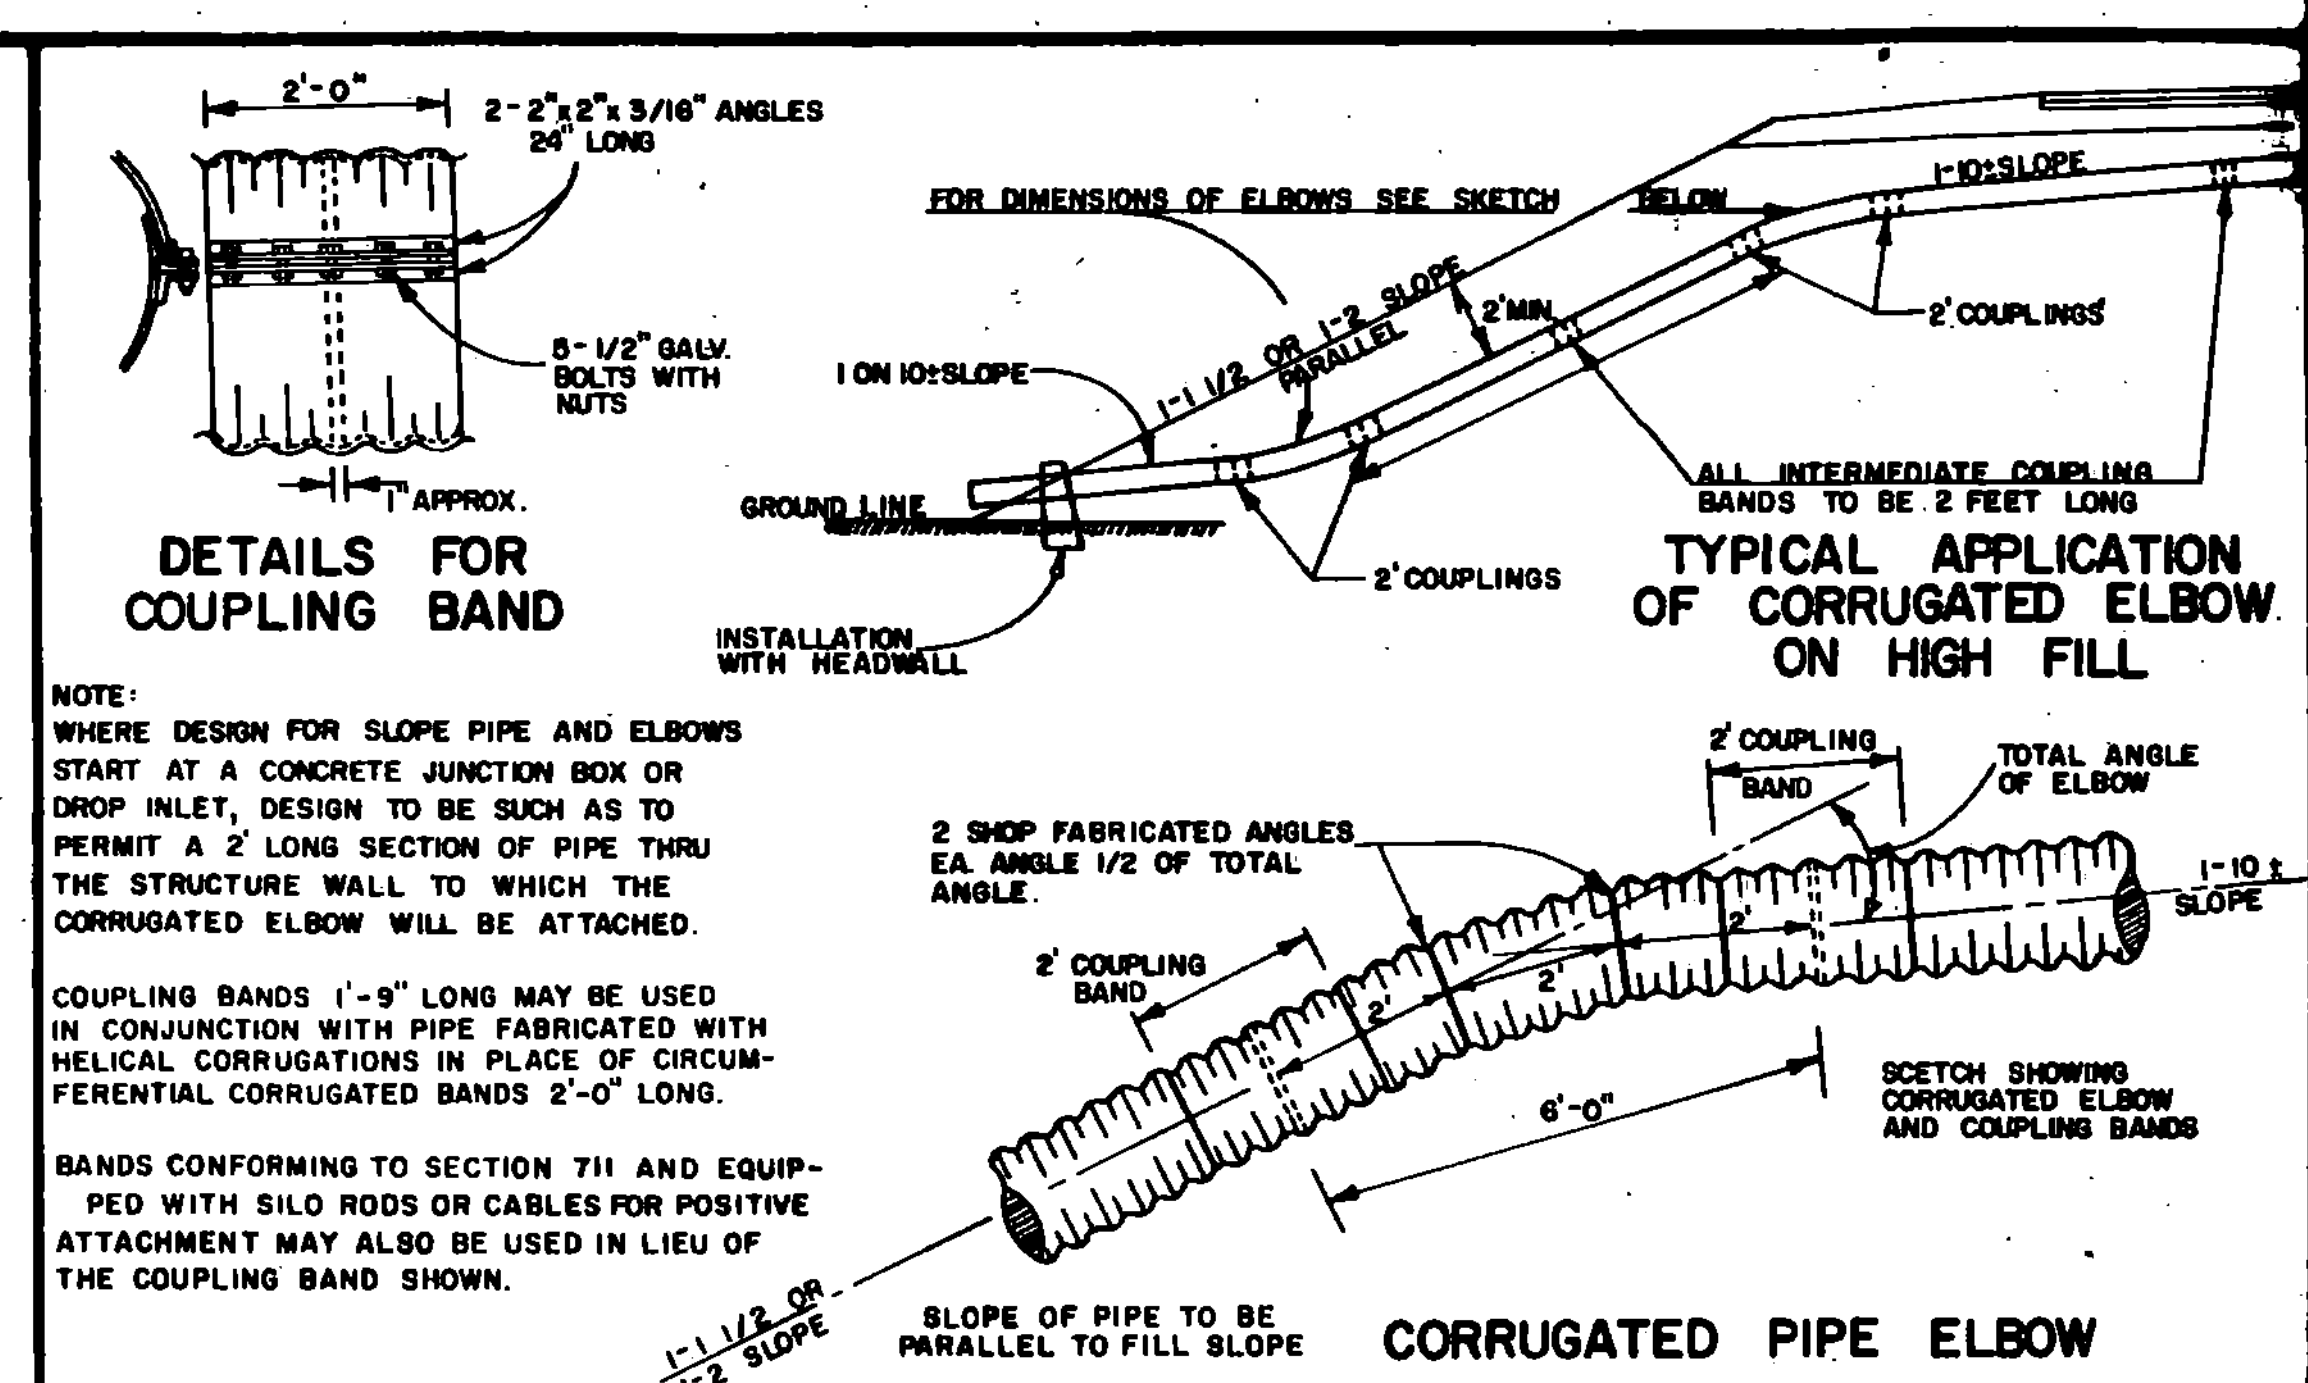
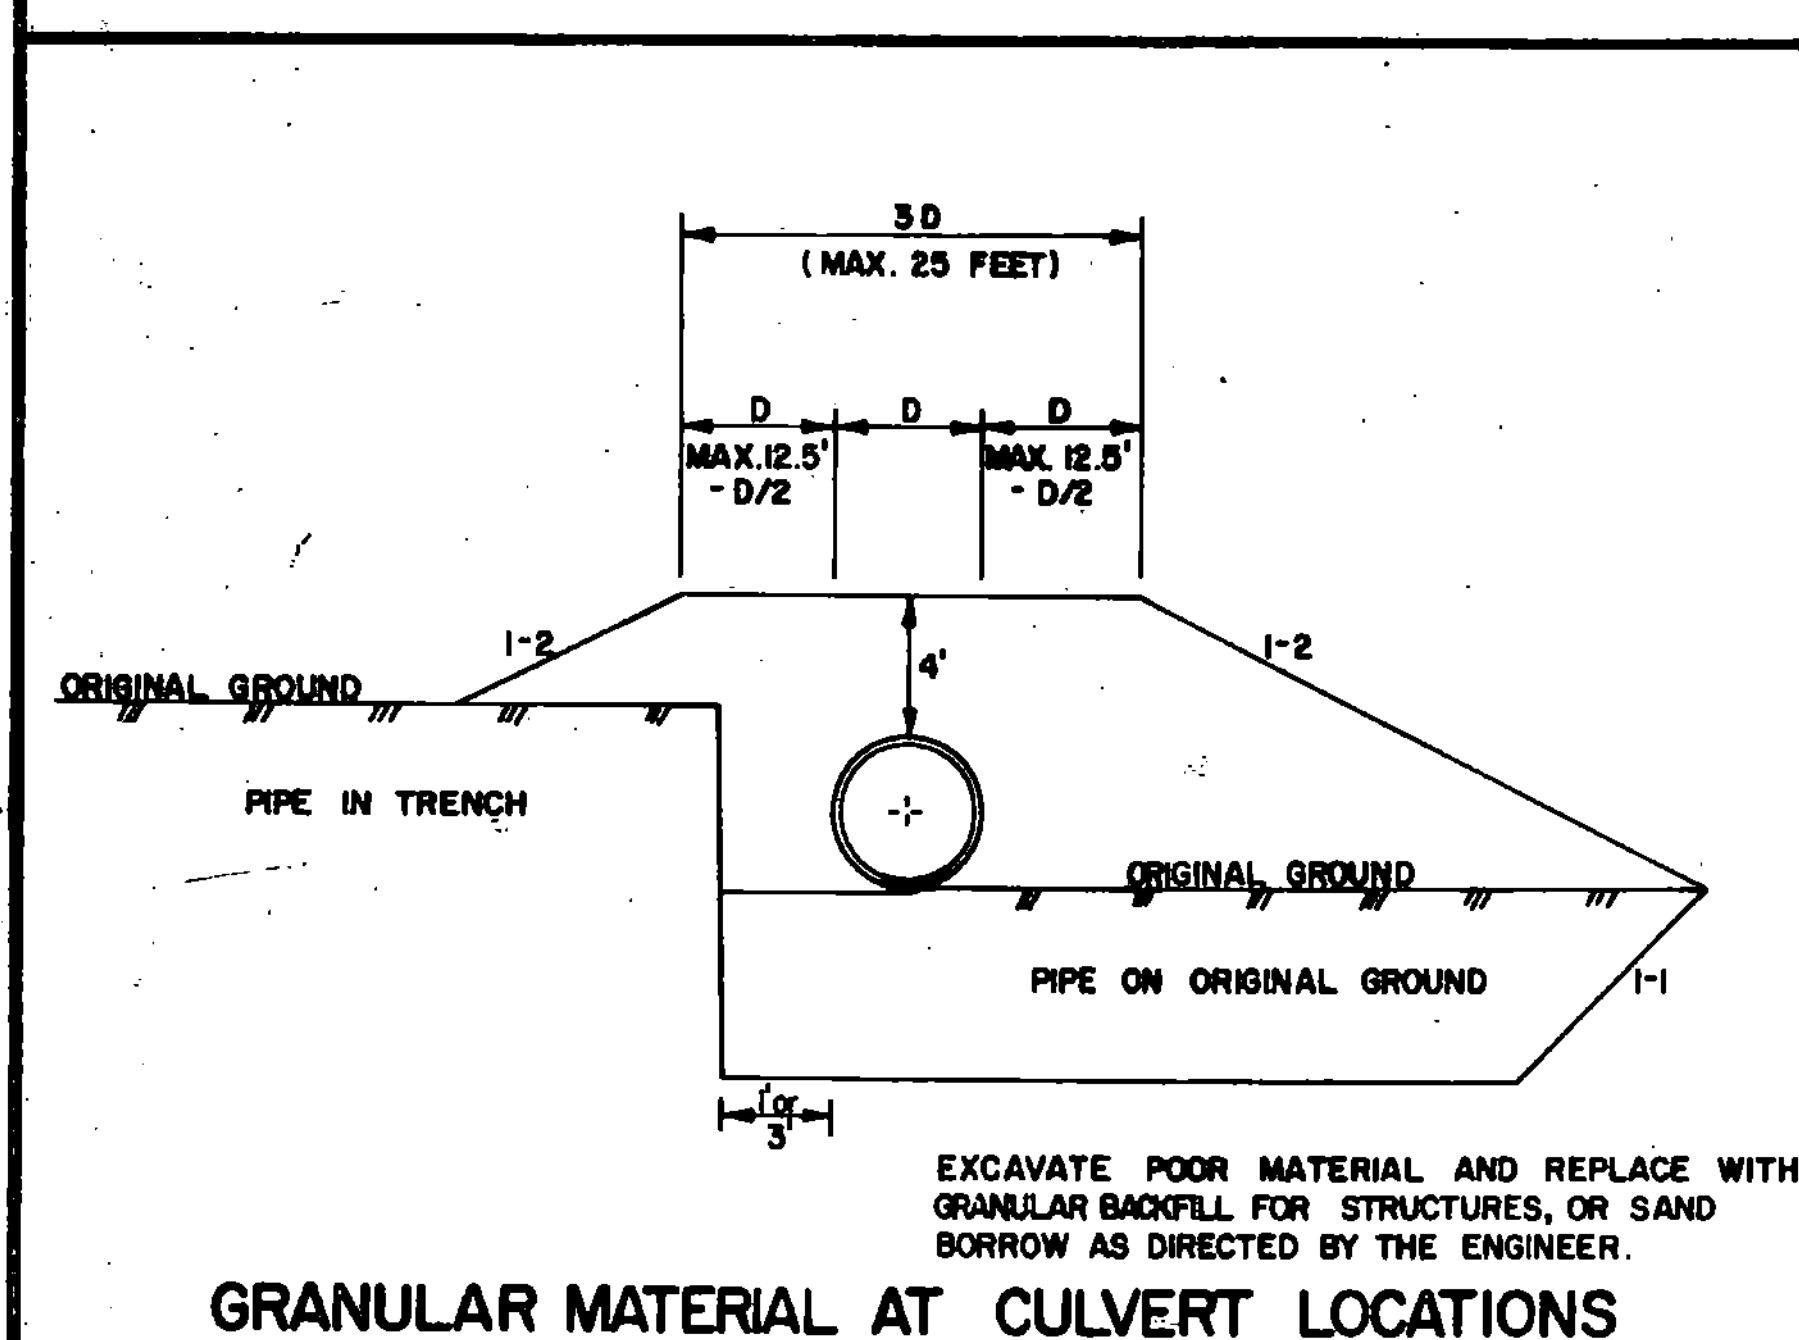
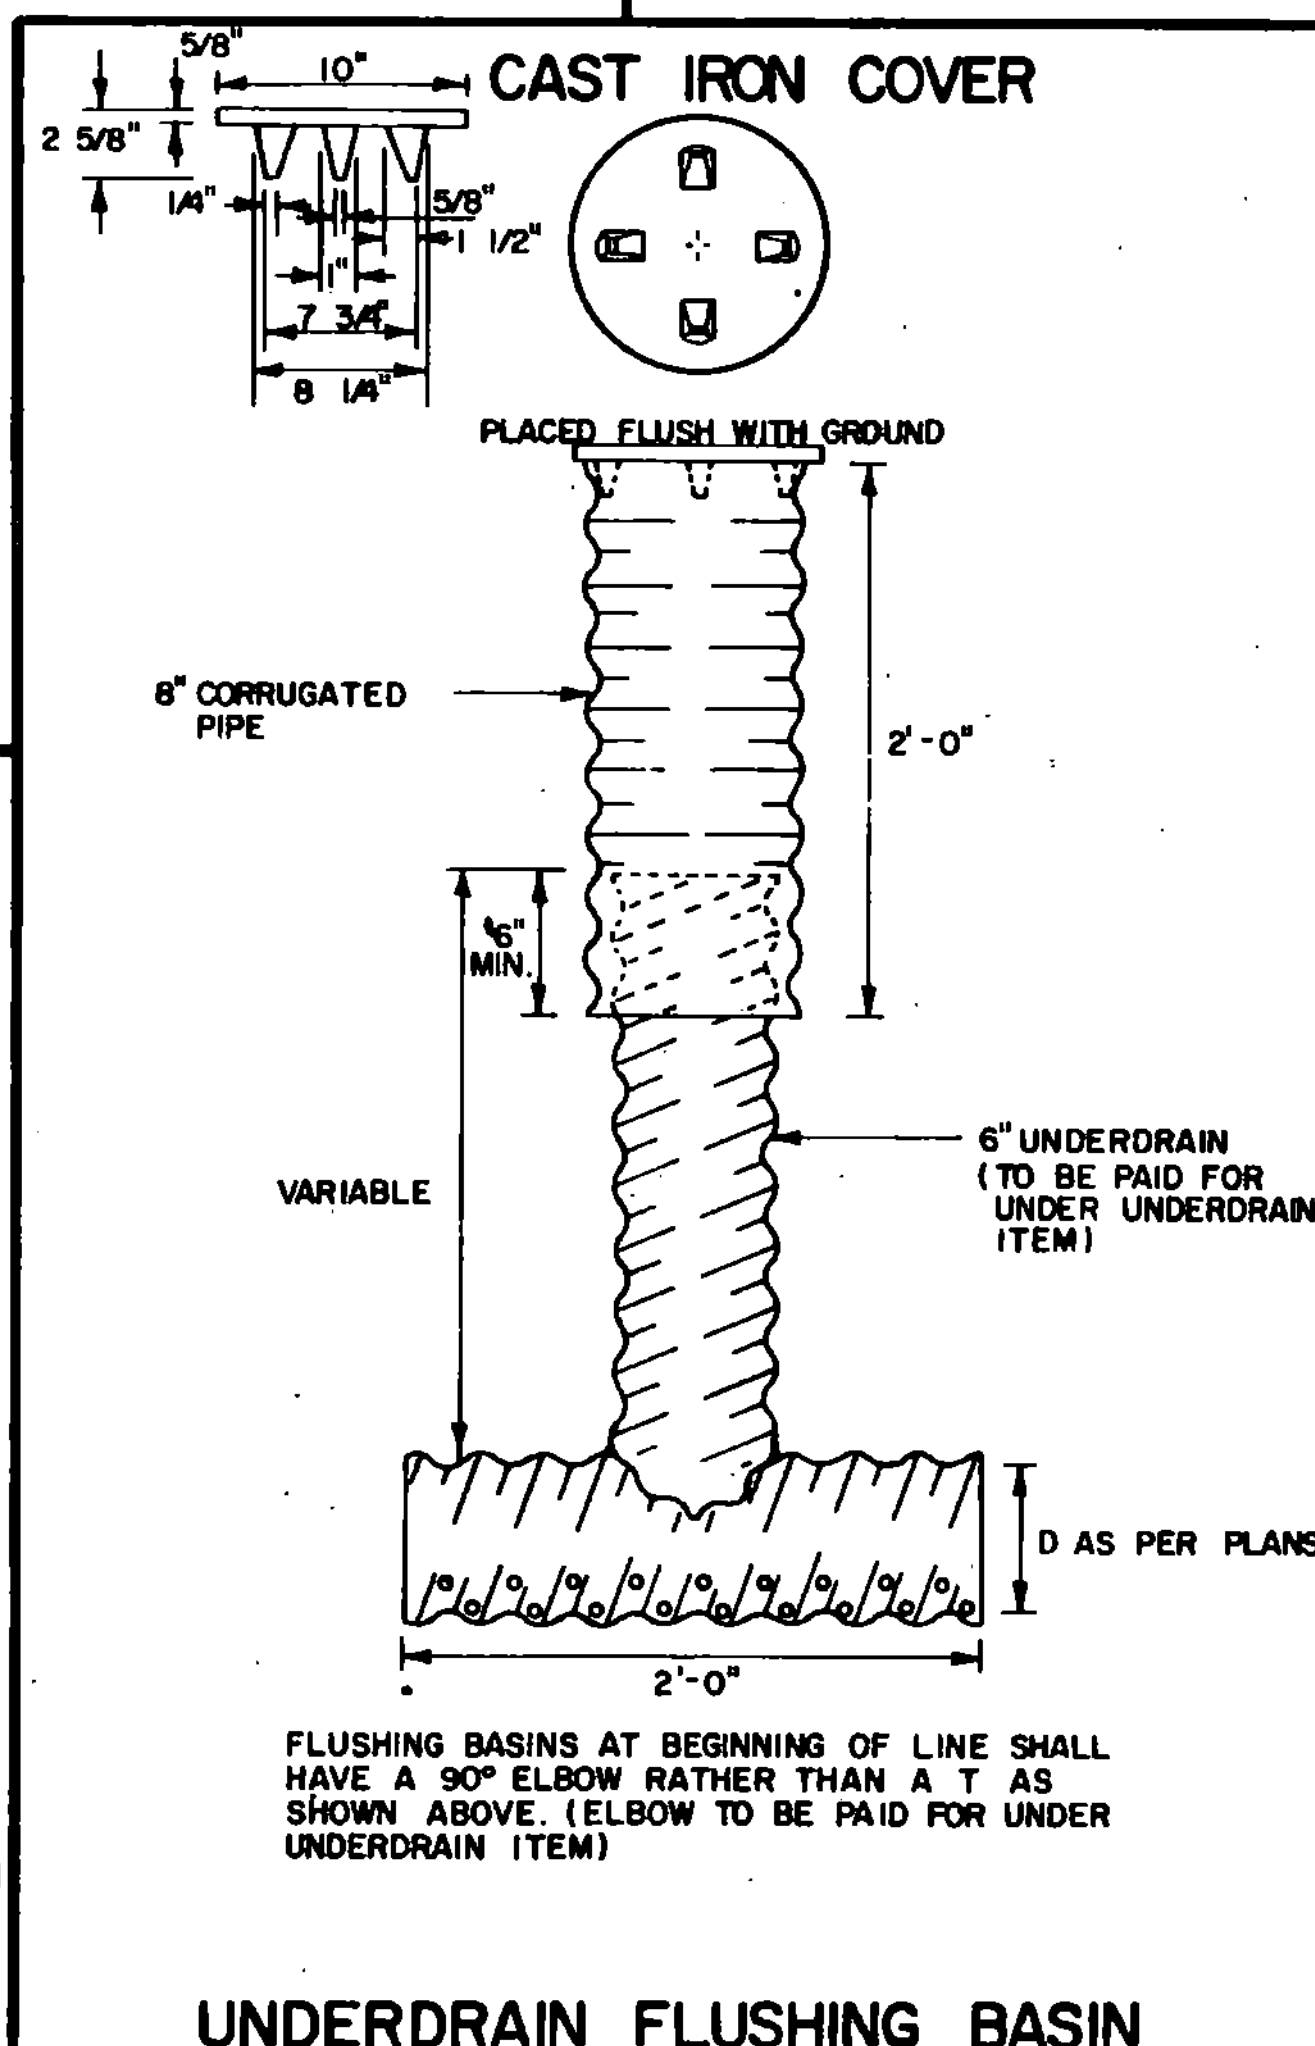
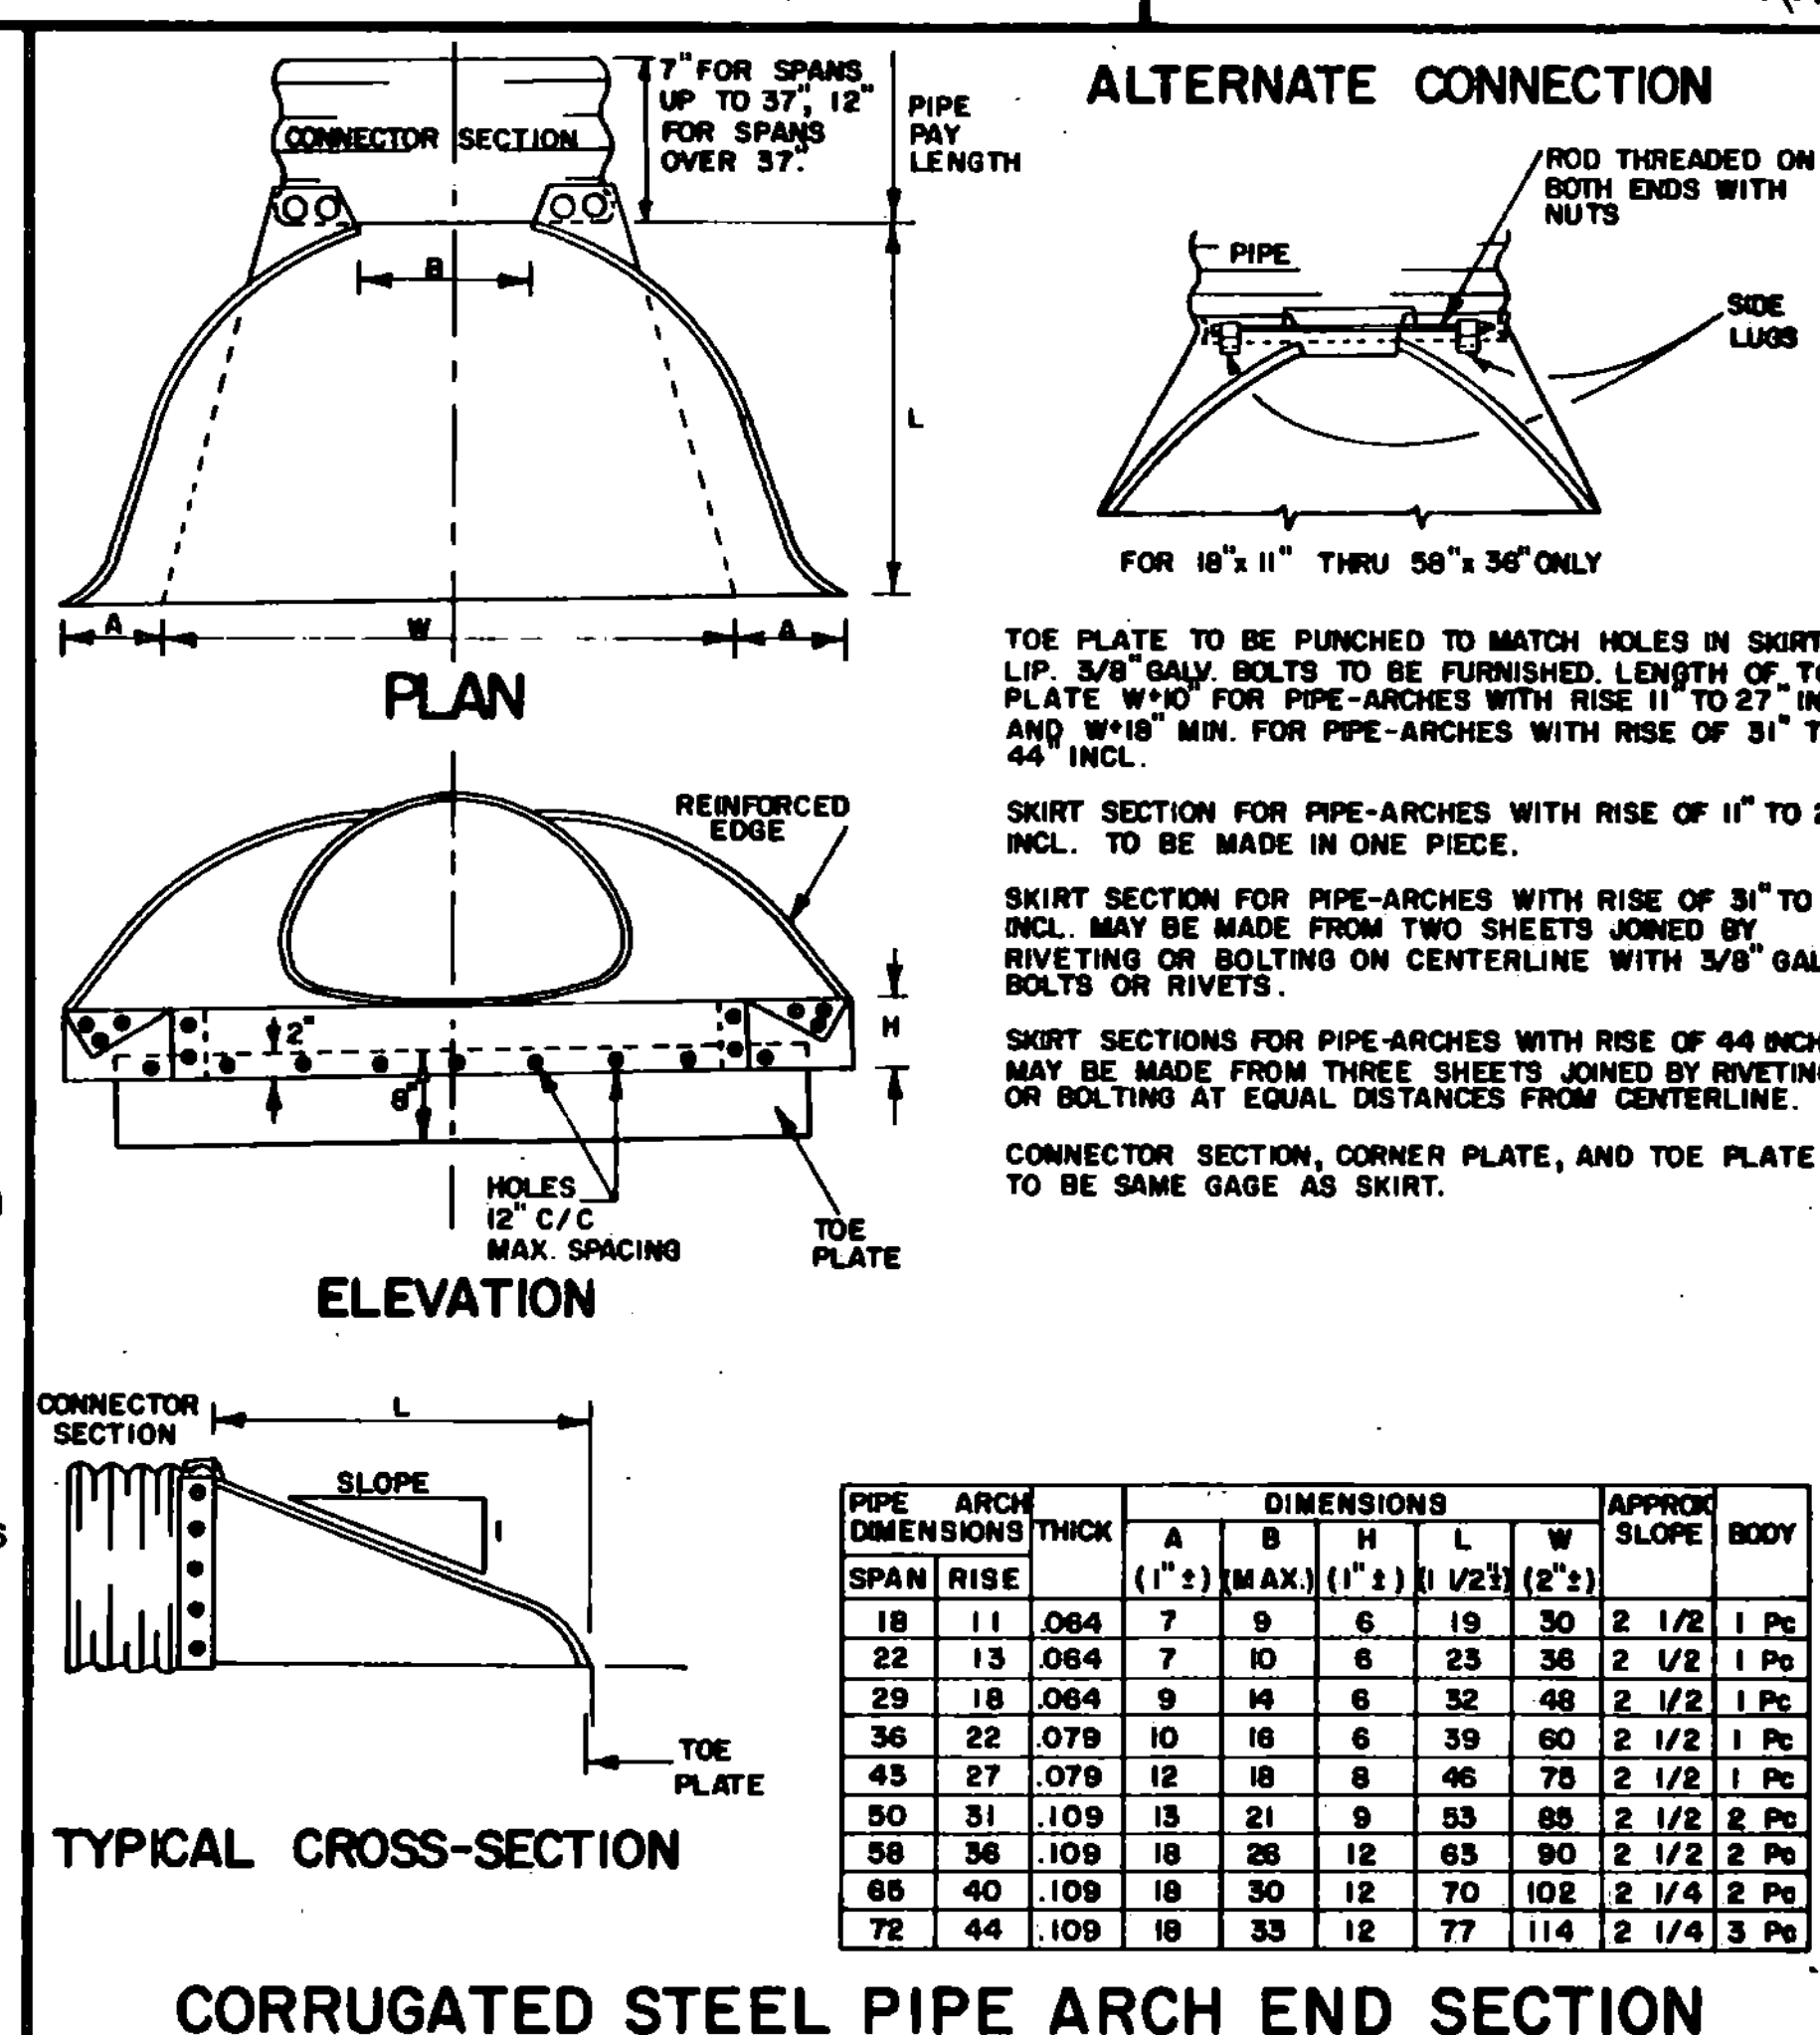
TYPICAL WATERFALL FOR CULVERTS UP TO AND INCLUDING 48" DIAMETER

EXTENSION SERVICE BOX AND CURB STOP

CORRUGATED PIPE ELBOW

GRANULAR BORROW AT CULVERT LOCATIONS

UNDERDRAIN FLUSHING BASIN

CORRUGATED STEEL PIPE END SECTION

CORRUGATED STEEL PIPE ARCH END SECTION
