PROJECT: <b>EAST MONTPELIER</b>	PROJECT NO. : <b>BRF 028-3(36)</b>
DESIGN FILE NAME: /98b254/str/sb254rd.dgn	PLOT DATE: 03-FEB-2009
IPARM FILE NAME: sb254rd14.1	DRAWN BY: R. PELLETT
DESIGNED BY: VTRANS	CHECKED BY: J. LACROIX
SQUAD LEADER: K. HIGGINS	SHEET: 22 OF 68
BRIDGE RAILING DETAILS SHEET #4

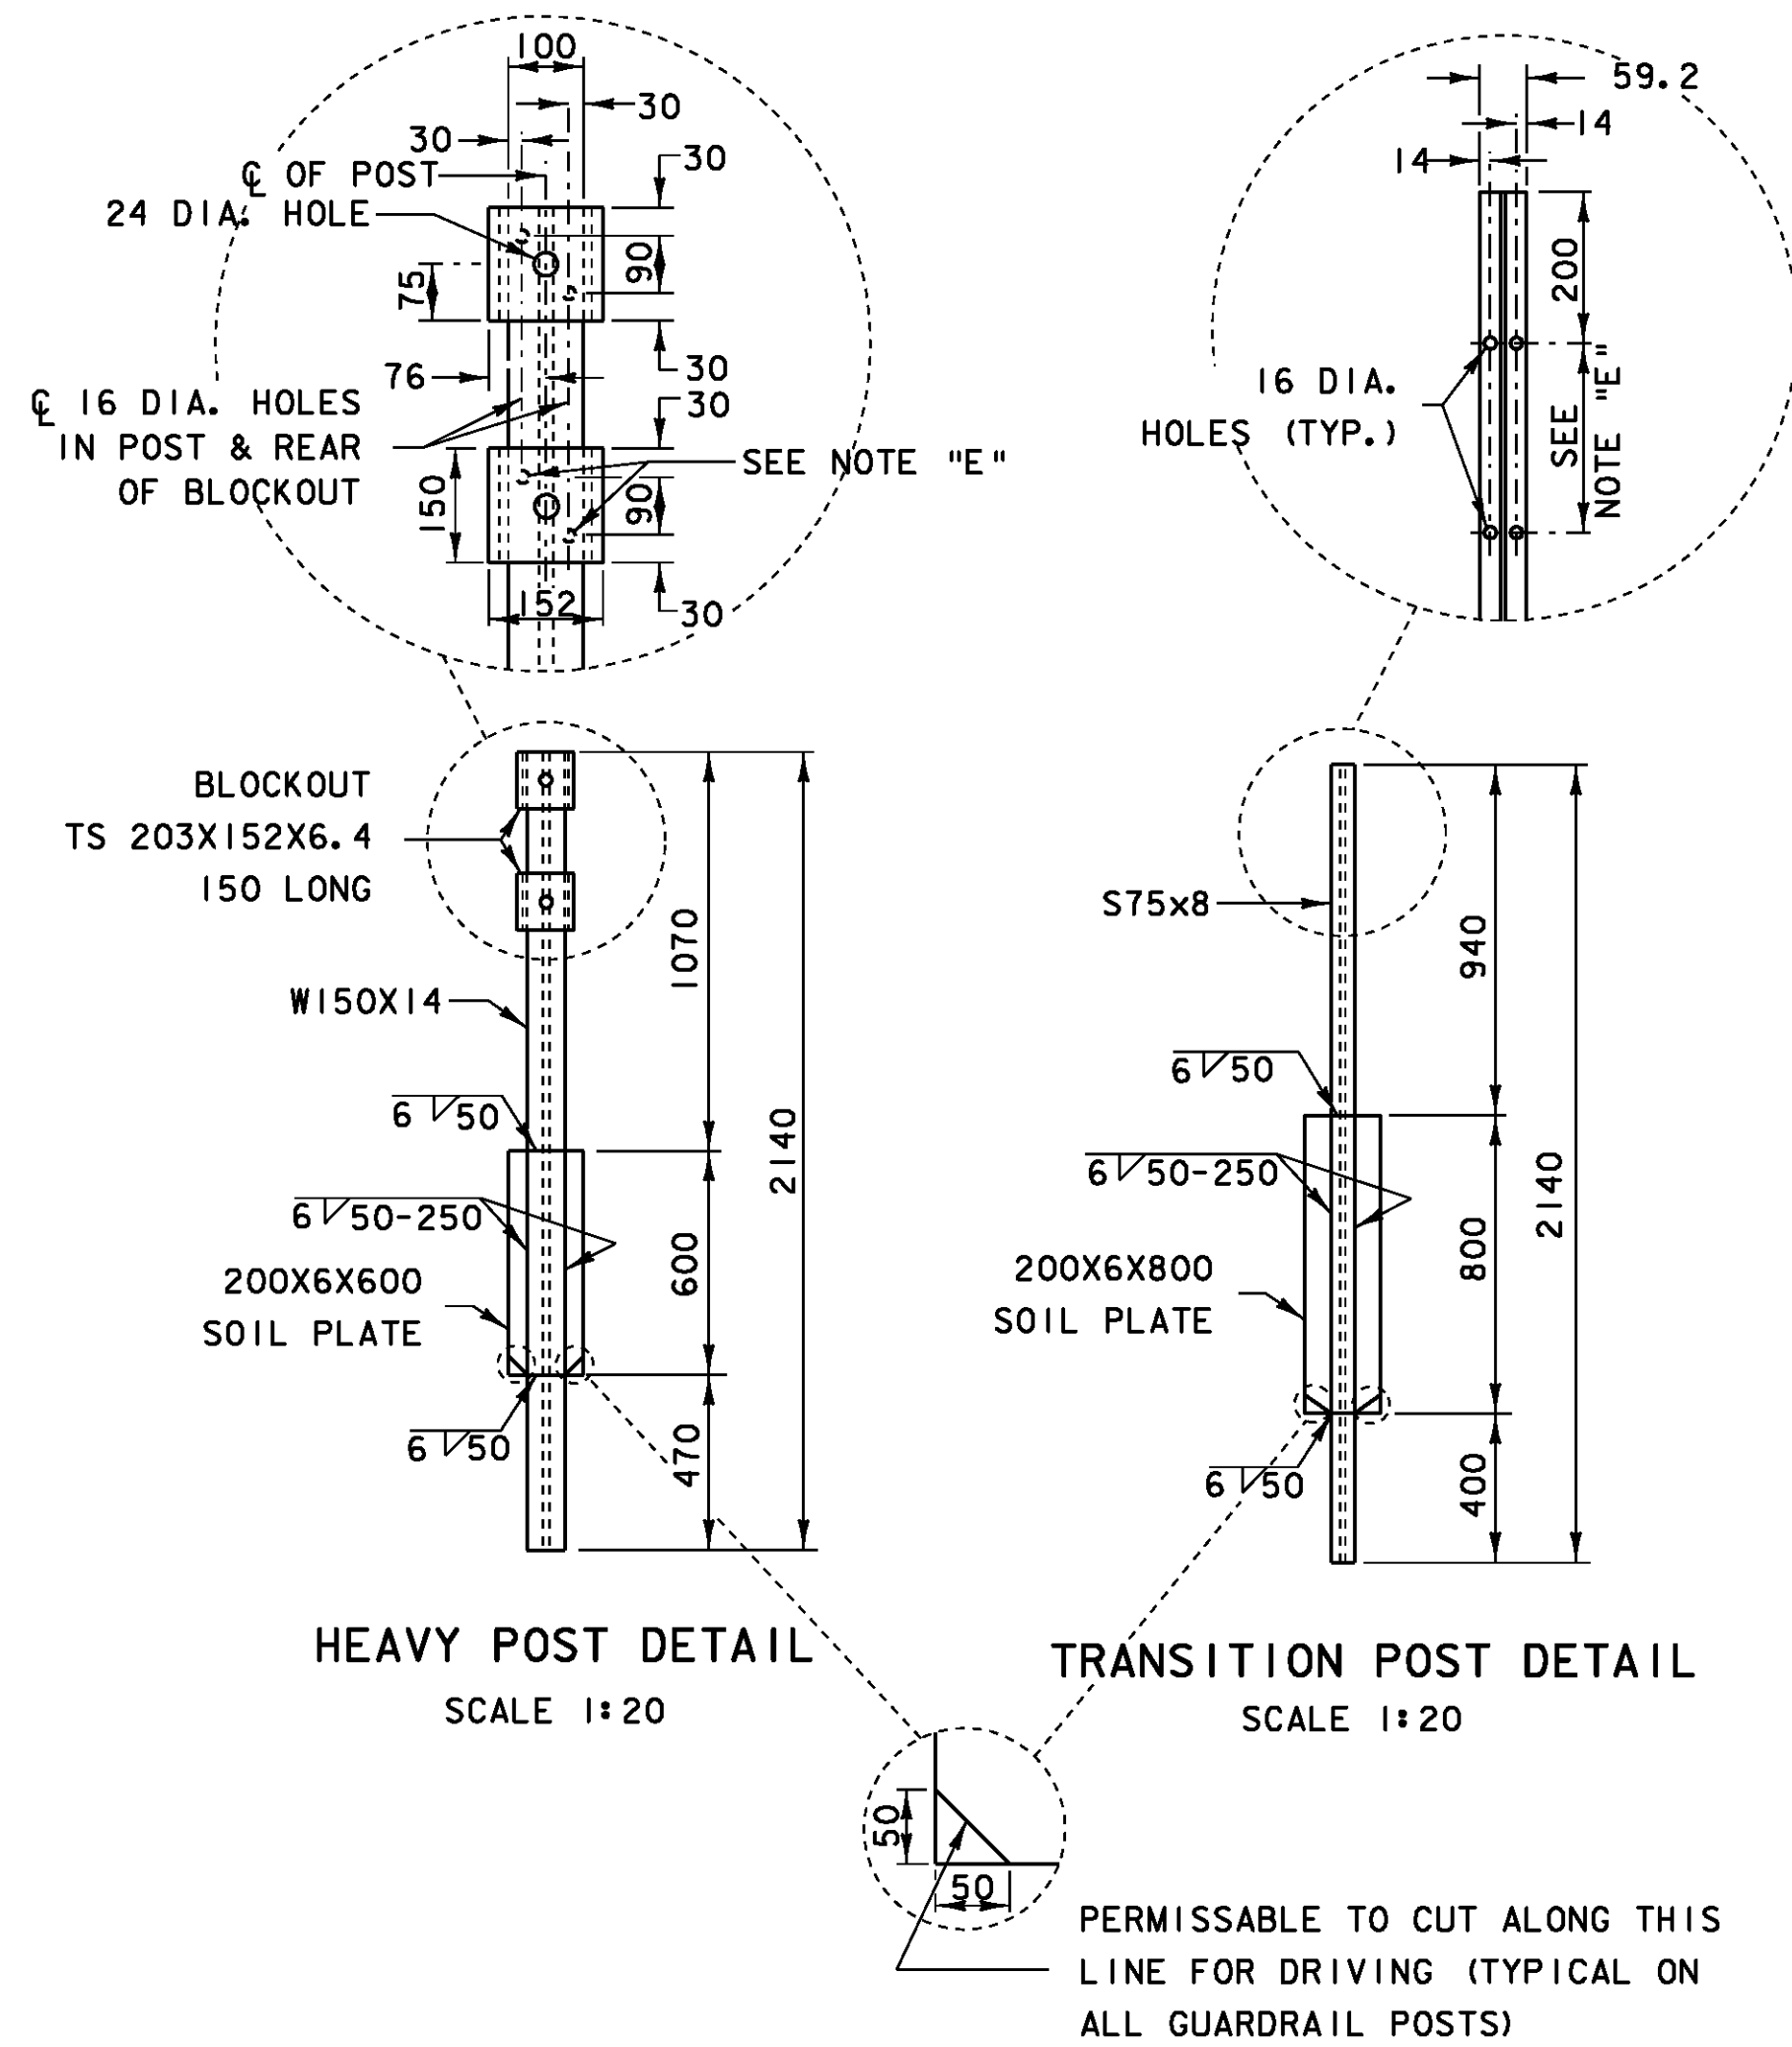
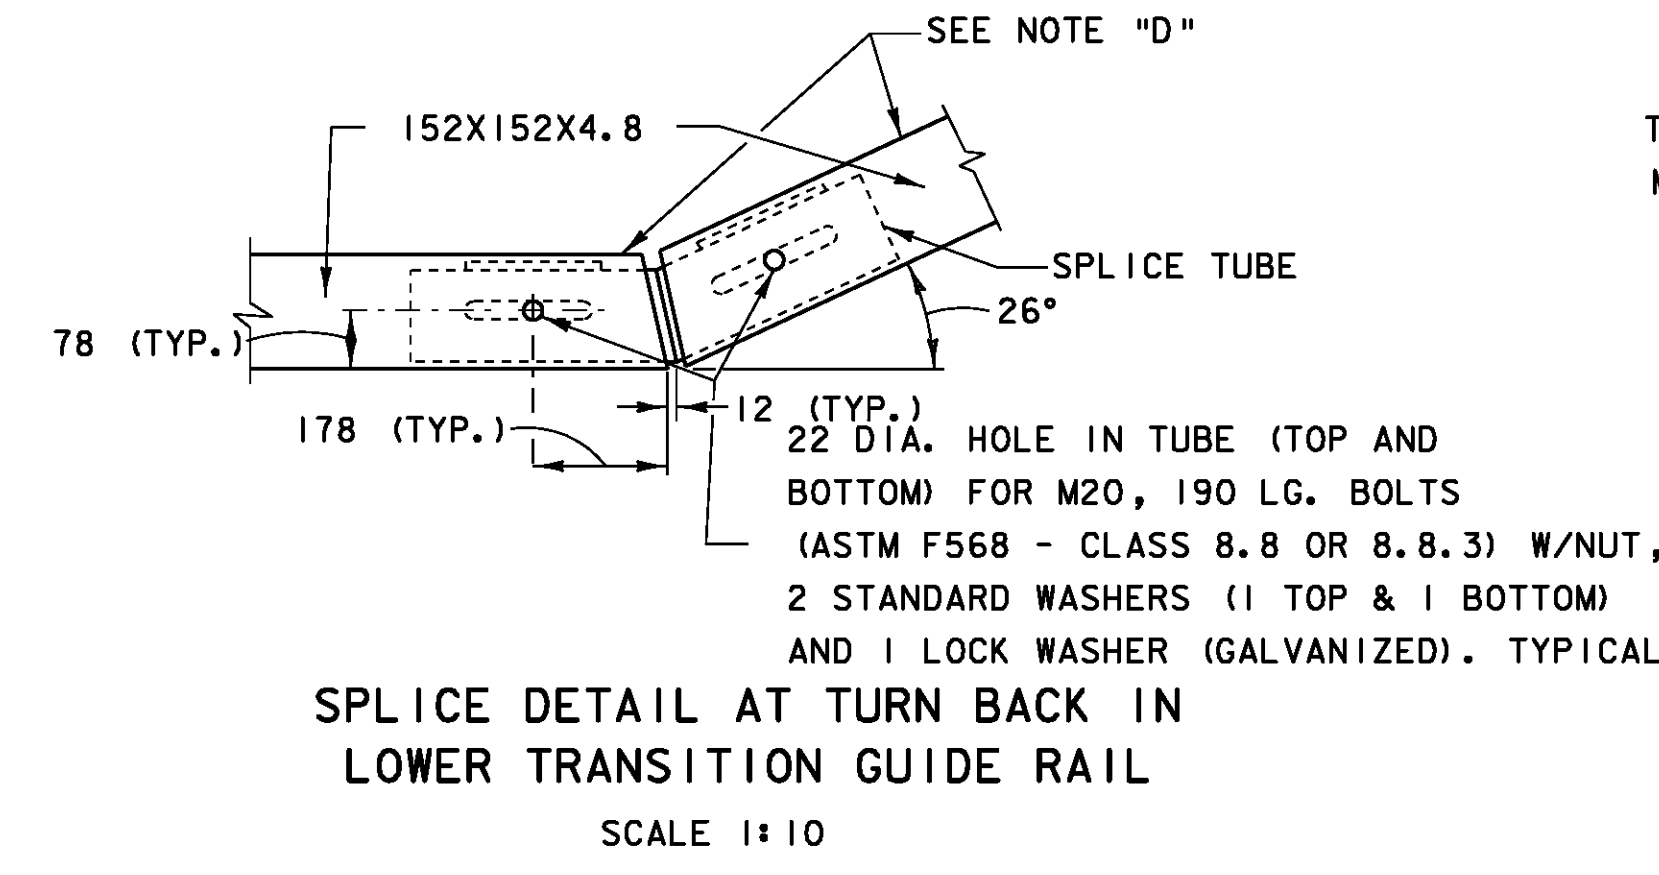
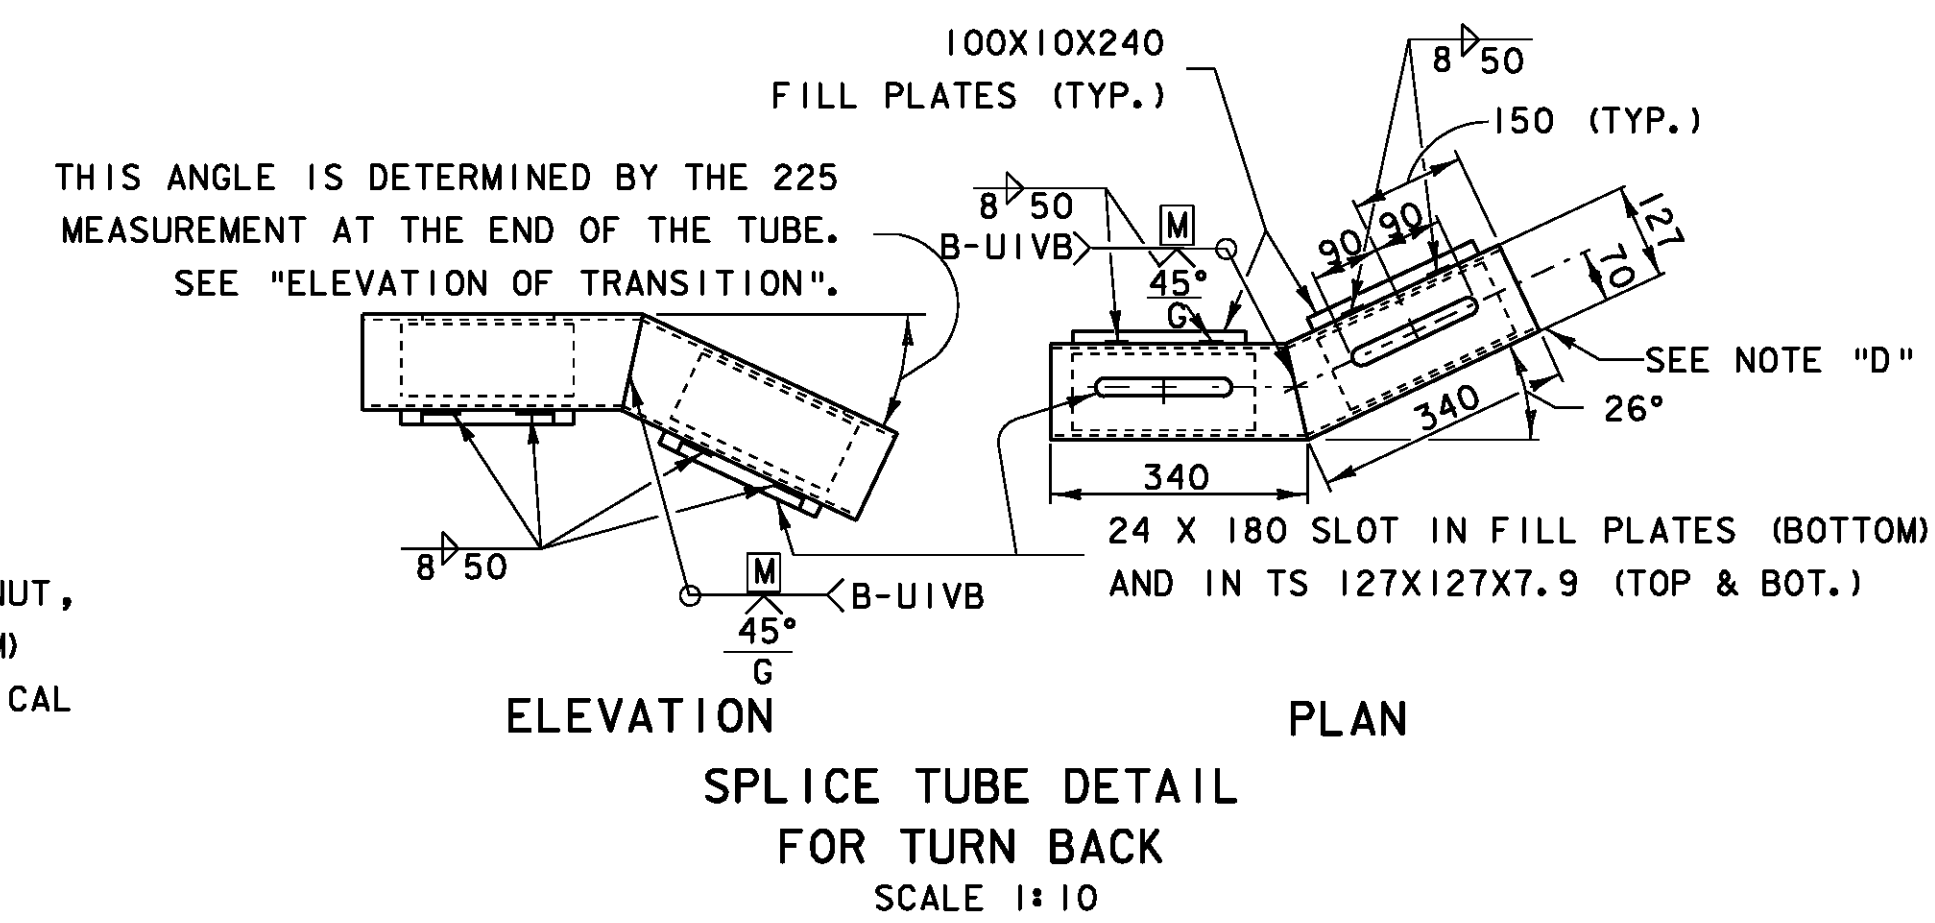
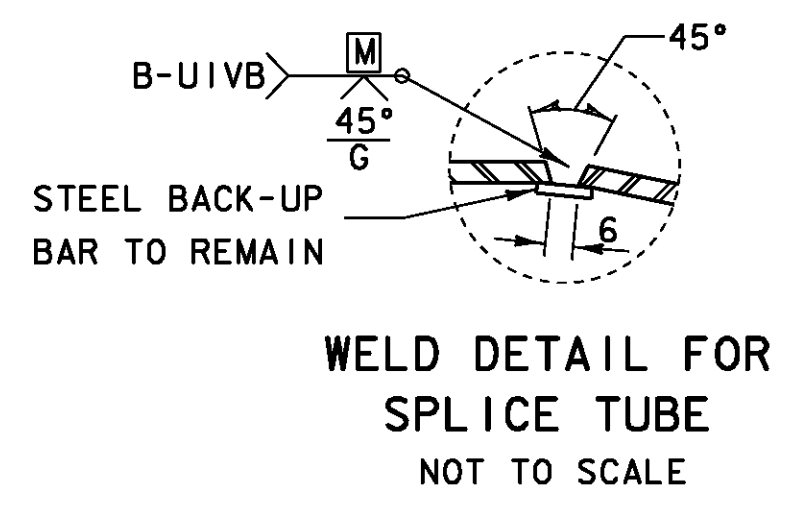
NOTE "D"  
PROTRUSIONS CAUSED BY WELDING OR GALVANIZING ARE NOT PERMITTED ON THE ADJOINING SURFACES OF THE BOX BEAM RAILS, SPLICE TUBES AND FILL PLATES.

NOTE "E":  
HOLES IN THE POST FOR THE LOWER RAIL MAY BE LOCATED AND DRILLED IN THE FIELD. IF SO, THE GALVANIZING SHALL BE REPAIRED IN ACCORDANCE WITH SECTION 505.
