HTA PROJECT	MODEL
904225	904225Detail5

PROJECT NAME: TOWNSHEND	PROJECT NUMBER: STP SCTT(1)
FILE NAME: 904225Detail5.dgn	PLOT DATE: 8/13/2015
PROJECT LEADER: M.D.SARGENT	DRAWN BY: T.A.OELINAS
DESIGNED BY: J.C.RIPLEY	CHECKED BY: S.T.JAMES
STRUCTURAL DETAILS (5 OF 5)	SHEET 45A OF 60

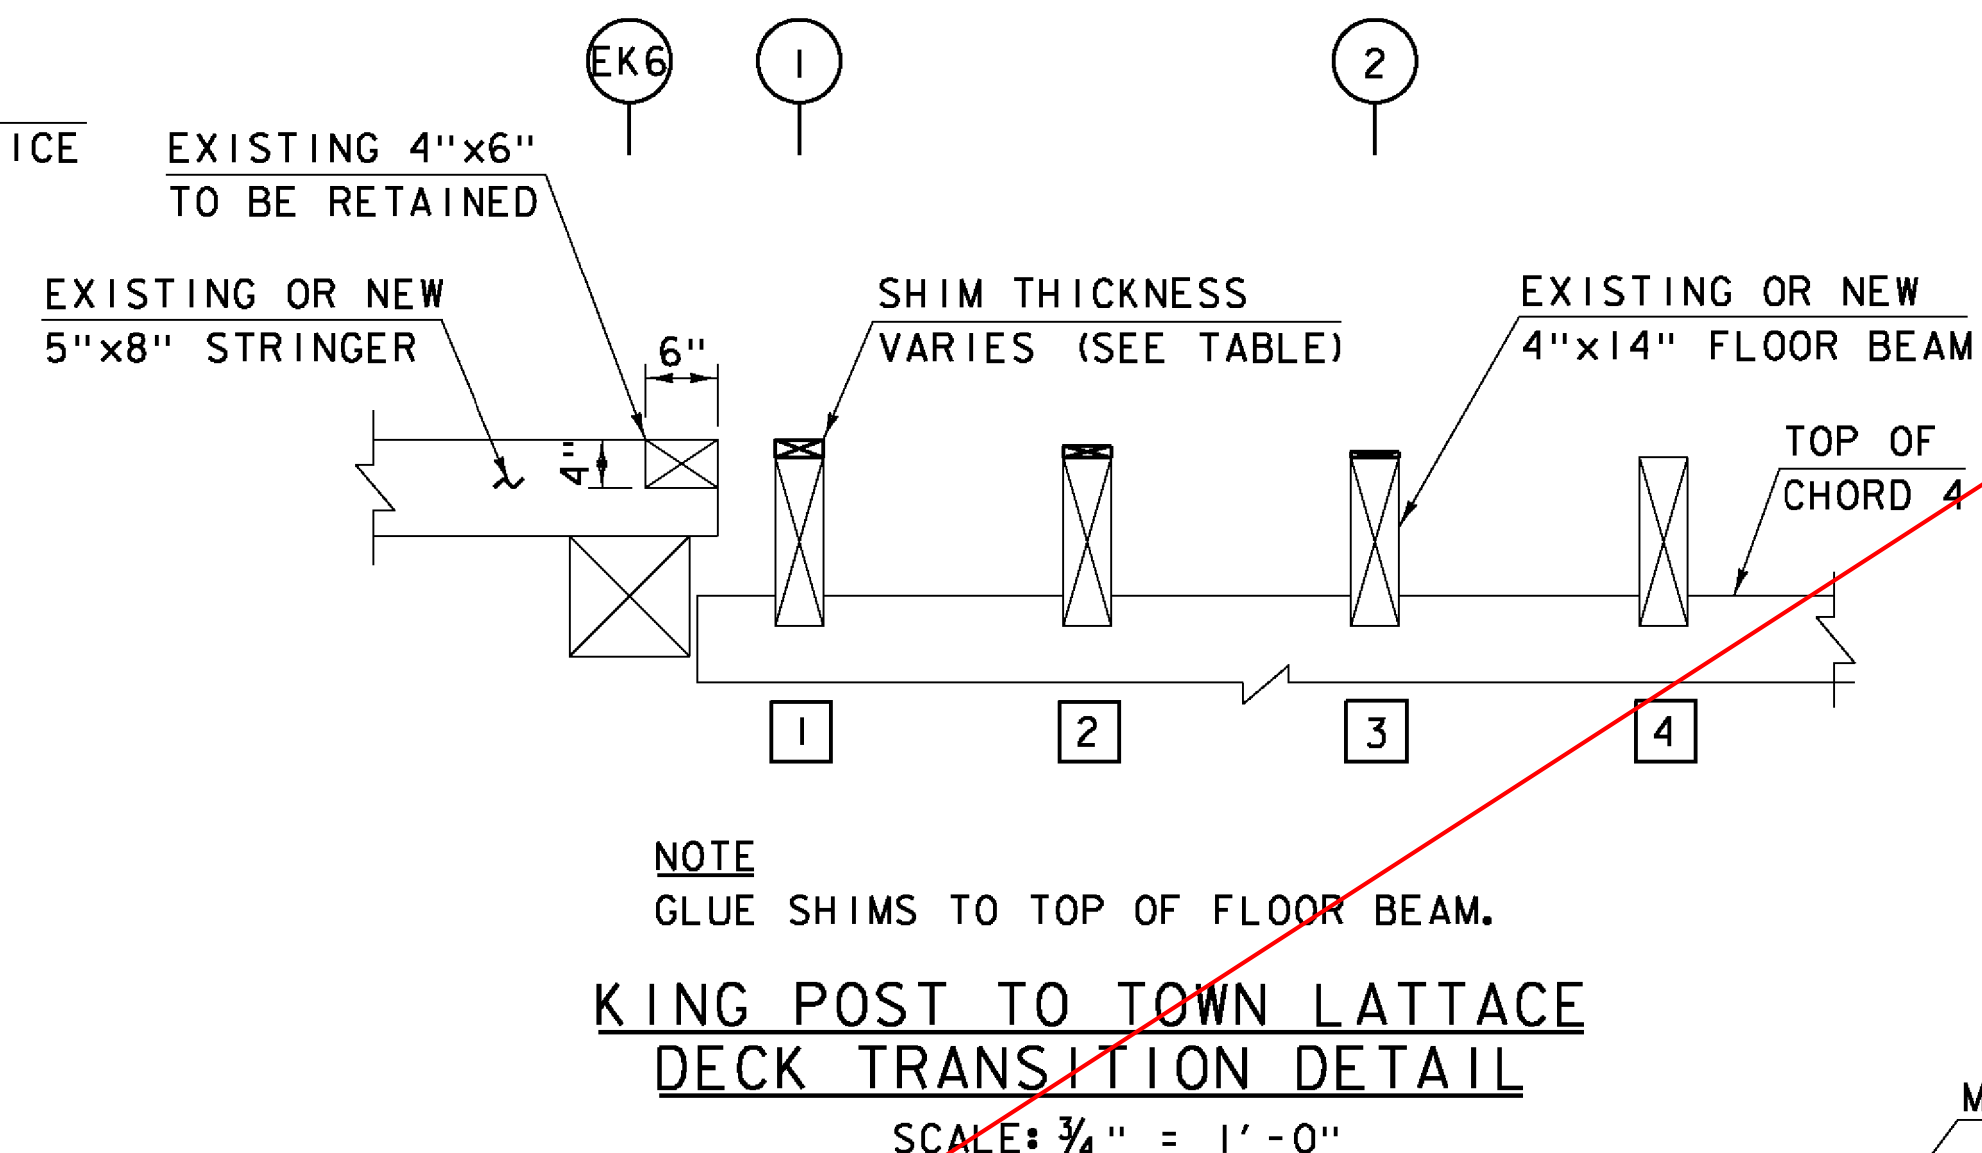
FLOOR BEAM	SHIM THICKNESS (INCHES)
1	1.5
2	1
3	0.5
4	0

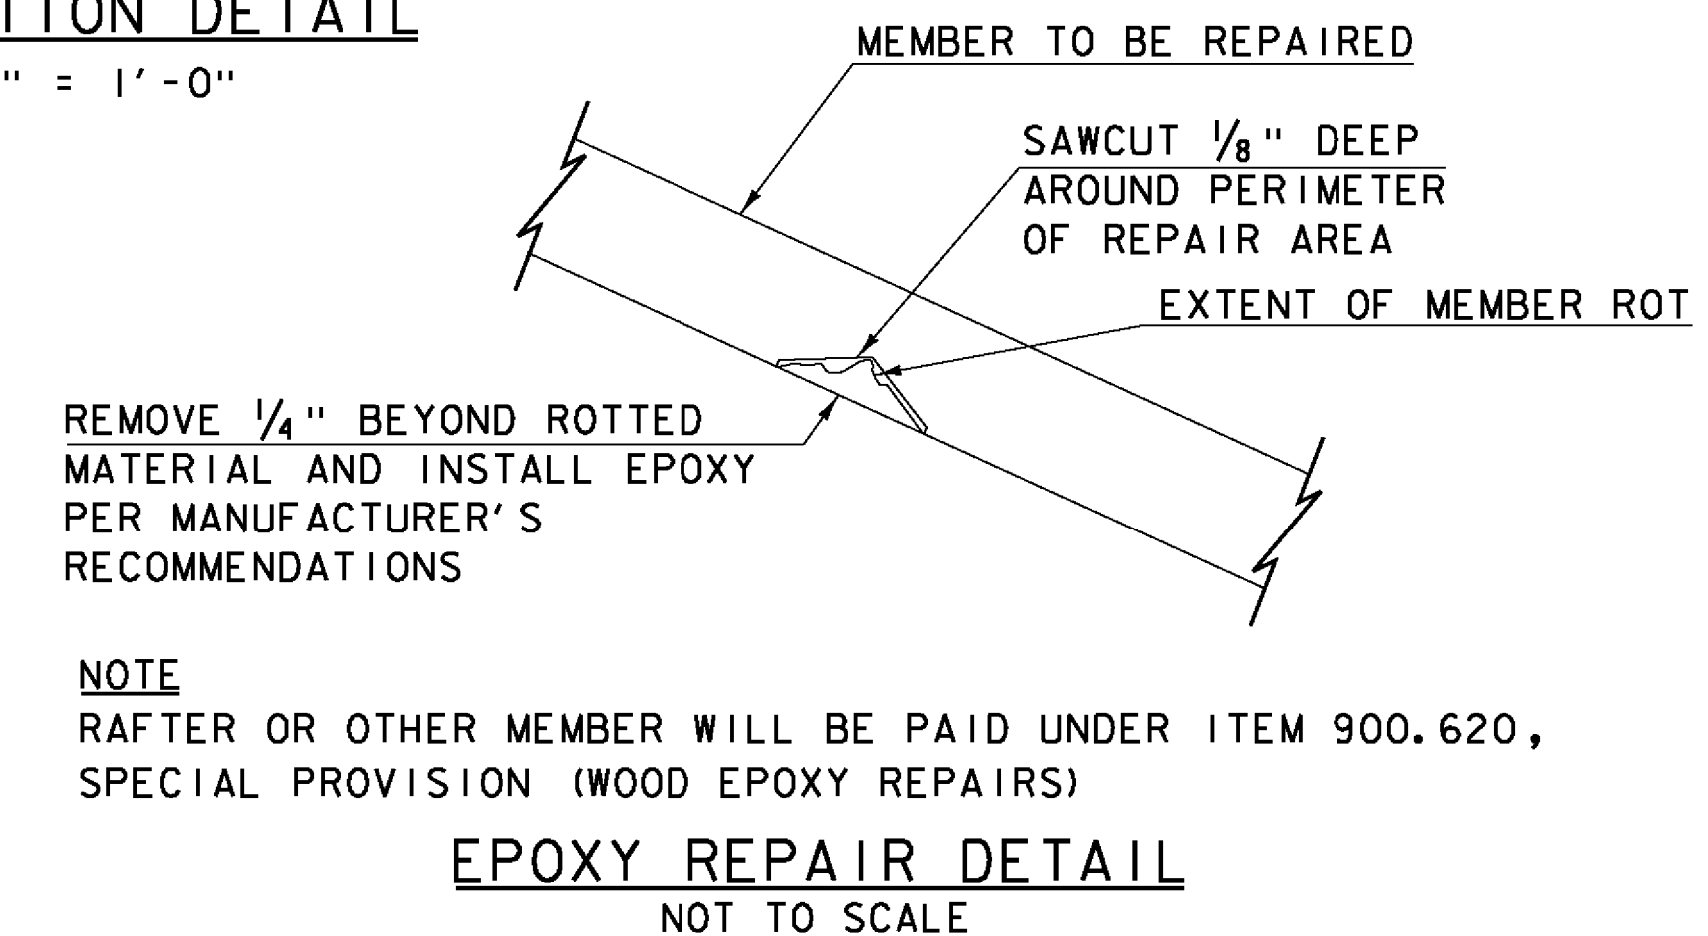
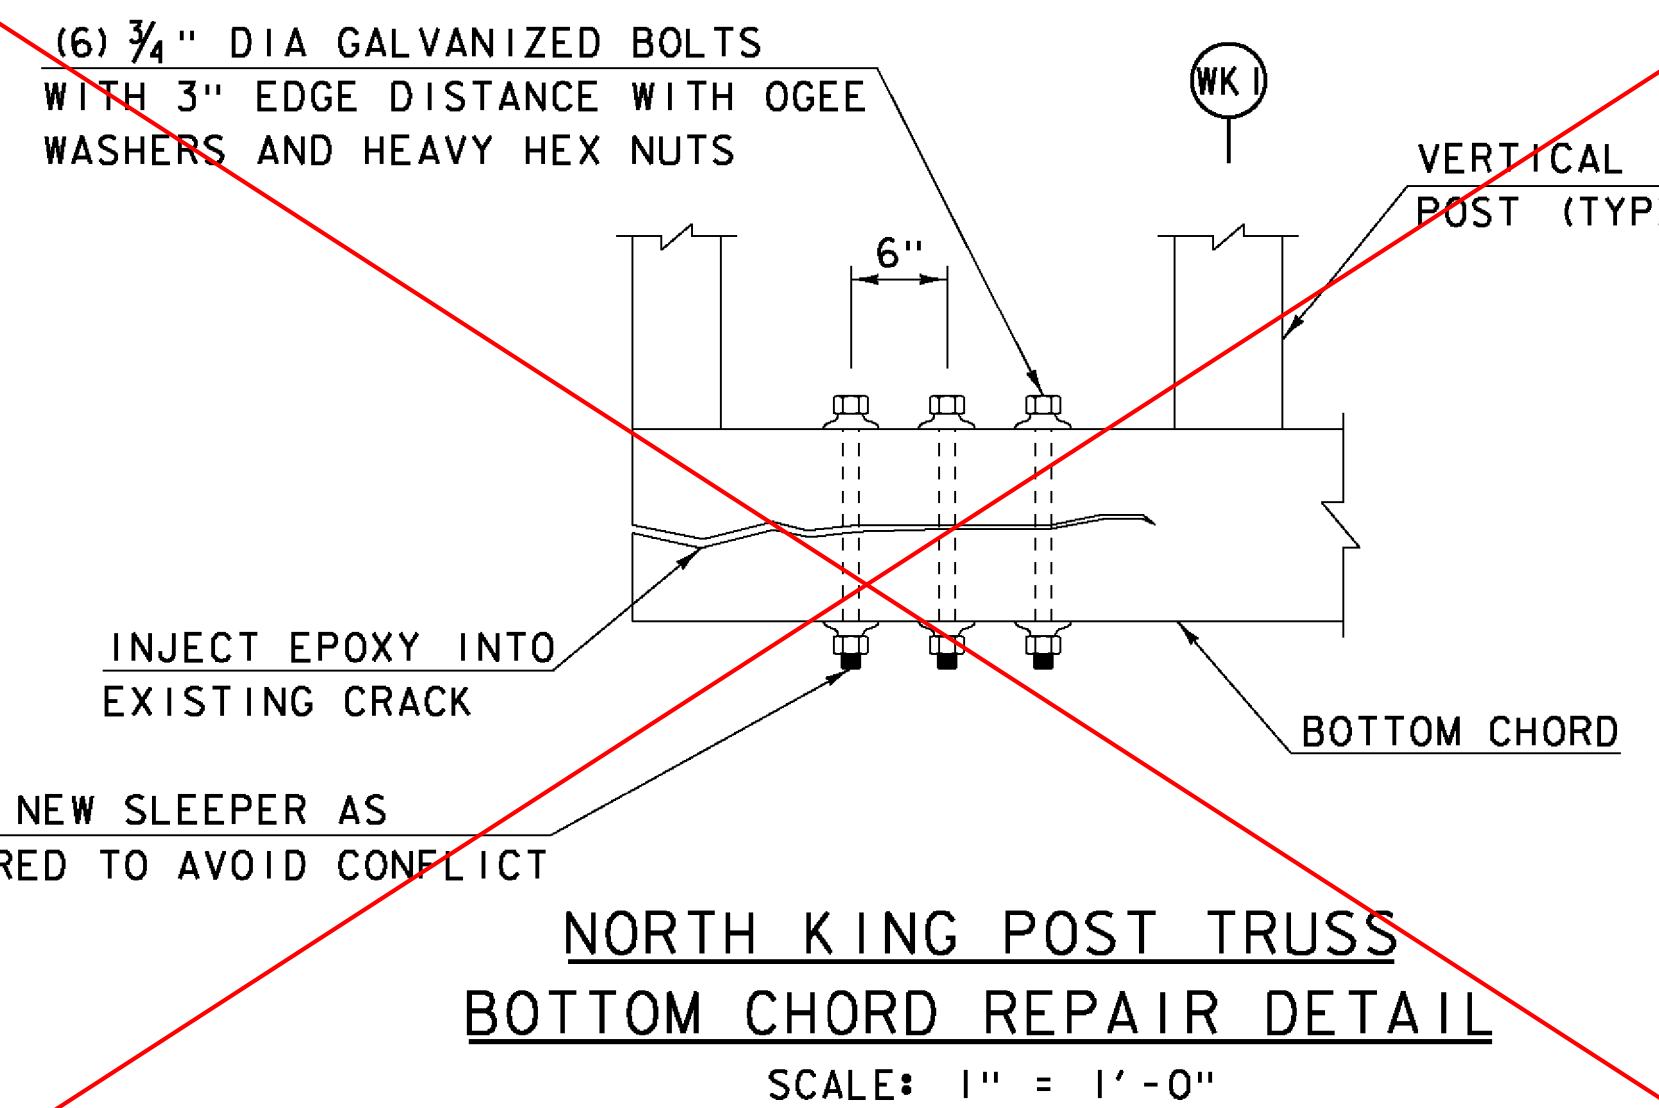
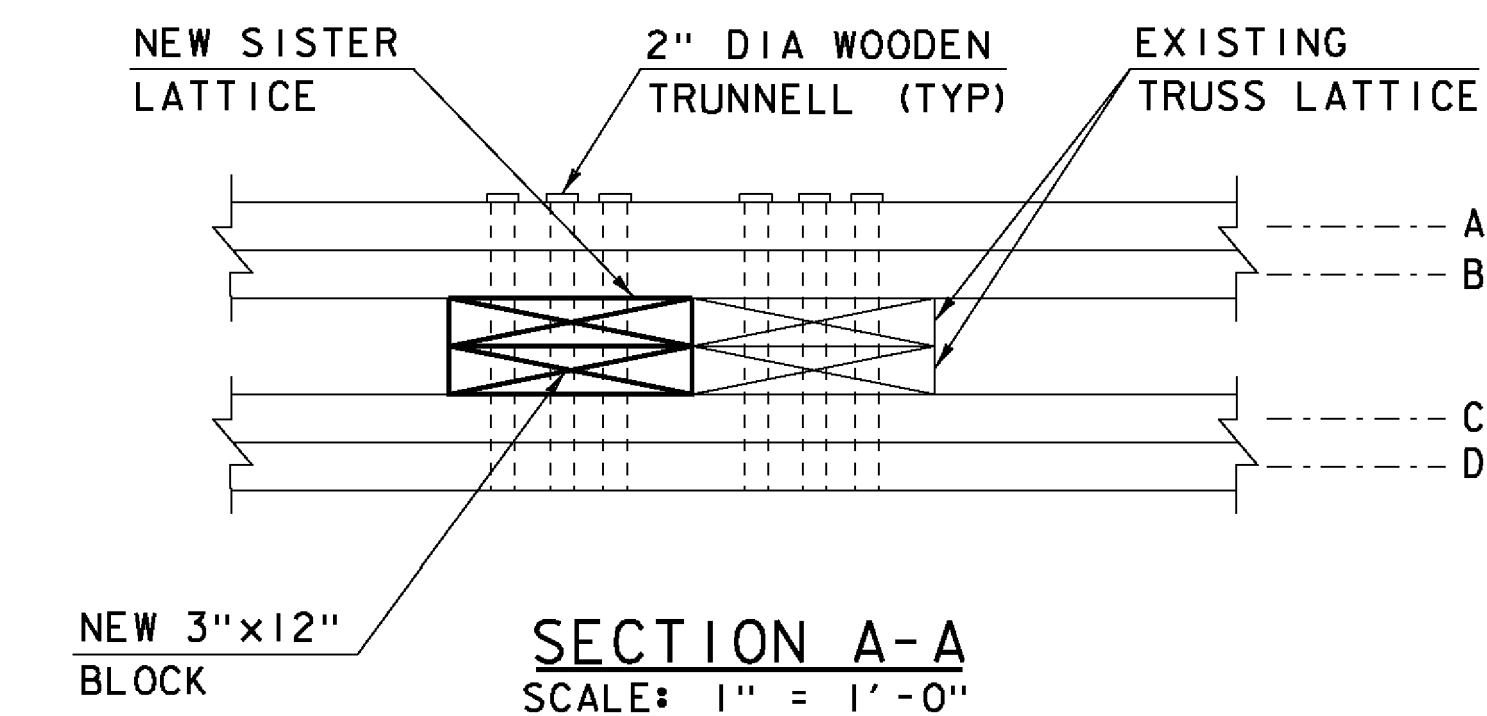
RECOMMENDED REPAIR SEQUENCE

1. IDENTIFIED ROTTED MATERIAL IN LUMBER AND TIMBER MEMBERS, IF LESS THAN 1 INCH IN DEPTH, SHALL BE REPAIRED AS SHOWN ABOVE ON THE "EPOXY REPAIR DETAIL". IF ROT IS GREATER THAN 1 INCH IN DEPTH, THE ENTIRE MEMBER SHALL BE REPLACED AS DIRECTED BY THE RESIDENT ENGINEER.

2. REMOVE ALL ROTTED MATERIAL TO A MINIMUM OF 1/4" BEYOND EXTENT OF ROT. SAWCUT 1/4" DEEP AROUND PERIMETER OF REPAIR AREA.
3. CLEAN EXISTING MEMBER OF ALL DIRT, SAWDUST, ETC. AND PREPARE SURFACE PER MANUFACTURER'S RECOMMENDATIONS.

4. INSTALL/INJECT APPROVED EPOXY REPAIR MATERIAL PER MANUFACTURER'S RECOMMENDATIONS, (PAID UNDER ITEM 900.620, SPECIAL PROVISION (WOOD EPOXY REPAIRS)). COLOR OF REPAIR MATERIAL TO MATCH EXISTING WOOD. A COMPLETED TEST SECTION SHALL BE MADE FOR APPROVAL BY THE RESIDENT ENGINEER.

5. INSTALL TWO GALVANIZED LAG SCREWS INTO EXISTING SPLIT THROUGH REPAIR MATERIAL (IF REQUIRED). SIZE OF LAG SCREWS TO BE DETERMINED BY THE RESIDENT ENGINEER.

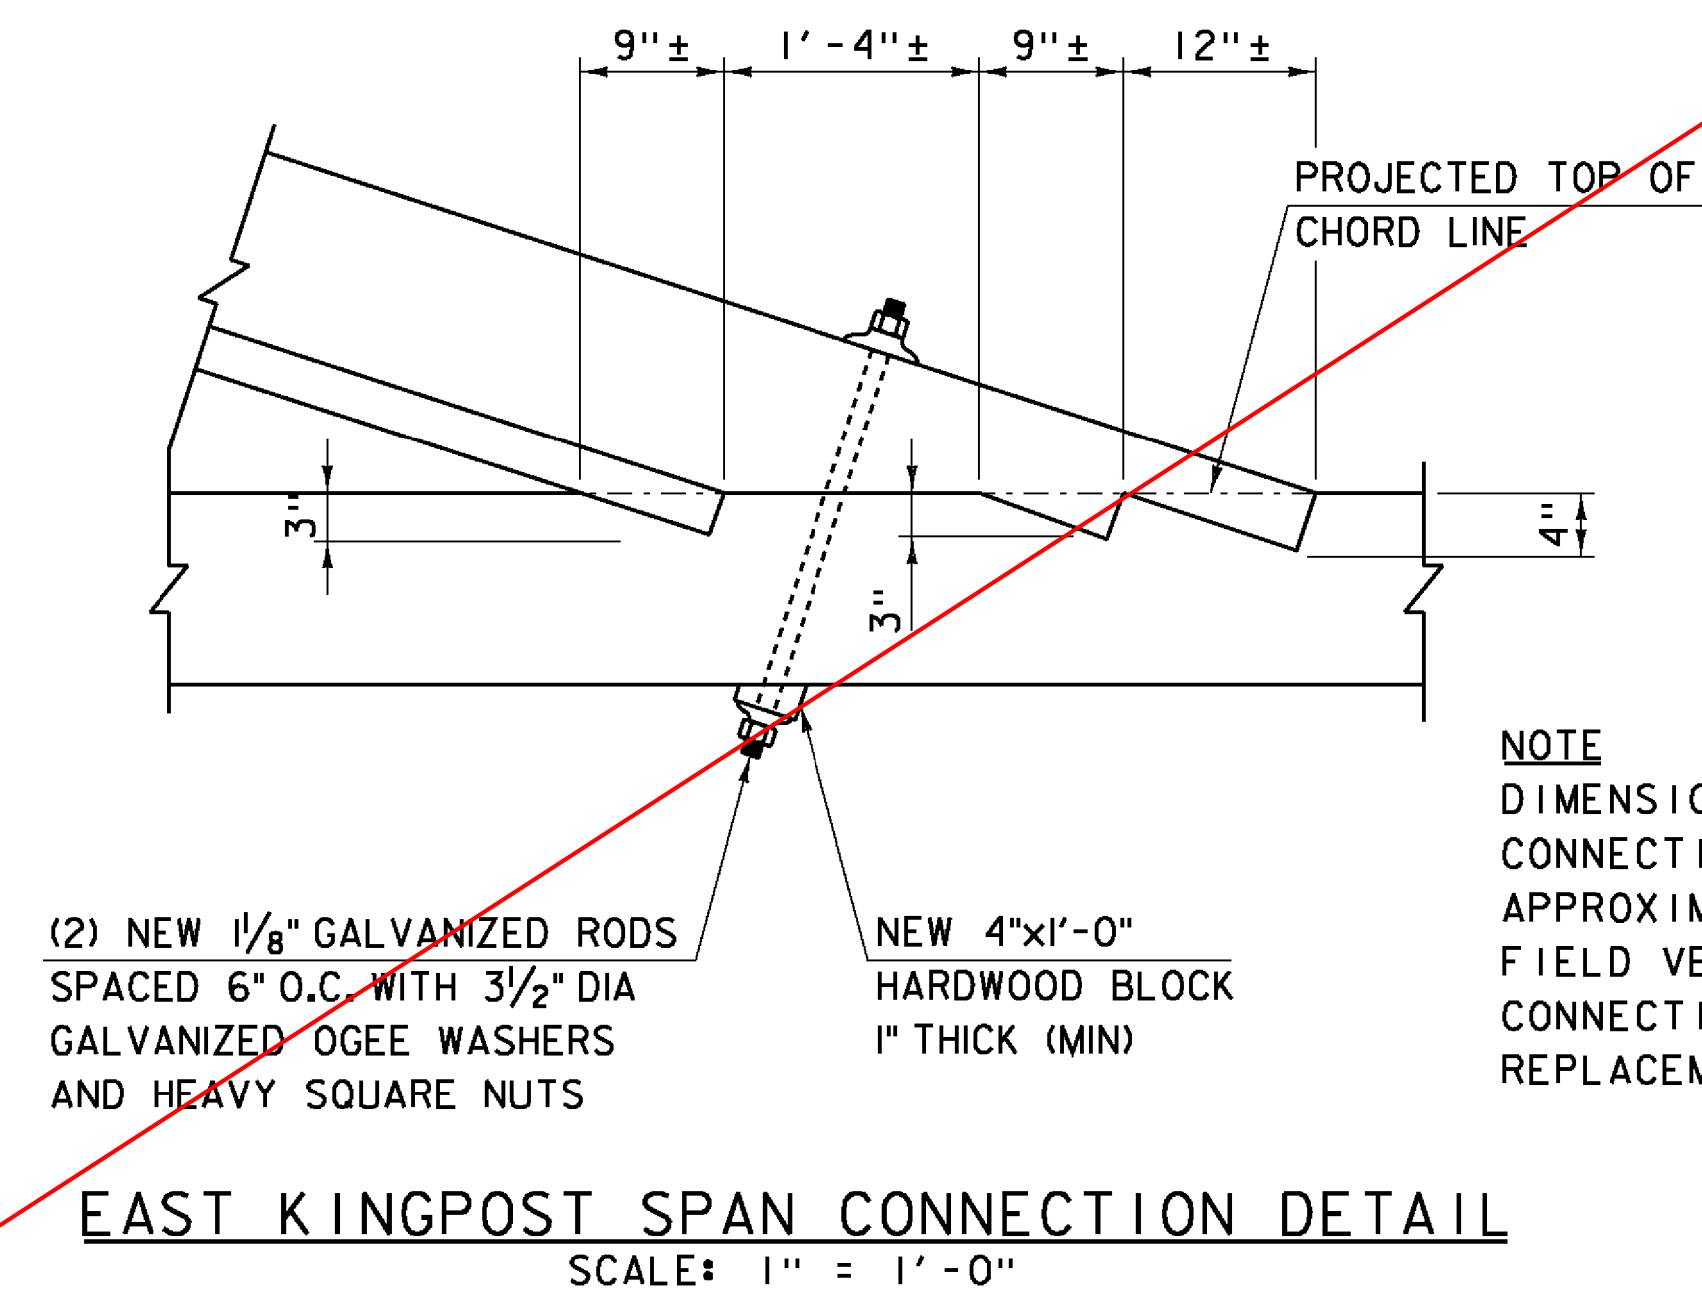
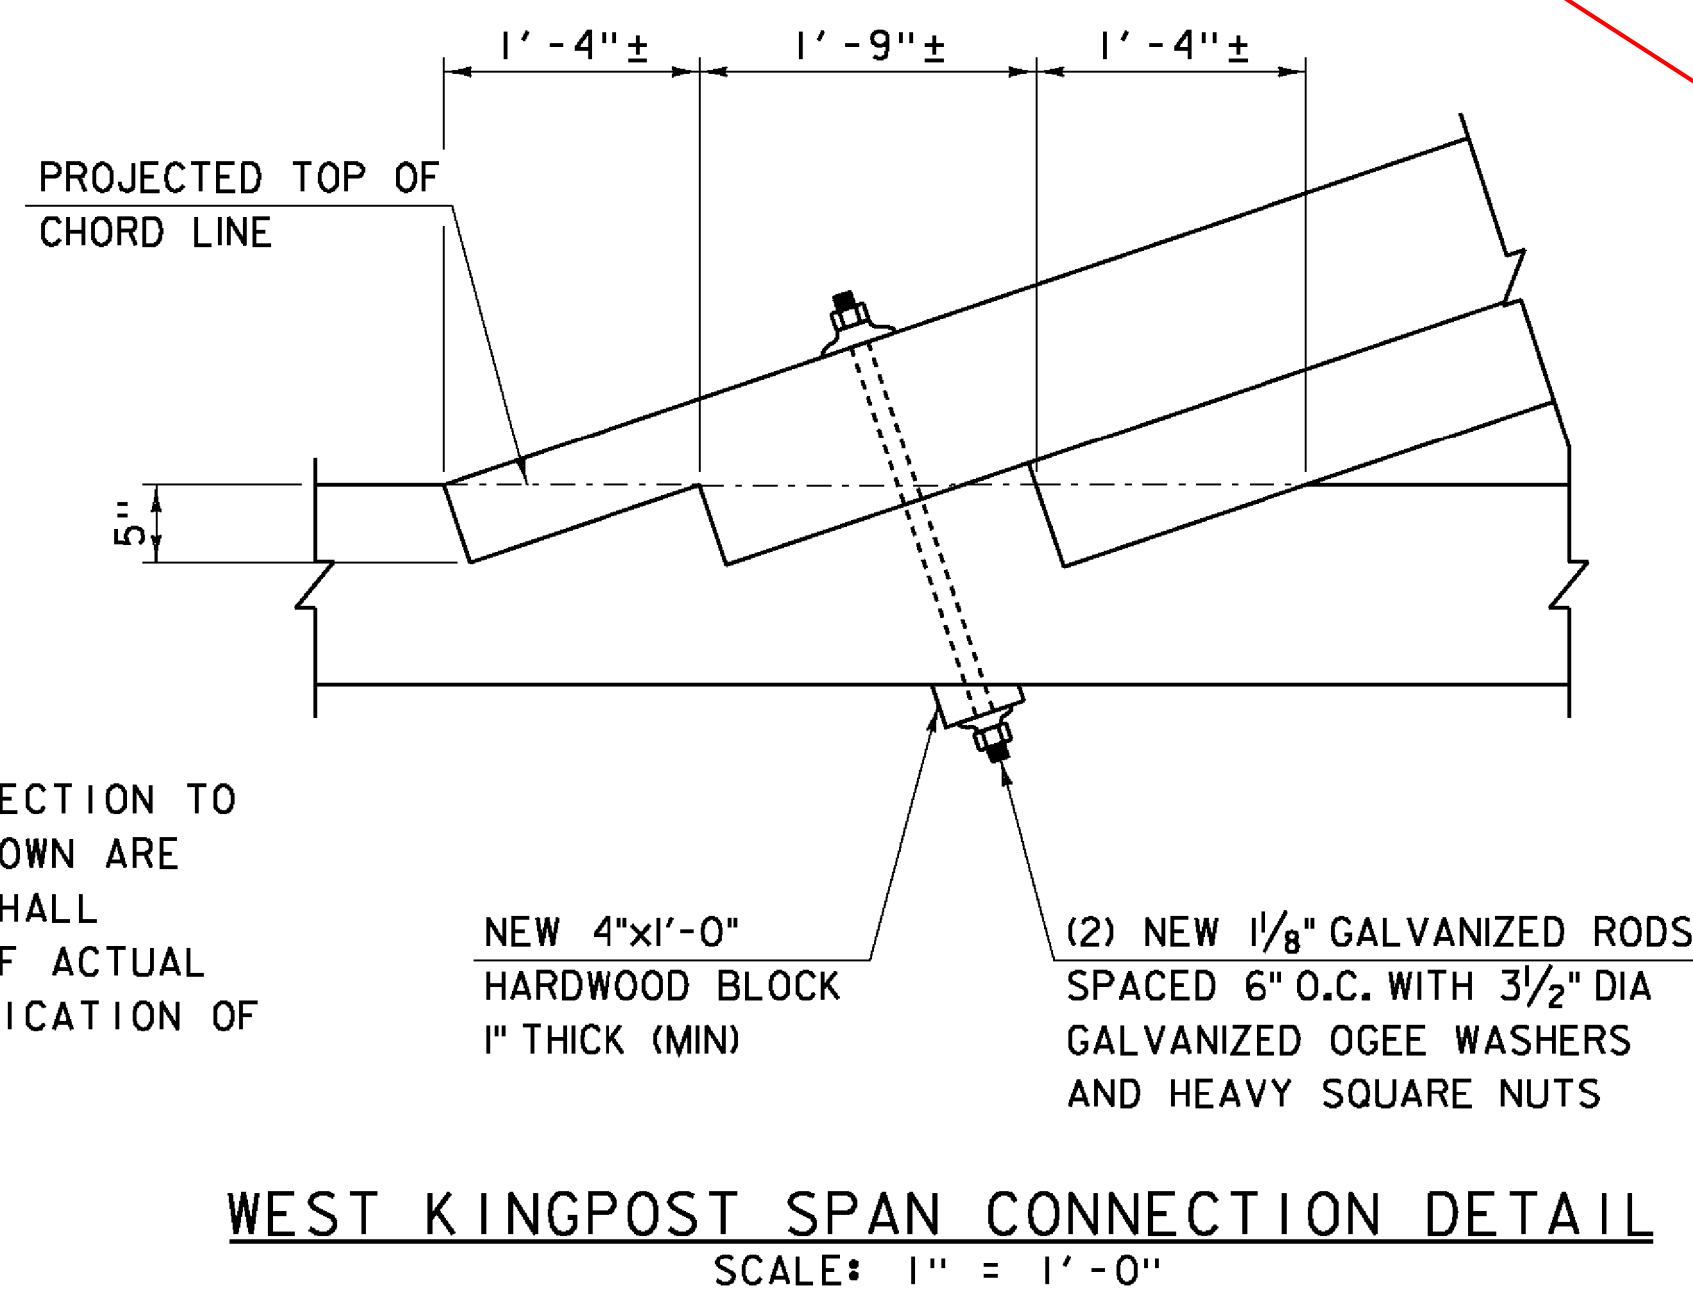
NOTE
DIMENSIONS VARY FROM CONNECTION TO CONNECTION. DIMENSIONS SHOWN ARE APPROXIMATE. CONTRACTOR SHALL FIELD VERIFY DIMENSIONS OF ACTUAL CONNECTIONS PRIOR TO FABRICATION OF REPLACEMENT ELEMENT.
