HTA PROJECT	MODEL
904225	904225ssDetail

PROJECT NAME: TOWNSEND	FILE NAME: 904225ssDetail.dgn	PLOT DATE: 8/13/2015
PROJECT NUMBER: STP SCTT(1)	PROJECT LEADER: M.D.SARGENT	DRAWN BY: T.A.GELINAS
	DESIGNED BY: J.C.RIPLEY	CHECKED BY: S.T.JAMES
	SUBSTRUCTURE DETAILS (1 OF 3)	SHEET 46 OF 60

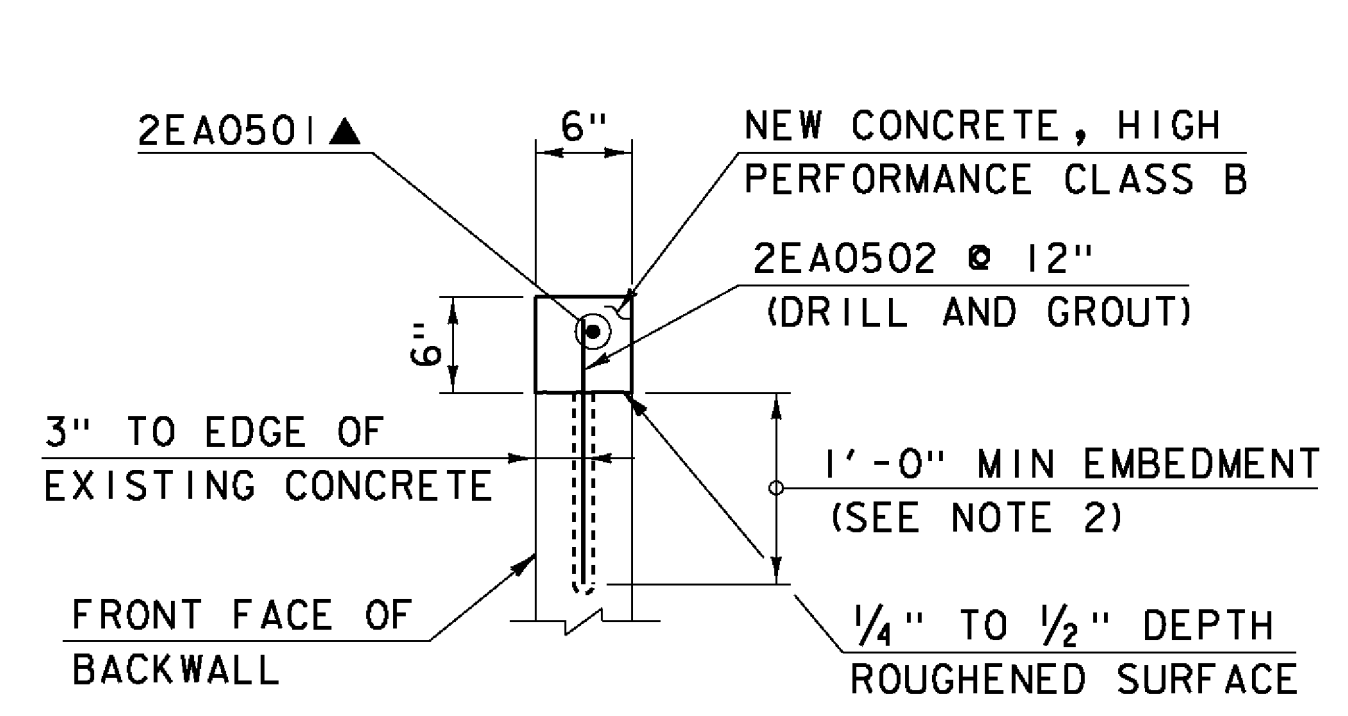
ABUTMENT NO. 2 BACKWALL REPAIR DETAIL
SCALE: 1" = 1'-0"

- NOTES**
- BACKWALL REPAIR WILL BE PAID UNDER ITEM 580.14, REPAIR OF CONCRETE SUBSTRUCTURE SURFACE, TYPE 11.
 - DRILLING AND GROUTING WILL BE PAID UNDER ITEM 507.16, DRILLING AND GROUTING BARS.
 - SAWCUT EACH END OF REPAIR AREA. COST PAID UNDER ITEM 580.14, REPAIR OF CONCRETE SUBSTRUCTURE SURFACE, TYPE 11.

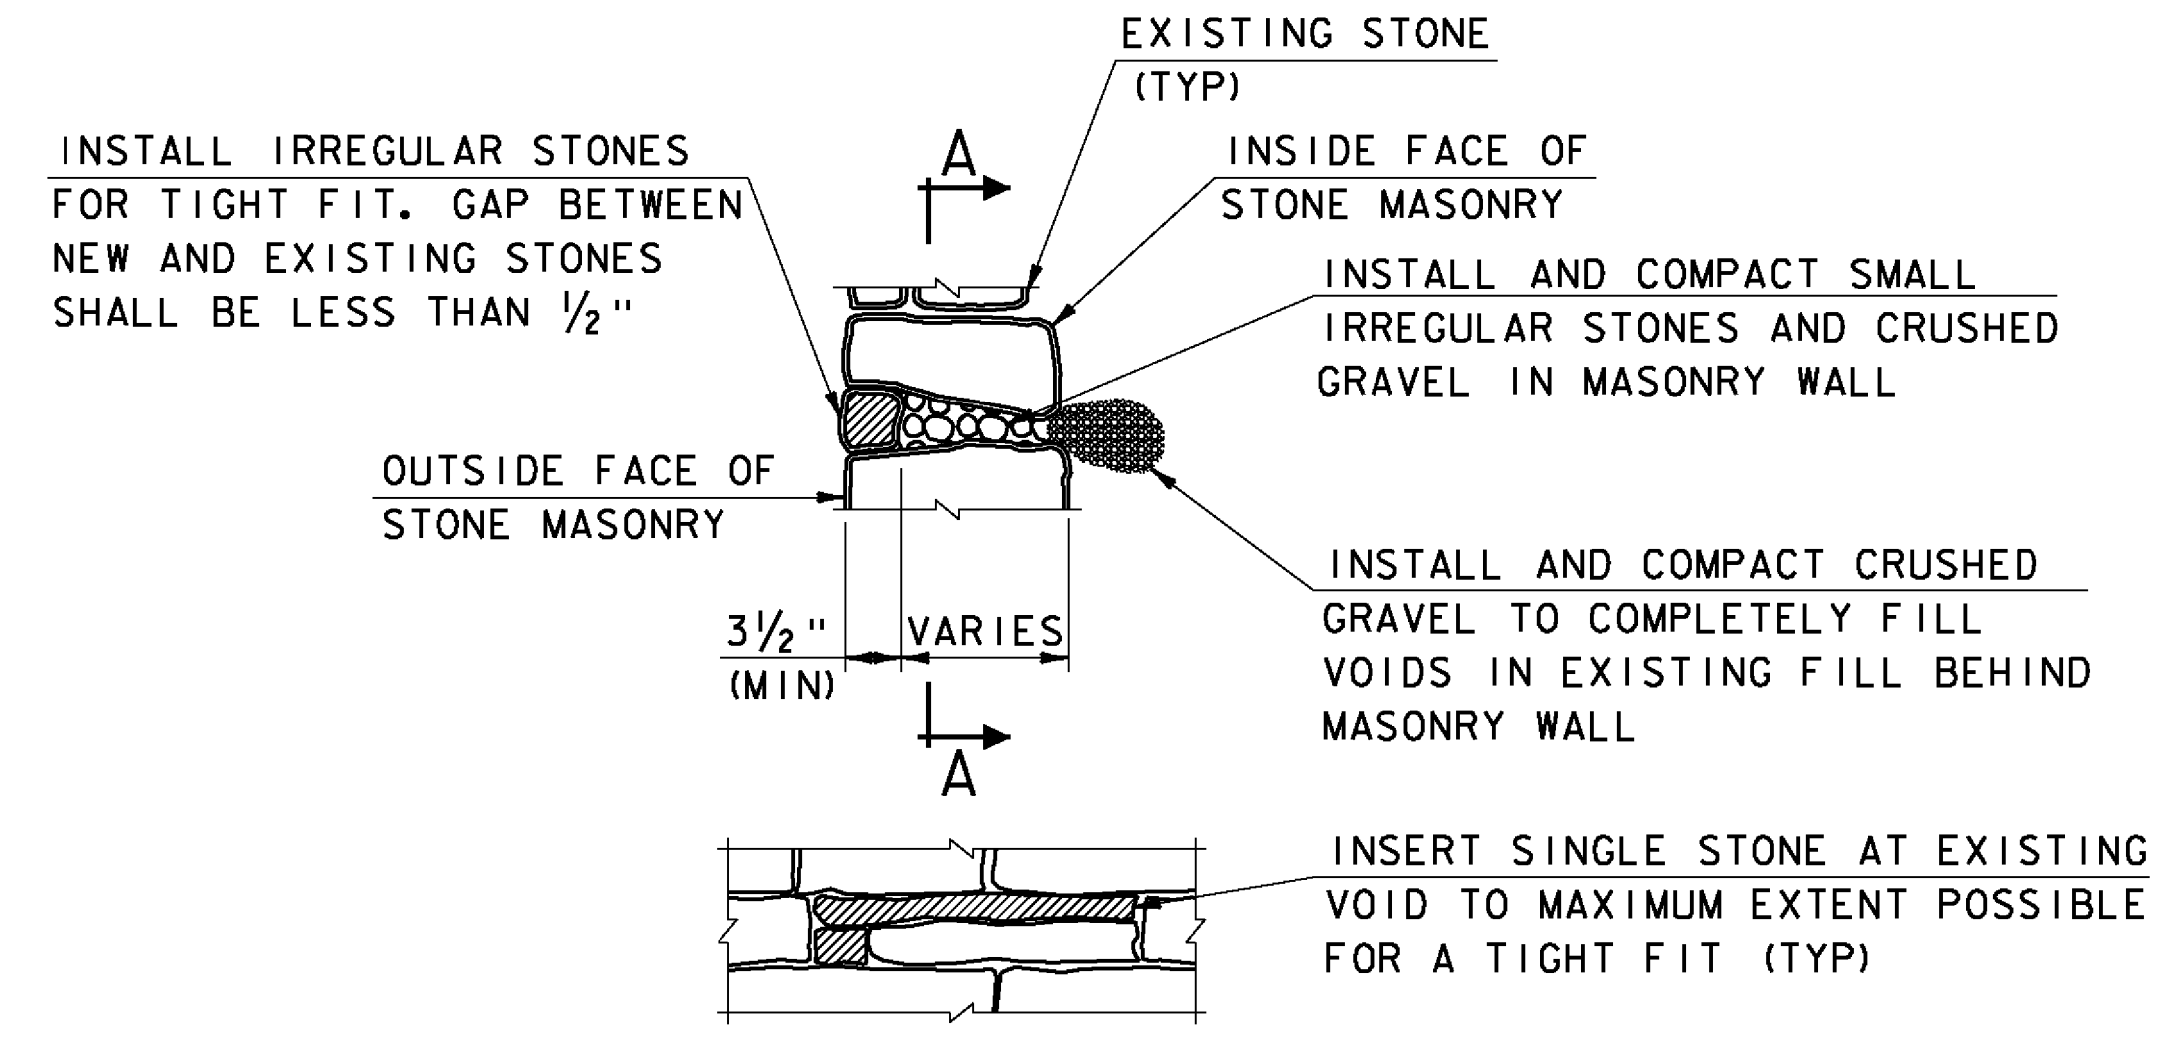
SECTION A-A
NOT TO SCALE
STONE MASONRY REPAIR DETAIL
NOT TO SCALE

NOTE
WORK SHALL CONFORM TO AND BE PAID UNDER ITEM 602.40, REPAIRING STONE MASONRY

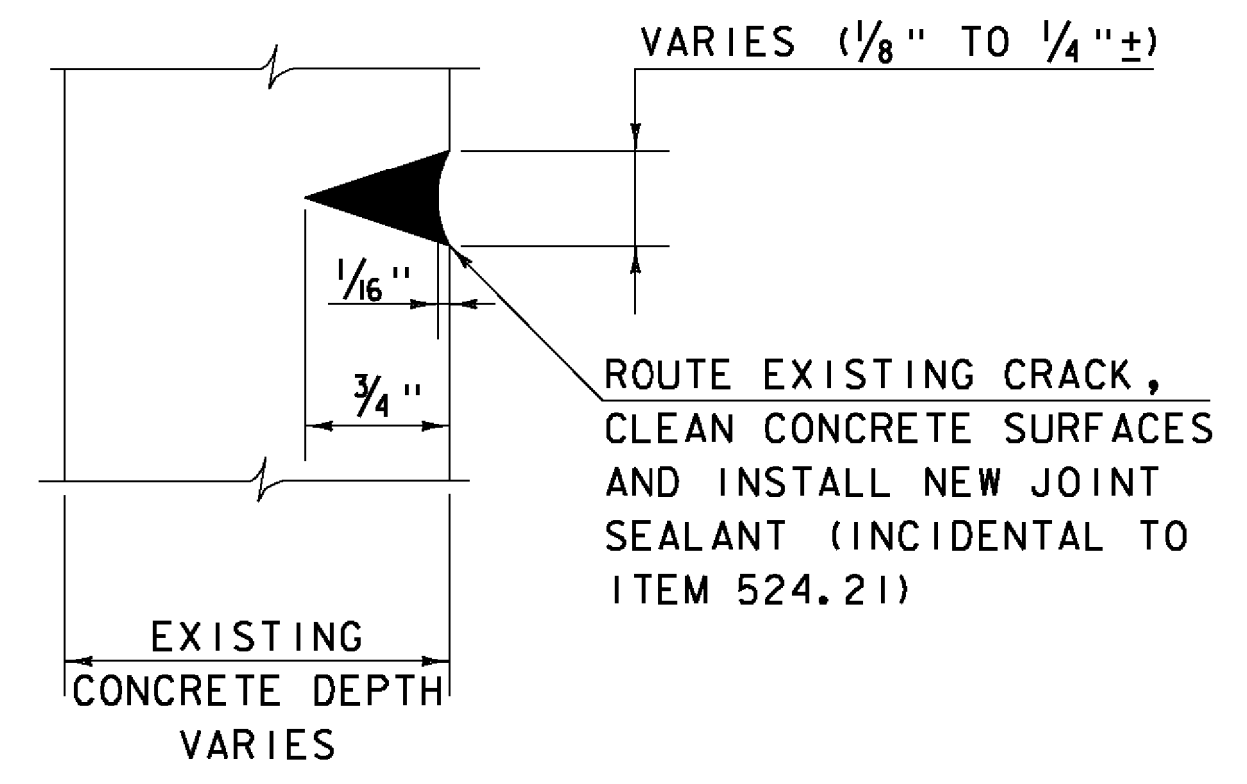
CRACK SEAL DETAIL
NOT TO SCALE

NOTE
NEW JOINT SEALANT SHALL BE AN APPROVED ONE COMPONENT POLYURETHANE ELASTOMERIC SEALANT COMPLYING WITH ITEM 524.21, JOINT SEALER, POLYURETHANE.
