SUBSTRUCTURE REPAIR NOTES FOR ABUTMENTS

SHEET NAME: REPAIR OF SUBSTRUCTURE SURFACE	
PROJECT NAME: JOHNSON	HIGHWAY NO.: TH 2
PROJECT NUMBER: BHO 1448(18)	BRIDGE NO.: 6
	OVER: THE LAMOILLE RIVER
FILE NAME: /s1/90j067/sj067rep.dgn	PLOT DATE: 02-SEP-2005
PROJECT MANAGER: R. WHITCOMB	DRAWN BY: D. BONNEAU
DESIGNED BY: C. MEUNIER	IPARM NAME: sc067rep.i
BRIDGE SHEET NUMBER:	SHEET 45 OF 73

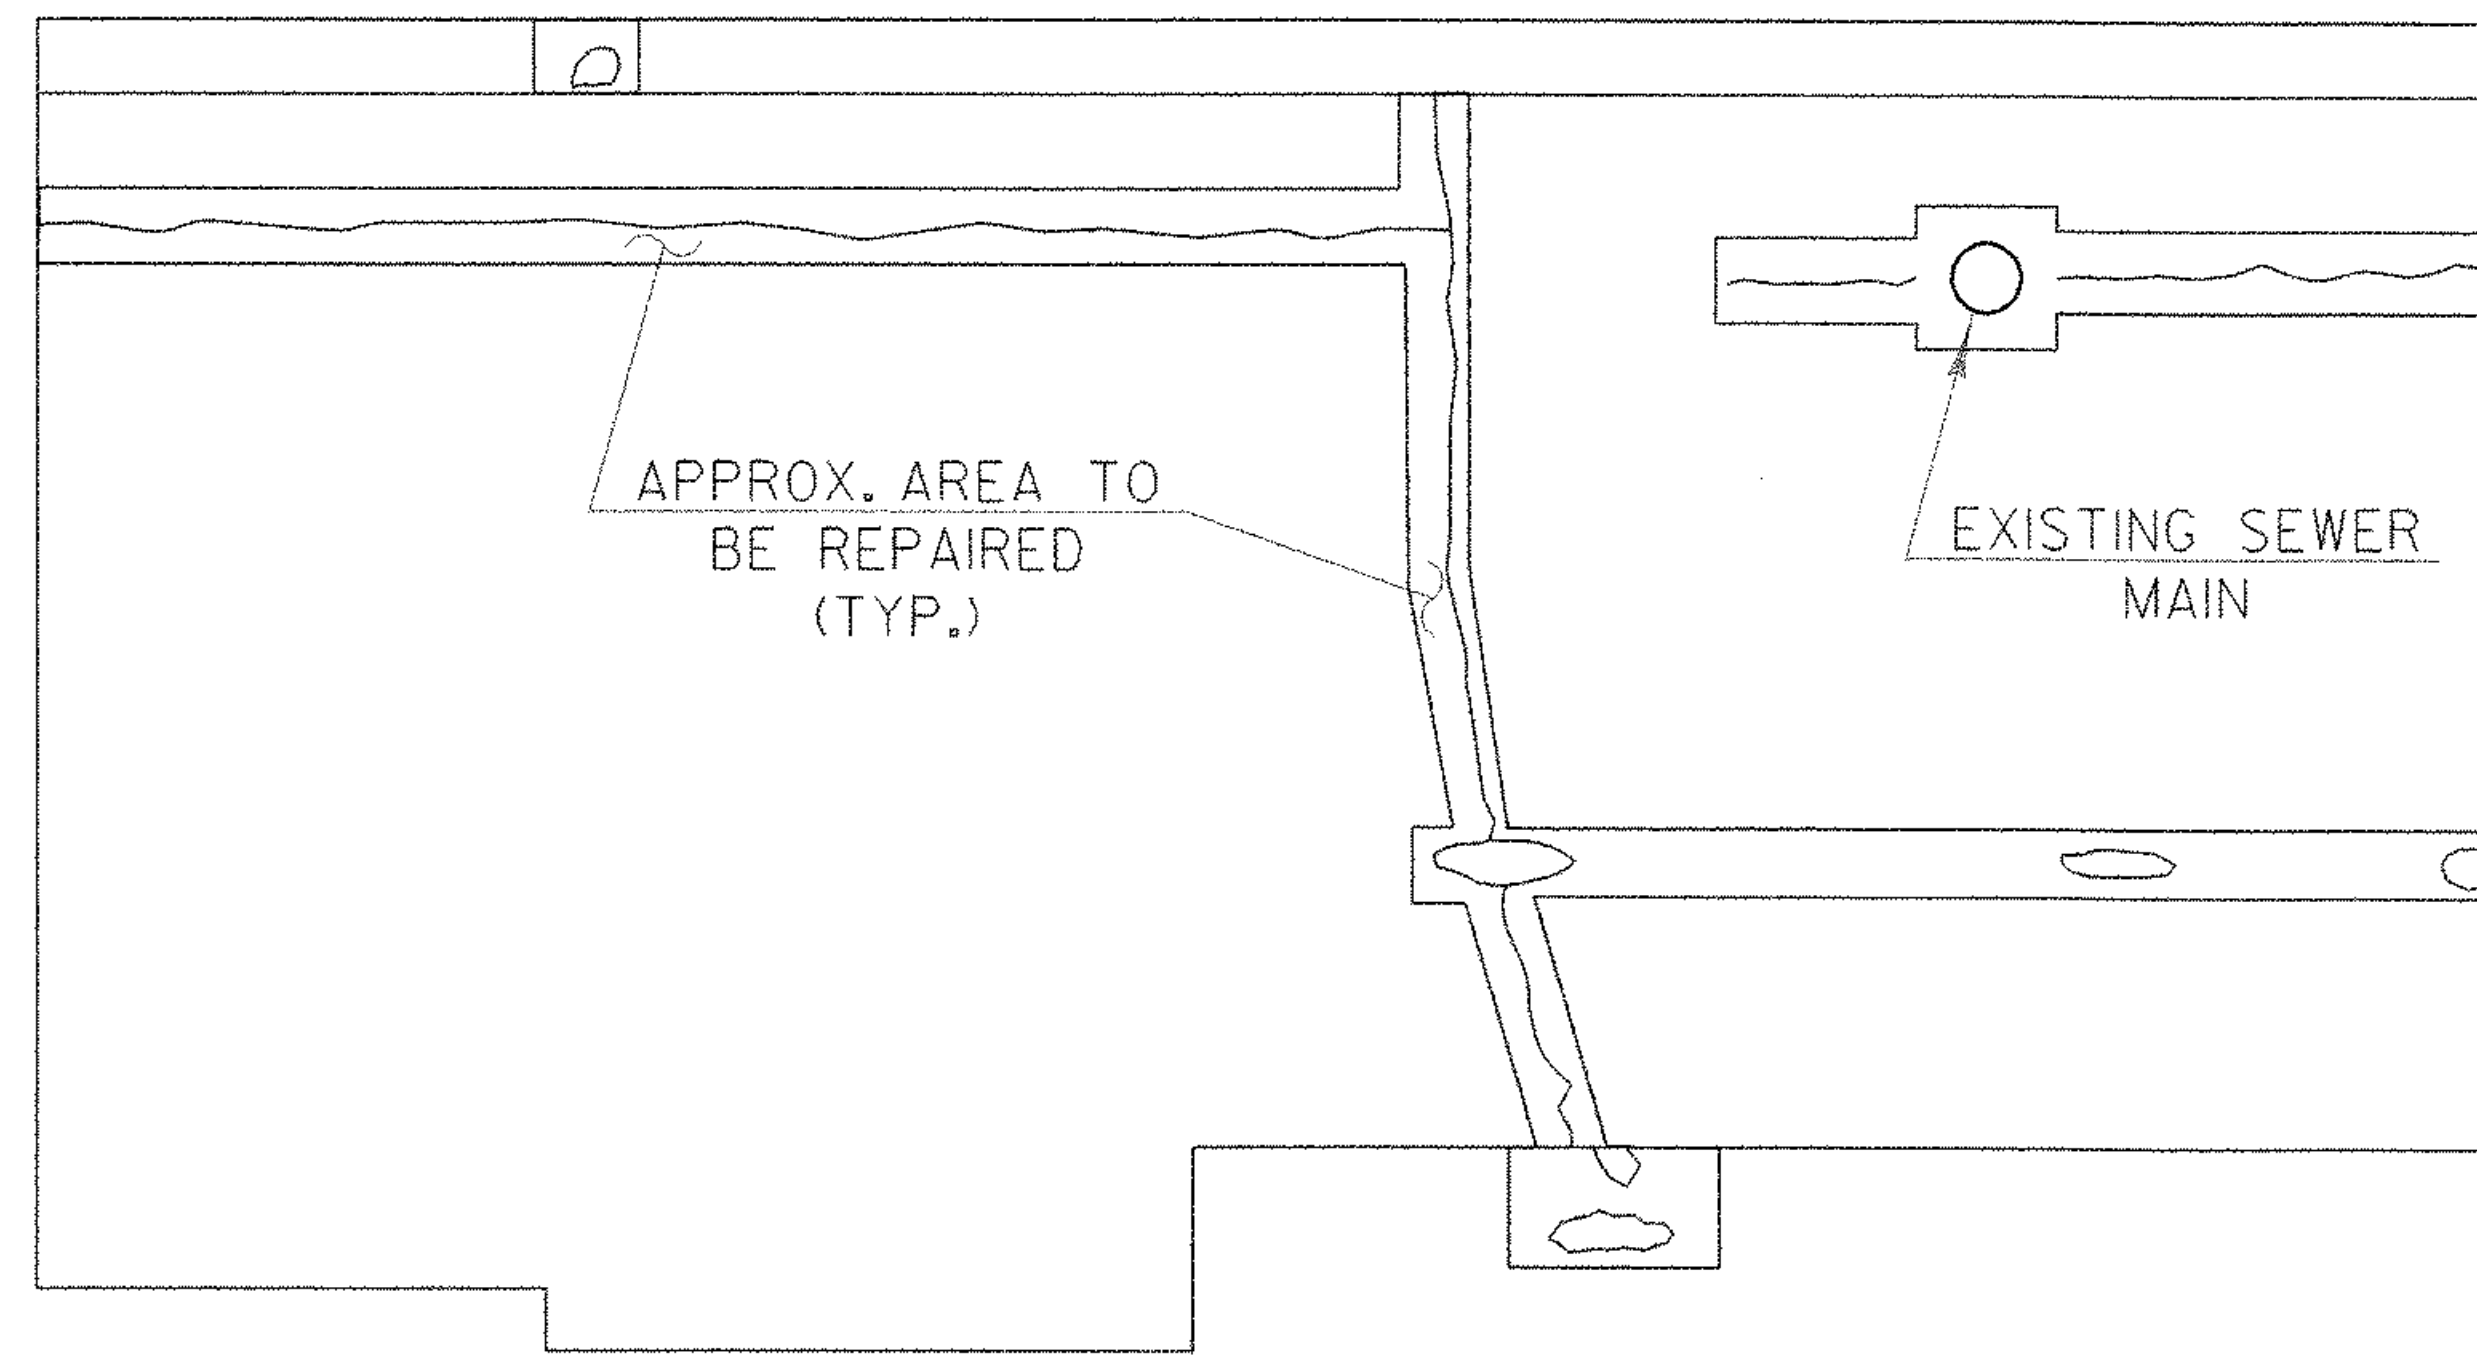
ABUTMENT #1

** The defective areas shown on these elevation views are only estimates, the exact area will be determined by the Resident Engineer in the field.

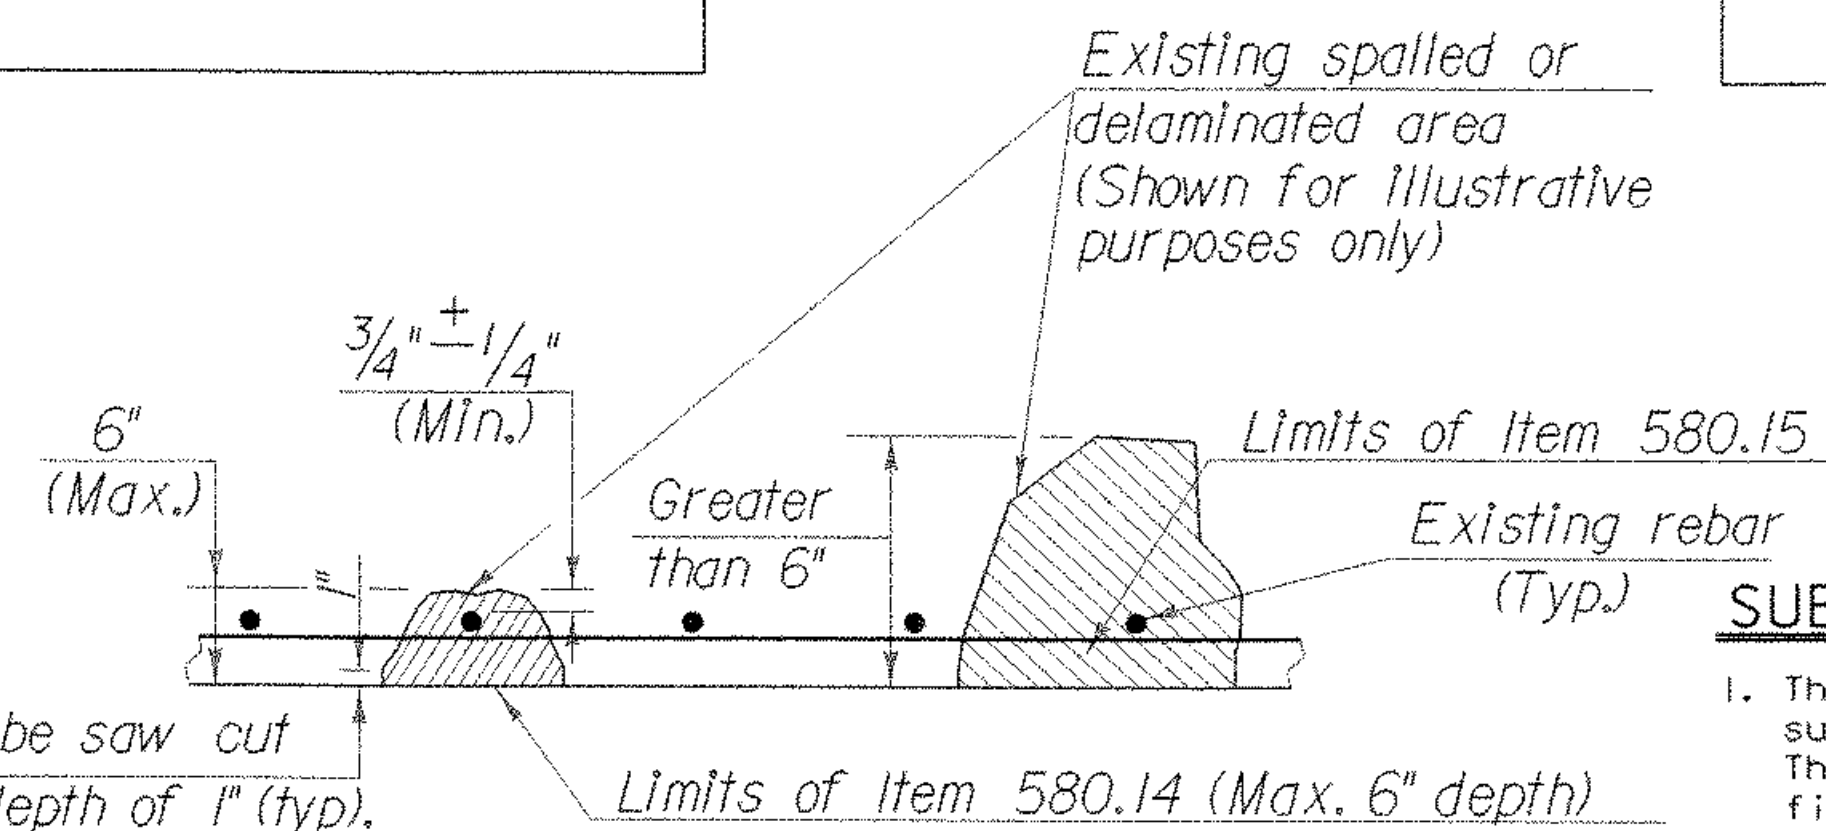
DETAIL SHOWING LIMITS OF ITEMS 580.14 AND 580.15
REPAIR OF CONCRETE SUBSTRUCTURE SURFACE CLASS II OR CLASS III
 N.T.S.

- A. The limits for removal of concrete under Item 580.14 "Repair of Concrete Substructure Surface, Class II" shall be from the existing concrete surface to a minimum depth of $(\frac{3}{4}) \pm \frac{1}{4}$ " inside the inside face of reinforcing steel and to a maximum depth of 6" from the existing concrete surface, all work and materials necessary for repairing a patch and filling it shall be included in the unit price bid Item 580.14, "Repair of Concrete Substructure Surface, Class II." The filling material will be "Concrete High Performance, Class A," or an acceptable pneumatically applied concrete (See Special Provisions). The edges of all patches shall be saw cut in straight lines to a minimum depth of one inch.

- B. The limits for removal of concrete under Item 580.15 "Repair of Concrete Substructure Surface, Class III" shall be from the existing concrete surface to a depth of greater than 6". All work and materials necessary for repairing and filling patches shall be included in the unit price for Item 580.15 "Repair of Concrete Substructure Surface, Class III." The filling material may be either Concrete High Performance, Class A, Concrete High Performance, Class B, or an acceptable pneumatically applied concrete (See Special Provisions). The edges of all patches shall be saw cut in straight lines to a minimum depth of one inch.

The edges of all patches shall be saw cut in straight lines to a minimum depth of 1" (typ).
