DISTRICT	TOWN	ROUTE
4	ROYALTON, SHARON	I-89

<p>Historic Projects</p> <ul style="list-style-type: none"> Unknown Retreatment Resurface Bituminous Mix Skinny Mix Bituminous Seal 	<p>Functional Class</p> <ul style="list-style-type: none"> 1 - Interstate System 2 - Other Freeways and Expressways 3 - Principal Arterial 4 - Minor Arterial 5 - Major Collector 6 - Minor Collector 	<p>Curves</p> <ul style="list-style-type: none"> Left grade up Right grade up Left grade down Right grade down 	<p>Grades</p> <ul style="list-style-type: none"> Continuous (CTC) Weight-In-Motion (WIM) Short-Term, Scheduled Short-Term, Unscheduled 	<p>Crash Locations</p> <ul style="list-style-type: none"> Fatal Injury Property Damage Only Unknown Crash Type 	<p>Mileage by Functional Class By Sheet</p> <p>89-1 1 - Interstate 9.000</p>	<p>Mileage by Town By Sheet</p> <p>ETE - I089-0000 9.0 of 130.254</p>	<p>DISTRICT</p> <p>4</p>	<p>TOWN</p> <p>ROYALTON, SHARON</p>	<p>Date: 02/14/24</p> <p>2 of 15 TWN mileage: 9.0 to 18.0</p>	<p>ROUTE</p> <p>I-89 ETE mileage: 9.0 to 18.0</p>

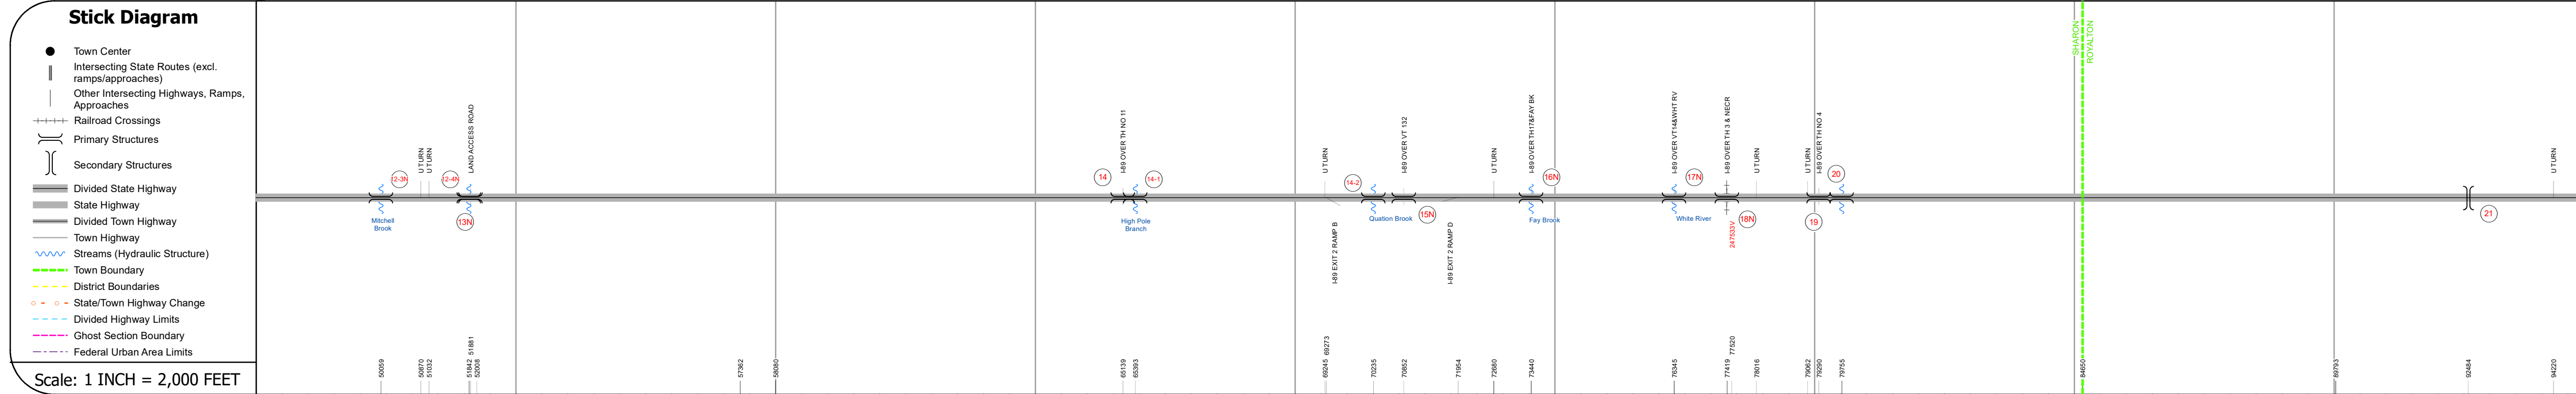
Scale: 1 INCH = 2,000 FEET	10	11	12	13	14	15	16	17	18
Road Widths									
Curves									
Grades									
Guardrails									
Rumblestrips									
Speed Zone									
Curves: Head-on, FTC6									
Curves: Overturn, FTC7									
Curves: Run-off Road, FTC8									
Curves: Fixed Object, FTC9									
Curves: Night Run-off Road, FTC10									
Interstate: Overturn, FTC11									
Tangents: Head-on, FTC12									
Tangents: Overturn, FTC13									
Tangents: Run-off Road, FTC14

Risk	Primary Risk	High Risk	Medium Risk	Low Risk	Minimal Risk	Not a Focus Facility
AADT	2022: 8793	2021: 8101	2020: 7175	2019: 9566	2018: 18800
