Route Log and Progress Chart

DISTRICT	TOWN	ROUTE
8, 5	GEORGIA, MILTON	I-89

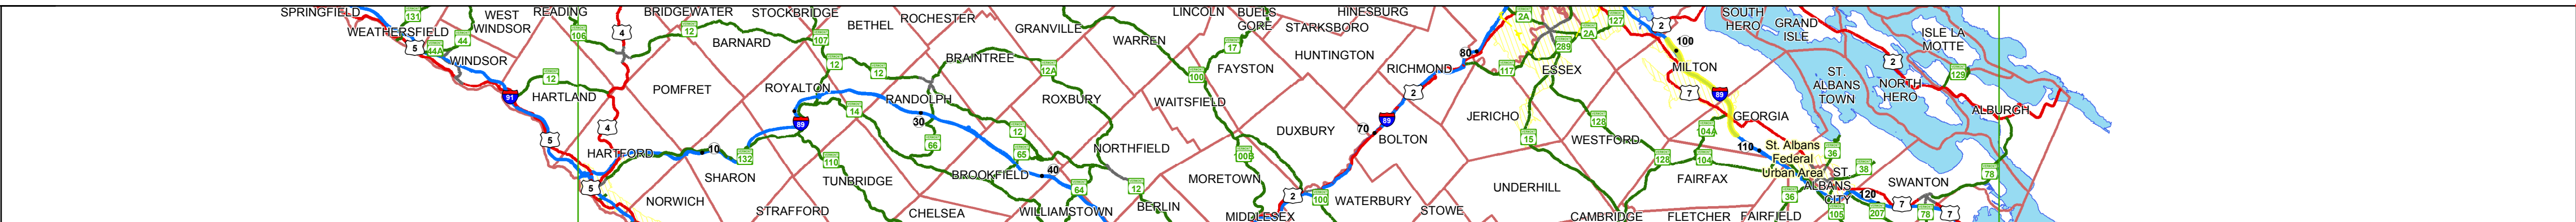
Stick Diagram

Scale: 1 INCH = 2000 FEET
