Trans Working to Get You There Vermont Agency of Transportation

Route Log and Progress Chart

DISTRICTTOWNROUTE5BOLTONUS-2

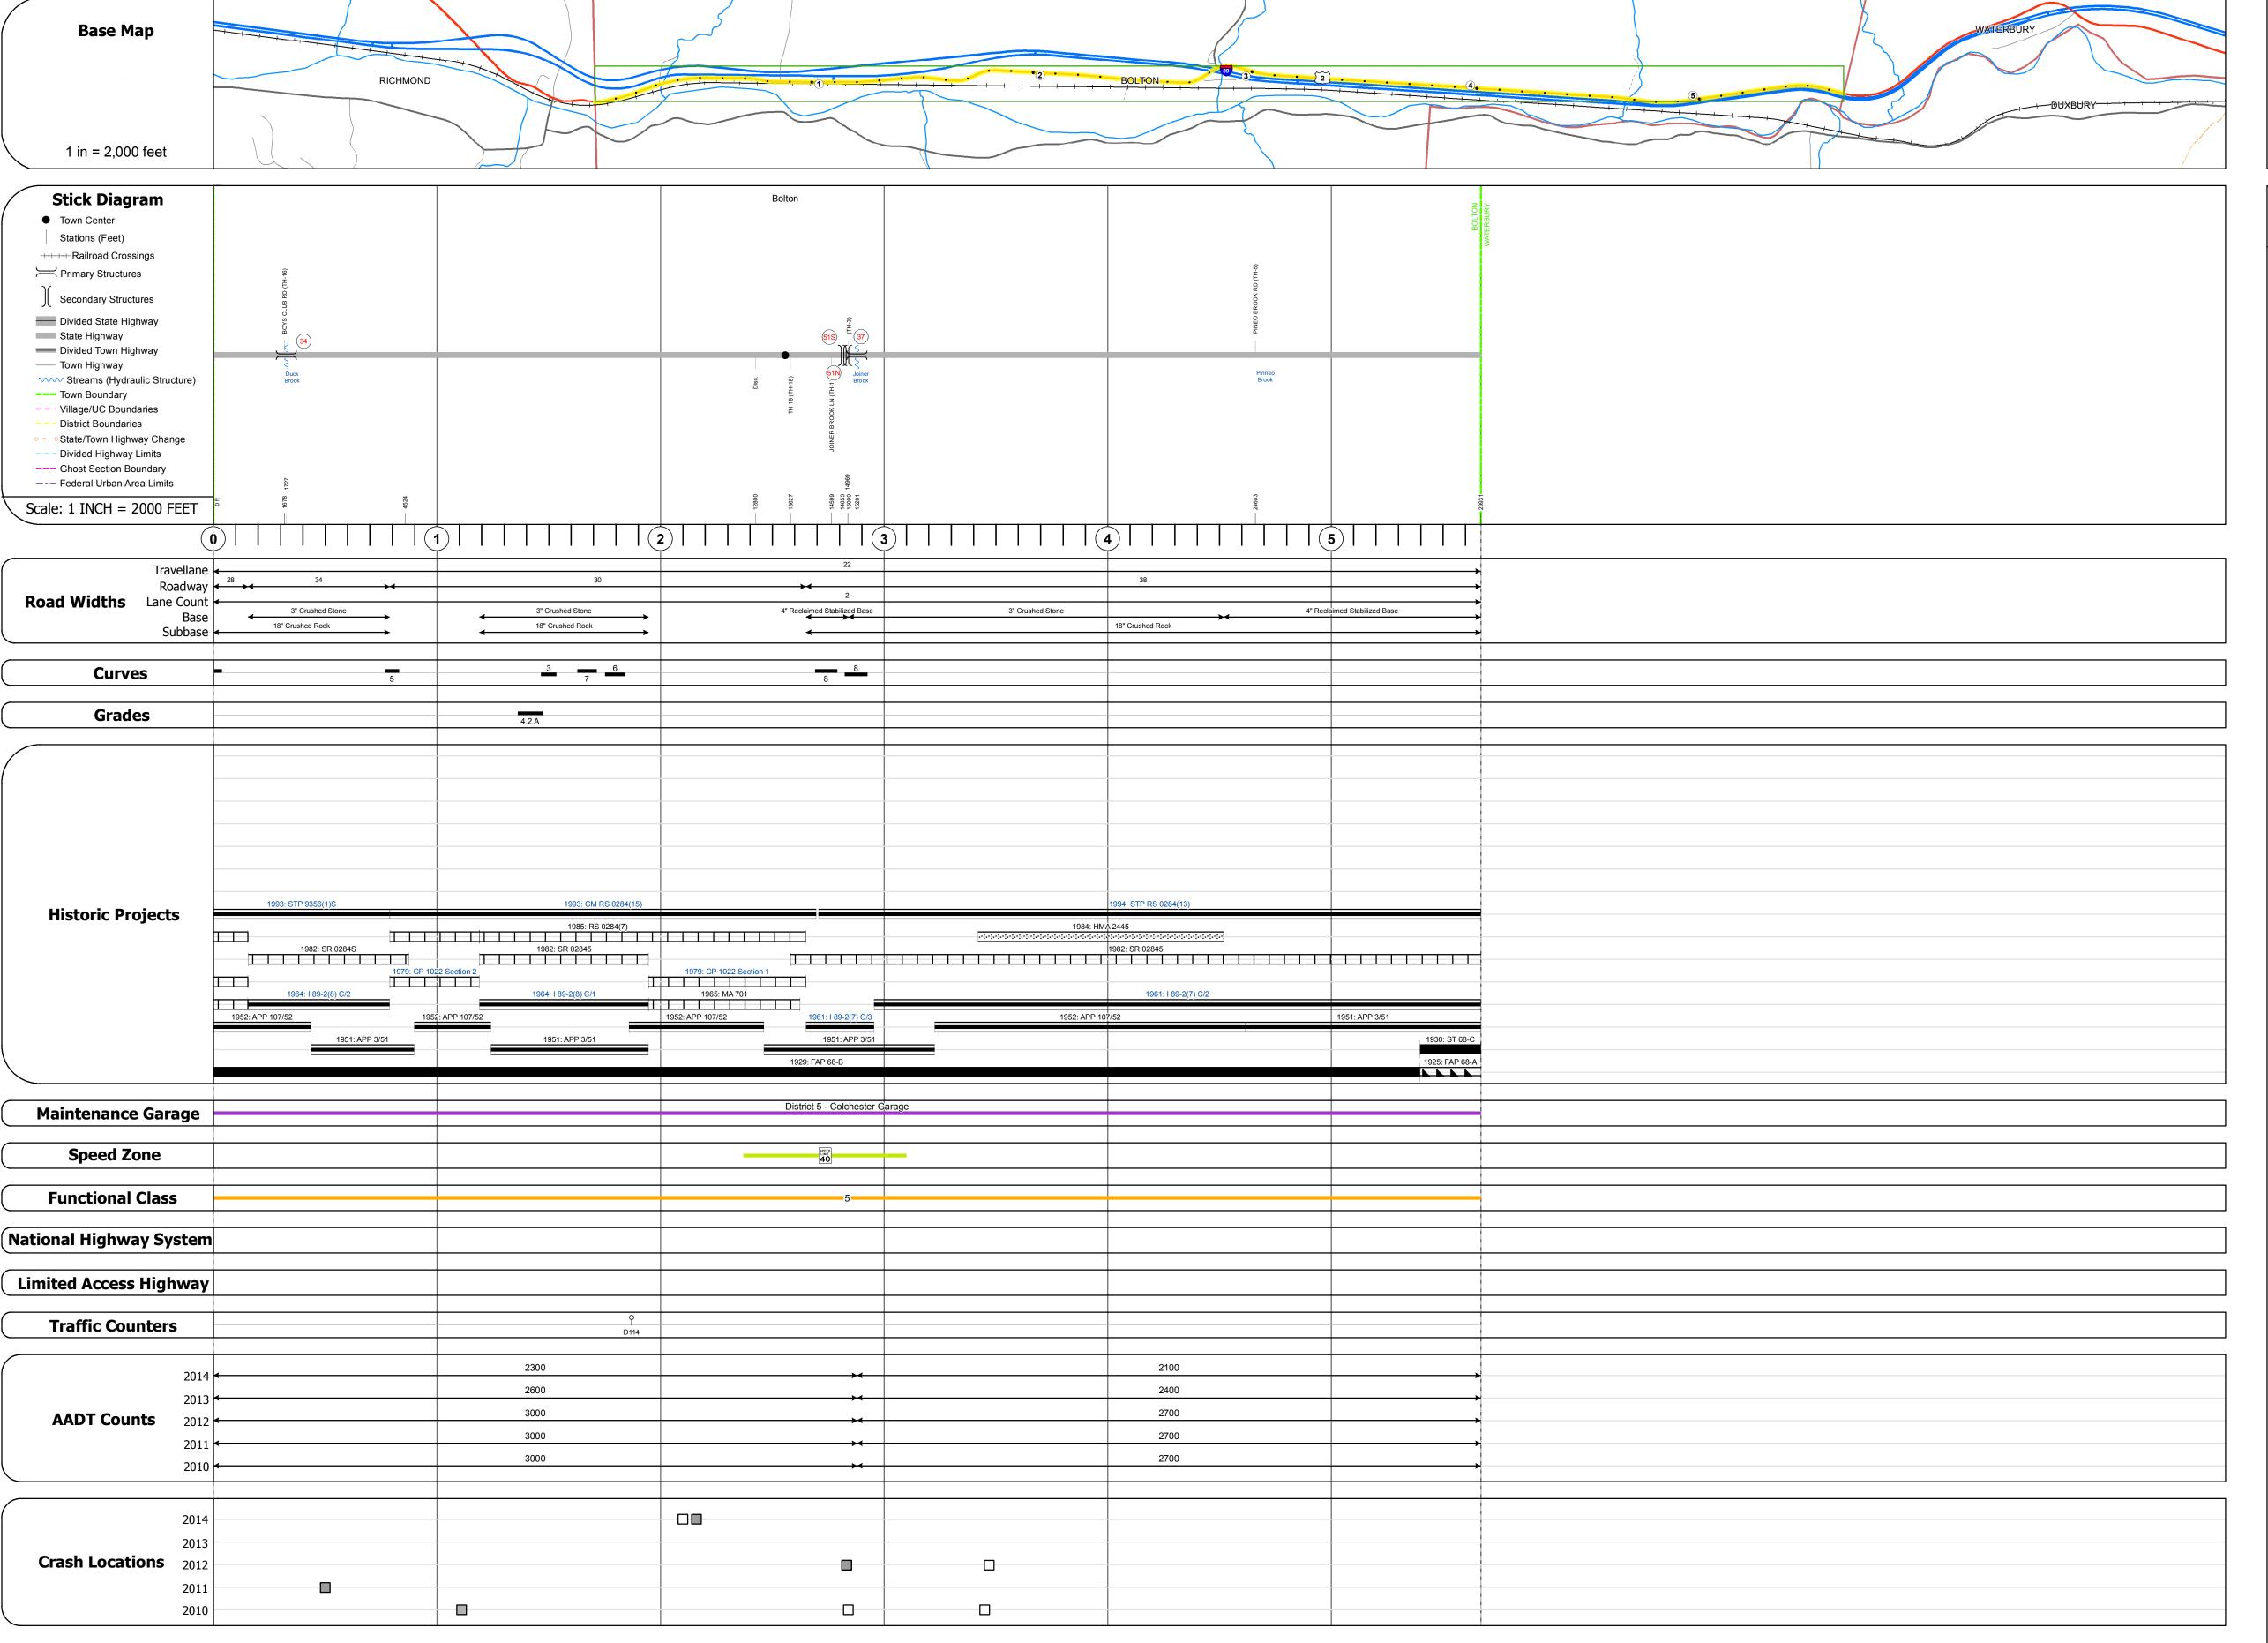
STRUCTURE	DESCRIPTIONS

Culvert 34:
Culvert - 1964
Structure No. 300284003404011
Length: 11'
Under Clearance: 11.0'
Facility Carried: US2
Bridge Type: MULTI PLATE PIPE
Features Intersected: DUCK BROOK
Maintenance: State

Bridge 51S:
Stringer/multi-beam or girder - 1961
Structure No. 200089051S04012
Length: 453'
Width: 32.0'
Under Clearance: 16.42'
Facility Carried: I 00089 ML
Bridge Type: 6 SPN CONT WGIR/RB
Features Intersected: I 89 OVER US2+JOINER BK
Surface: Bituminous
Maintenance/Ownership: State

Bridge 51N:
Stringer/multi-beam or girder - 1961
Structure No. 200089051N04012
Length: 364'
Width: 32.0'
Under Clearance: 14.75'
Facility Carried: I 00089 ML
Bridge Type: 5 SPN CONT WGIR/RB
Features Intersected: I 89 OVER US2+JOINER BK
Surface: Bituminous
Maintenance/Ownership: State

Stringer/multi-beam or girder - 1961 Structure No. 200284003704012 Length: 90' Width: 35.0' Facility Carried: US 00002 ML Bridge Type: ROLLED BEAM Features Intersected: JOINER BROOK Surface: Bituminous Maintenance/Ownership: State
