DISTRICT	TOWN	ROUTE
3	CLARENDON	US-7

Historic Projects	Functional Class	Curves	Grades	Traffic Counters	Crash Locations	Mileage by Functional Class By Sheet	Mileage by Town By Sheet	DISTRICT	TOWN	Date: 11/17/21	ROUTE
<ul style="list-style-type: none"> Unknown Bituminous Concrete Retreatment Resurface Bituminous Mix Skinny Mix Bituminous Seal 	<ul style="list-style-type: none"> 1 - Interstate System 2 - Other Freeways and Expressways 3 - Principal Arterial 4 - Minor Arterial 5 - Major Collector 6 - Minor Collector 	<ul style="list-style-type: none"> Left Right 	<ul style="list-style-type: none"> Special grade up Special grade down 	<ul style="list-style-type: none"> Continuous (CTC) Weigh-In-Motion (WIM) Short-Term, Scheduled Short-Term, Unscheduled 	<ul style="list-style-type: none"> High Crash Locations (HCL's) Sections (& Intersections) 1 - 100 (1 - 10) 101 - 200 (11 - 20) 201 - 300 (21 - 30) 301 - 400 (31 - 40) 401 - 800 (41 - 113) 	019-3 3 - Other Principal Arterial 019-2 3 - Other Principal Arterial 2.317 3.339	CLARENDON - U007-1105 5.656 of 5.656	3	CLARENDON	1 of 1 TWN mileage: 0.0 to 5.656	US-7 ETE mileage: 57.828 to 63.484

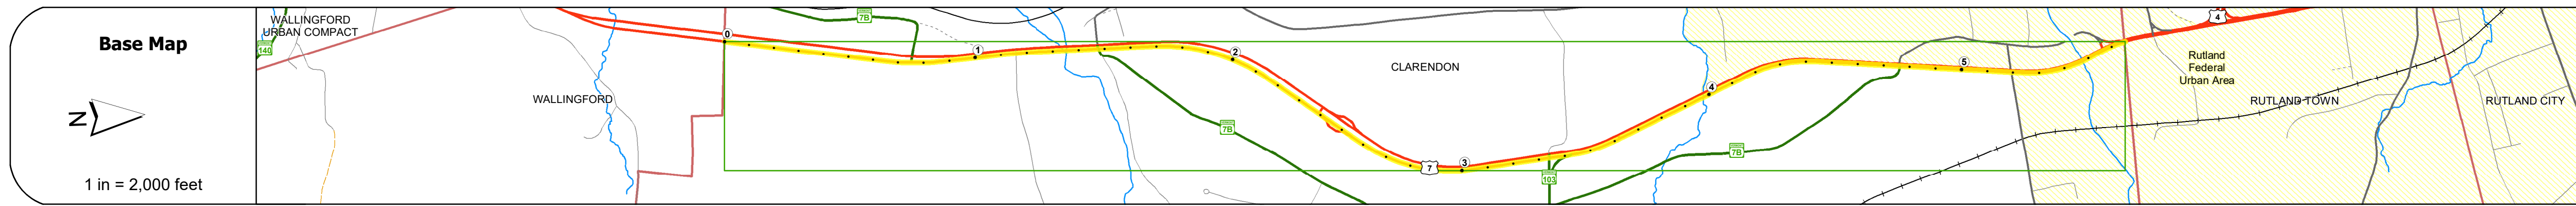
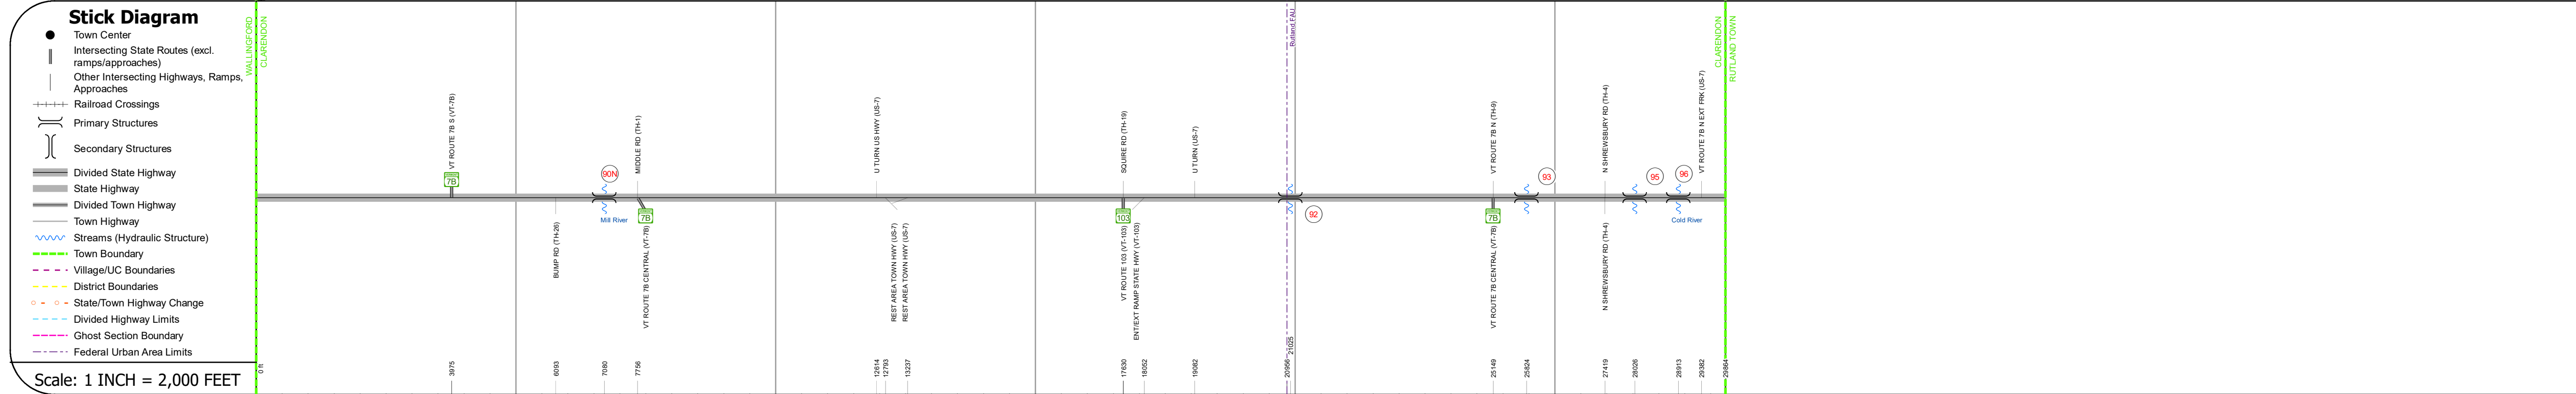
Station	Travellane	Roadway	Lane Count	Base	Subbase
0	24	38			
1	24	38		5" Crushed Gravel Base Course	
2	24	38			
3	24	38		24" Crushed Gravel	
4	24	38			
5	24	38		Two 2 1/2" Crushed Stone Base Courses

Year	Station 0	Station 1	Station 2	Station 3	Station 4	Station 5	Station 5.656
2020	6197	5527	6017	10618	10317	10576	11165
2019	7317	6525	7104	12536	12536	12850	13666
2018	7300	7400	7800	7100	12500	13000	14900
2017	7000	7100	7300	6700	12500	12900	15000
2016	6700	6800	6800	6300	12600	12900	15100
