Route Log and Progress Chart

DISTRICT	TOWN	ROUTE
8	GEORGIA, FAIRFAX, ST. ALBANS TOWN, FAIRFIELD	I-89

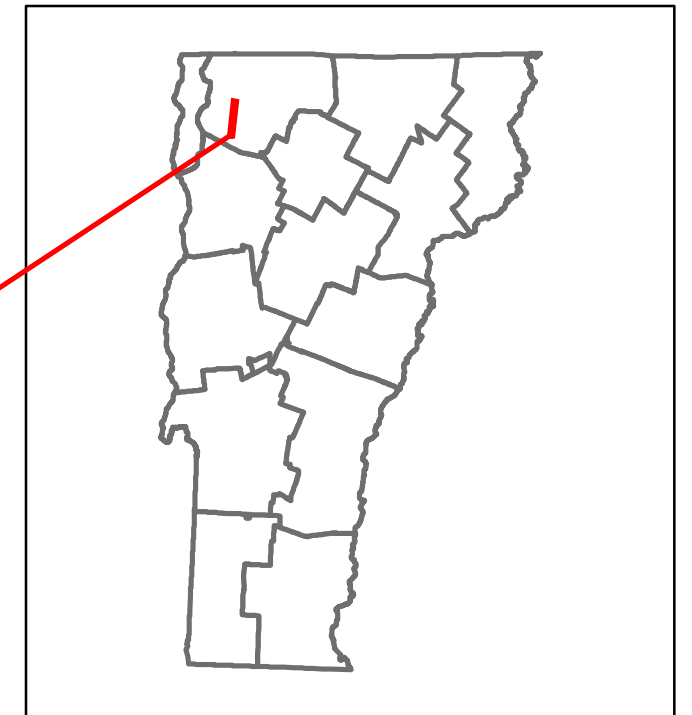
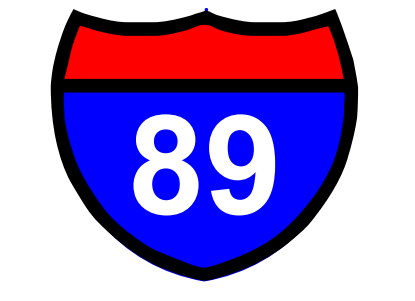
Stick Diagram

- Town Center
- Intersecting State Routes (excl. ramps/approaches)
- Other Intersecting Highways, Ramps, Approaches
- Railroad Crossings
- Primary Structures
- Secondary Structures
- Divided State Highway
- State Highway
- Divided Town Highway
- Town Highway
- Streams (Hydraulic Structure)
- Town Boundary
- Village/IC Boundaries
- District Boundaries
- State/Town Highway Change
- Divided Highway Limits
- Ghost Section Boundary
- Federal Urban Area Limits

Scale: 1 INCH = 2,000 FEET

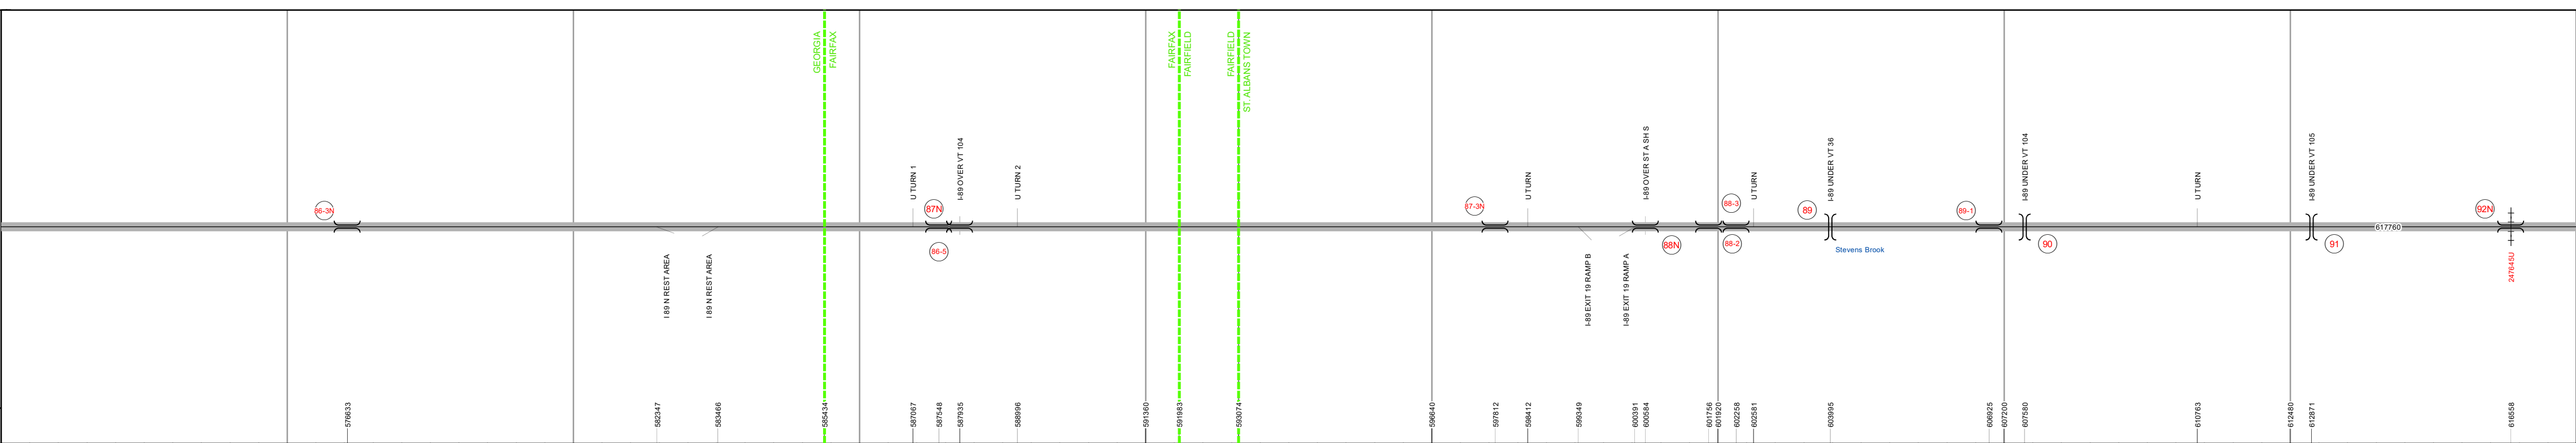
STRUCTURE DESCRIPTIONS

Bridge 86-3N:
Culvert - 1968
Structure No. 300089863N06081
Length: 8'
Facility Carried: I 89
Structure Type: CGMPP STEEL SLEEVE
Features Intersected: BROOK
Maintenance/Ownership: State

Bridge 86-5:
Culvert - 1968
Structure No. 30008986-506041
Length: 10'
Facility Carried: I 89
Structure Type: CGMPP
Features Intersected: BROOK
Maintenance/Ownership: State

Bridge 87N:
Stringer/multi-beam or girder - 2002
Structure No. 200089087N06042
Length: 83'
Height: 5.33'
Width: 3.7'
Under Clearance: 1.33'
Facility Carried: I 89 ML
Structure Type: WELDED PLATE GIRDER
Features Intersected: I 89 OVER VT 104
Surface: Bituminous
Maintenance/Ownership: State

Bridge 87-3N:
Culvert - 2002
Structure No. 300089873N06131
Length: 6'
Facility Carried: I 89
Structure Type: SEGMENTAL RC BOX
Features Intersected: BROOK
Maintenance/Ownership: State

Bridge 88N:
Stringer/multi-beam or girder - 1967
Structure No. 200089088N06132
Length: 169'
Height: 5.33'
Width: 4.4'
Under Clearance: 1.42'
Facility Carried: I 89 ML
Structure Type: 3 SP CONT ROLLED BM
Features Intersected: I 89 OVER ST A SH S
Surface: Bituminous
Maintenance/Ownership: State

Bridge 88-2:
Culvert - 1968
Structure No. 30008988-206131
Length: 6'
Facility Carried: I 89
Structure Type: ACCGMPP
Features Intersected: BROOK
Maintenance/Ownership: State

Bridge 88-3:
Culvert - 1968
Structure No. 30008988-306131
Length: 14'
Under Clearance: 1.0'
Facility Carried: I 89
Structure Type: RC BOX
Features Intersected: LAND ACCESS ROAD
Maintenance/Ownership: State

Bridge 89-1:
Culvert - 1968
Structure No. 30008989-106131
Length: 6'
Facility Carried: I 89
Structure Type: ACCGMPPA COMP LINER
Features Intersected: BROOK
Maintenance/Ownership: State
