EROSION & SEDIMENT CONTROL PLANS

REVISIONS		# OF SHEETS
THESE PLANS WITH LATEST REVISIONS SHOULD ONLY BE USED FOR THE PURPOSE SHOWN BELOW:		
STP WALK (9)		proj. no.
TOWN OF ESSEX		02-132
ROUTE 15 IN ESSEX CENTER, VT		survey
EXISTING CONDITIONS		&D/OTHERS
		design
STATION 12+25 TO 17+61.22		DLH/LAL
		drawn
		DB
		checked
		LAL/DLH
		date
		03/01/04
		scale
		1" = 20'
		sh. no.
		25E
		02132-25E

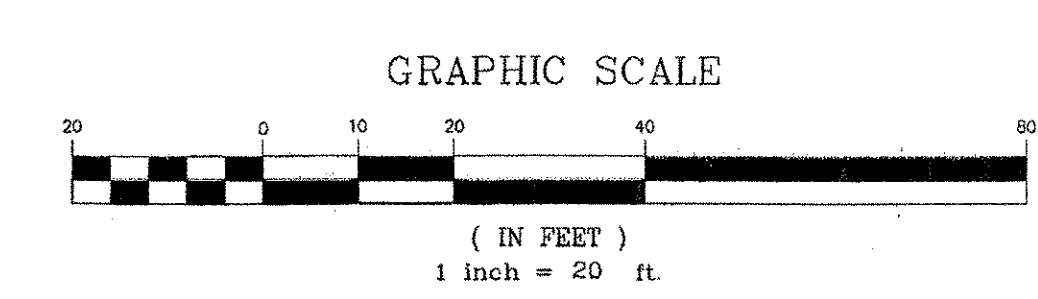
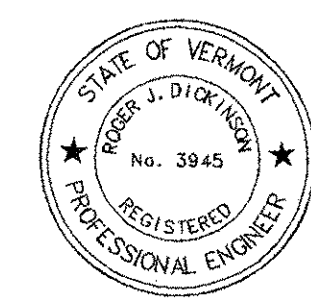
ADAMS & WINDSOR LOAMY SANDS, 0% - 5% SLOPES	
HYDROLOGIC SOIL GROUP	A
DEPTH TO BEDROCK	5'+
DEPTH TO WATER TABLE	4'+
K - FACTOR	0.17
LOW ERODABILITY

NOTE:
WITH THE EXCEPTION OF THE PAVED, CONCRETE & WOODED AREAS NOTED ABOVE, THE VEGETATION COVER IS GRASS IN THE AREA BETWEEN THE BUILDINGS AND THE ROAD.

NOTE:
SOIL PROPERTIES AND BOUNDARIES WERE APPROXIMATED BASED ON USDA SOIL SURVEY, ACTUAL FIELD CONDITIONS MAY VARY.

HARTLAND VERY FINE SANDY LOAM, 25 TO 60 PERCENT SLOPES	
HYDROLOGIC SOIL GROUP	B
DEPTH TO BEDROCK	5'+
DEPTH TO WATER TABLE	3'+
K - FACTOR	0.49
HIGHLY ERODIBLE
