STATE OF VERMONT AGENCY OF TRANSPORTATION			
Town Of HARTFORD		Bridge No. 11S	
Highway No. I-89 SB		Log Sta.	
		Surv. Sta.	
I-89 SB OVER WHITE RIVER, VT 14 & NECR			
PIER 1 REPAIR AREAS			
Designed By T.S. BRYANT		Drawn By B.J. MASSE	
Checked By S.M. HODGDON	Date 9/98	Bridge Design Supervisor C.D. BAKER	Date 9/98
PROJECT HARTFORD		PROJECT NO. IR 089-1(13)	
VHB Cad Filename 50699P1		Bridge Sheet No. 34	
		Sheet 34 of 101

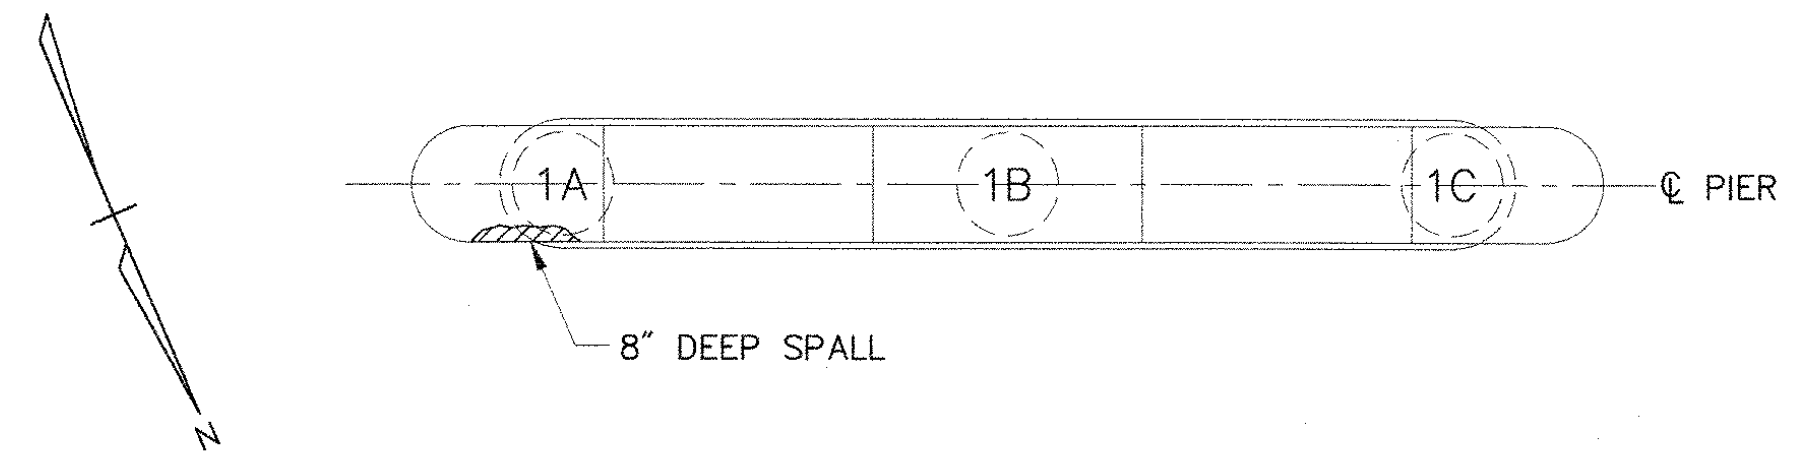
KEY:
 DELAMINATED AREAS
 SPALLED AREAS

- NOTES:
 1. ONLY PIERS WITH DEFICIENCIES NOTED DURING THE INSPECTION ARE SHOWN.
 2. SEE SHEET 22 FOR SUBSTRUCTURE CONCRETE REPAIR DETAILS.
