Town Of	GUILFORD	Bridge No.	<b>3S</b>
Highway No.	I-91	Log Sta.	
		Surv. Sta.	
I-91 SB OVER BROAD BROOK & BROAD BROOK ROAD			
<b>PIER MASONRY (3S)</b>			
Designed By	M.J. MOZER	Drawn By	G.K. MORZE
Checked By	Date	Bridge Design Supervisor	
P.W. SZUSTAK	01/03	J.P. HALSTEAD	Date 01/03
PROJECT	GUILFORD	PROJECT NO.	IM 091-(133)
		TVGA CAD Drawing No.	G SB PIER.dgn Date 05/12/08
		Bridge Sheet No.	BR148 Sheet 74 of 114

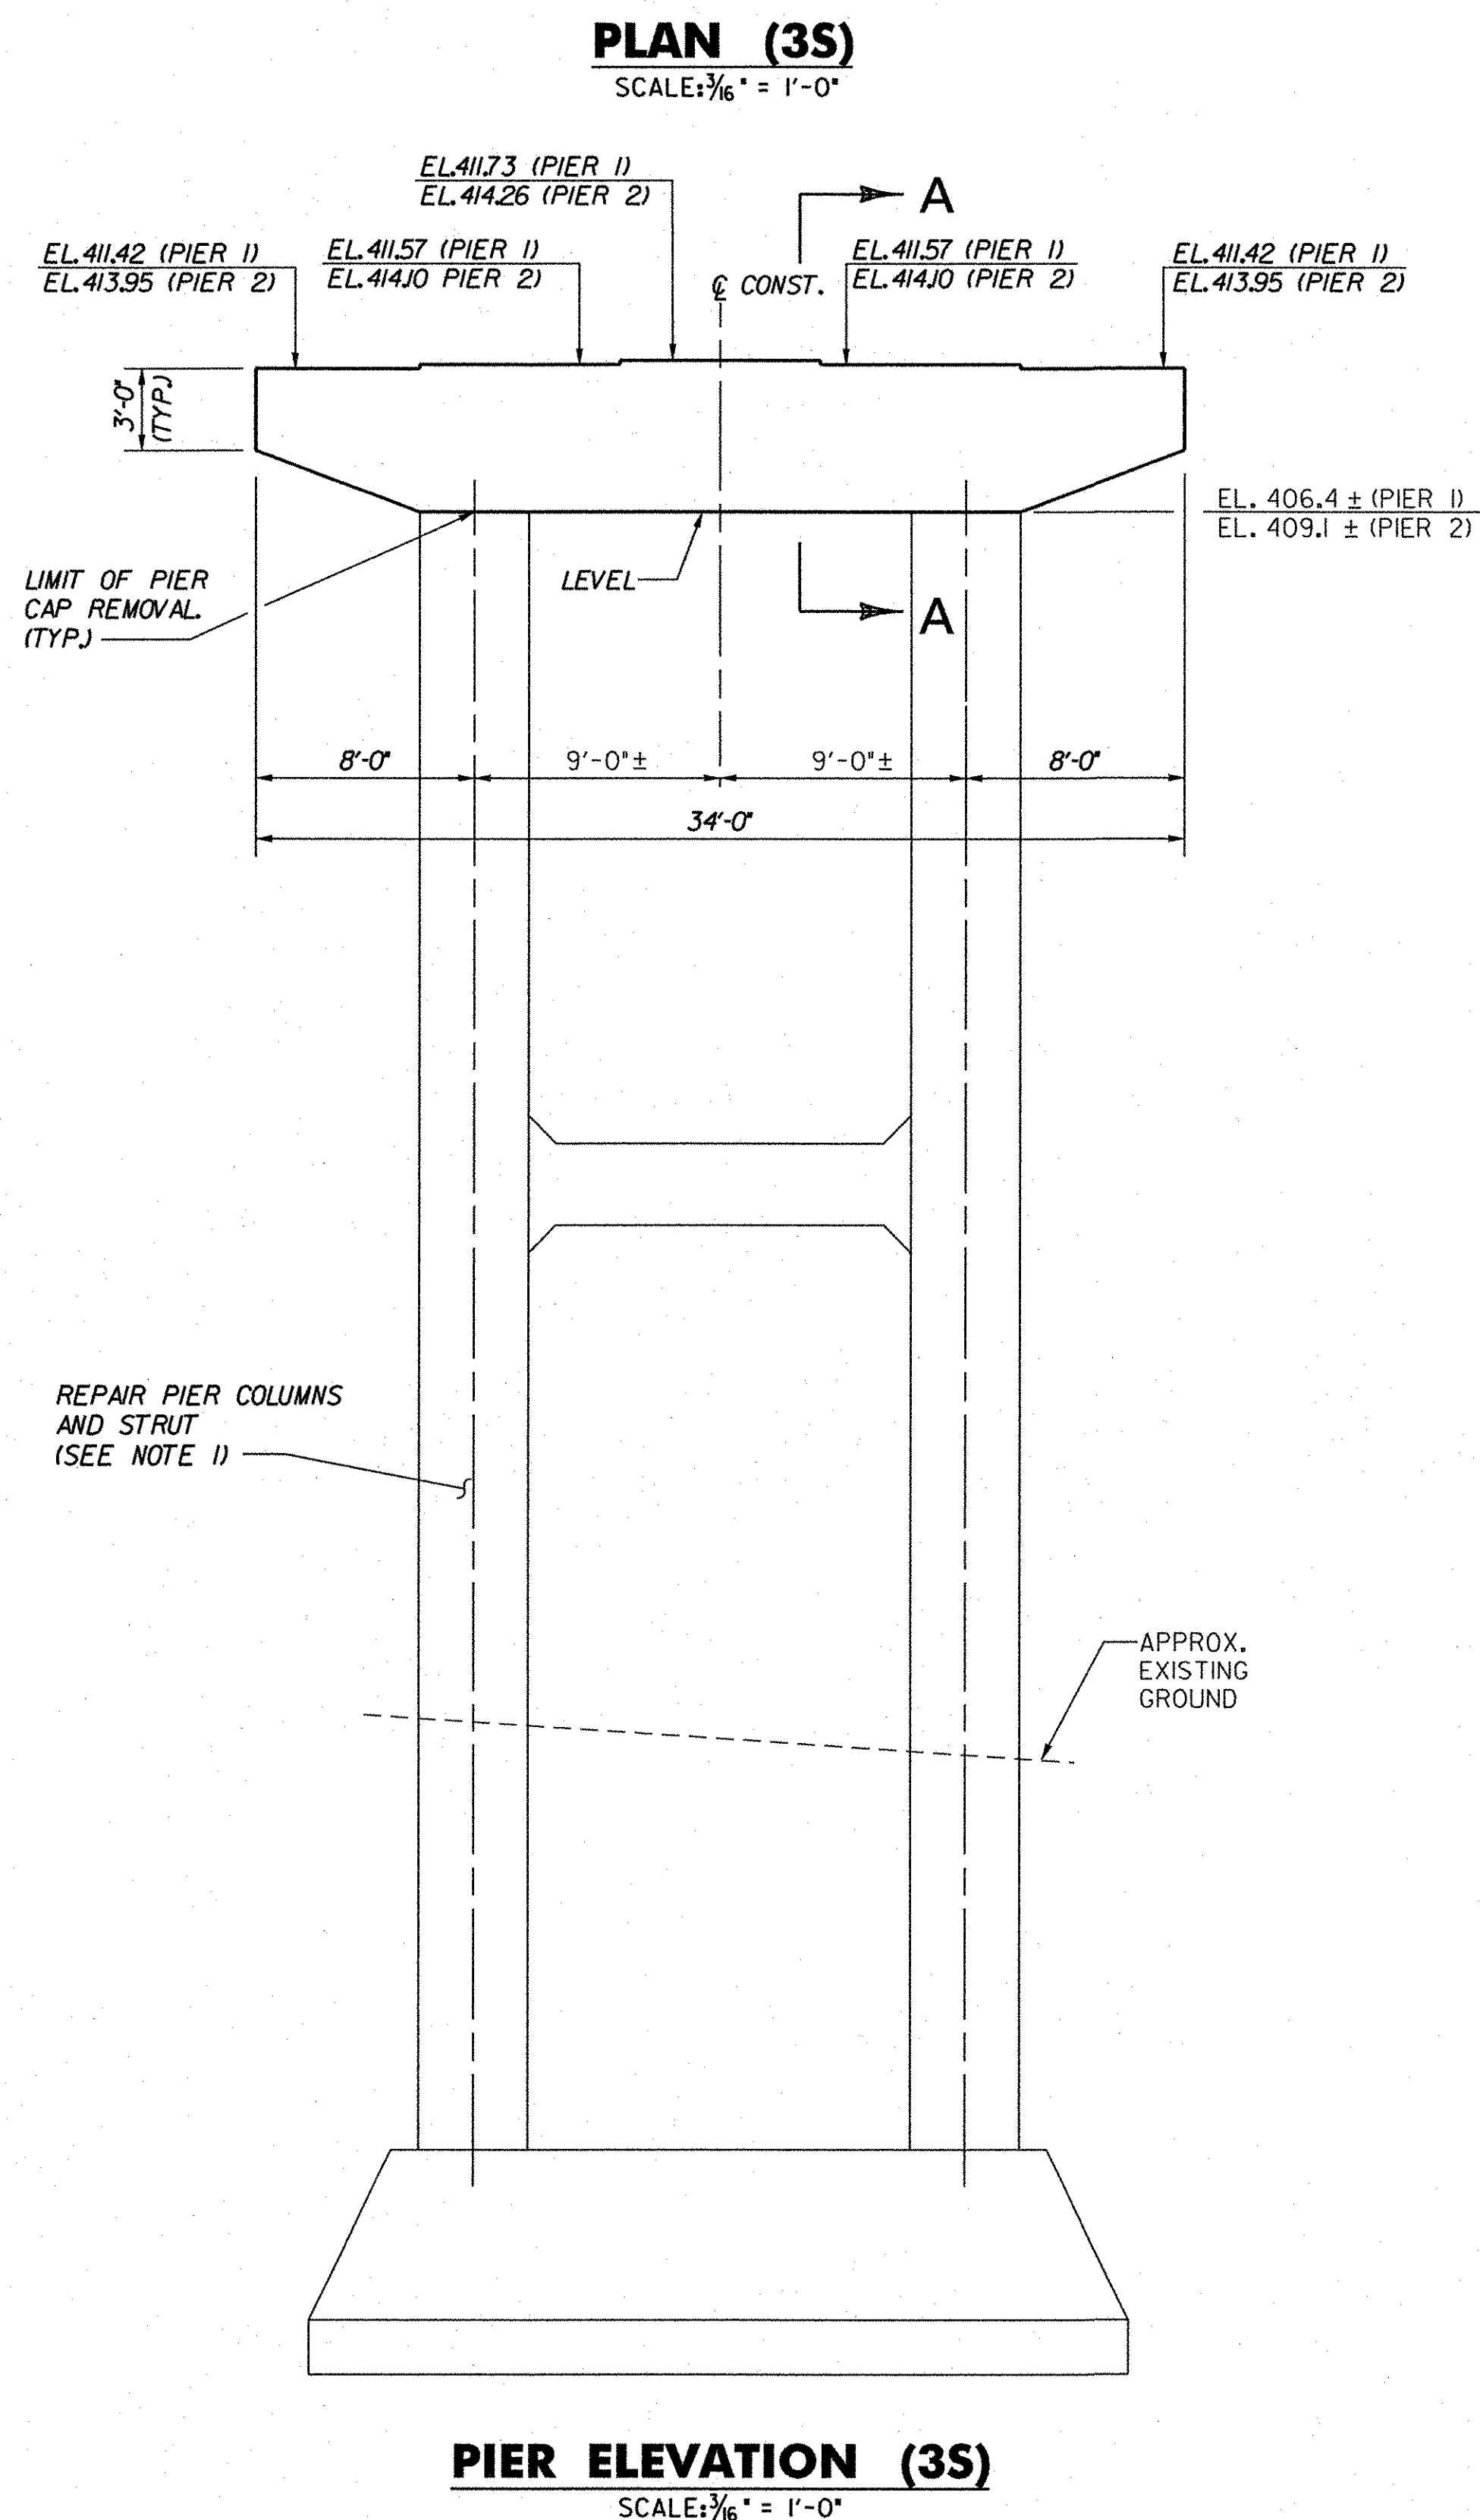
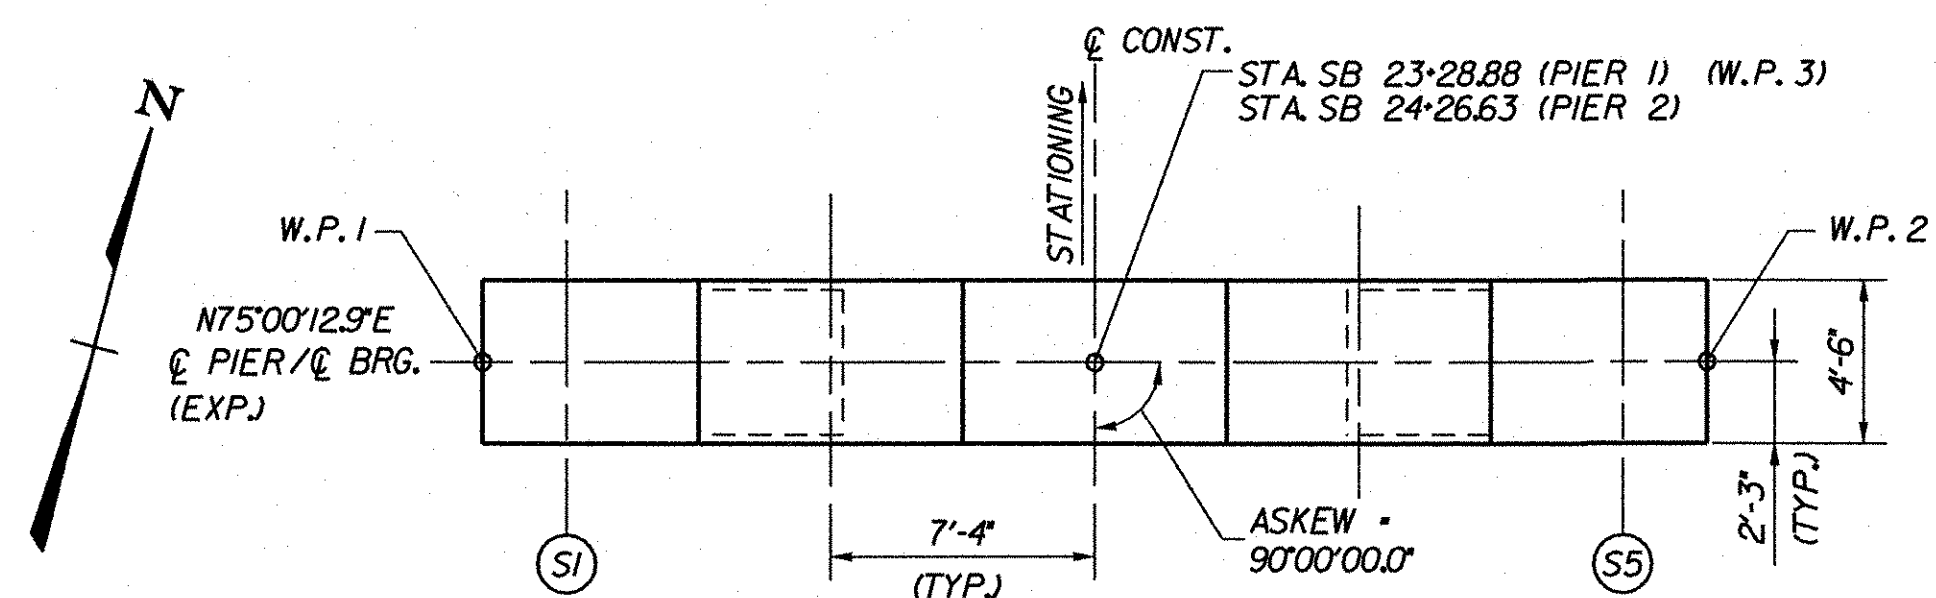
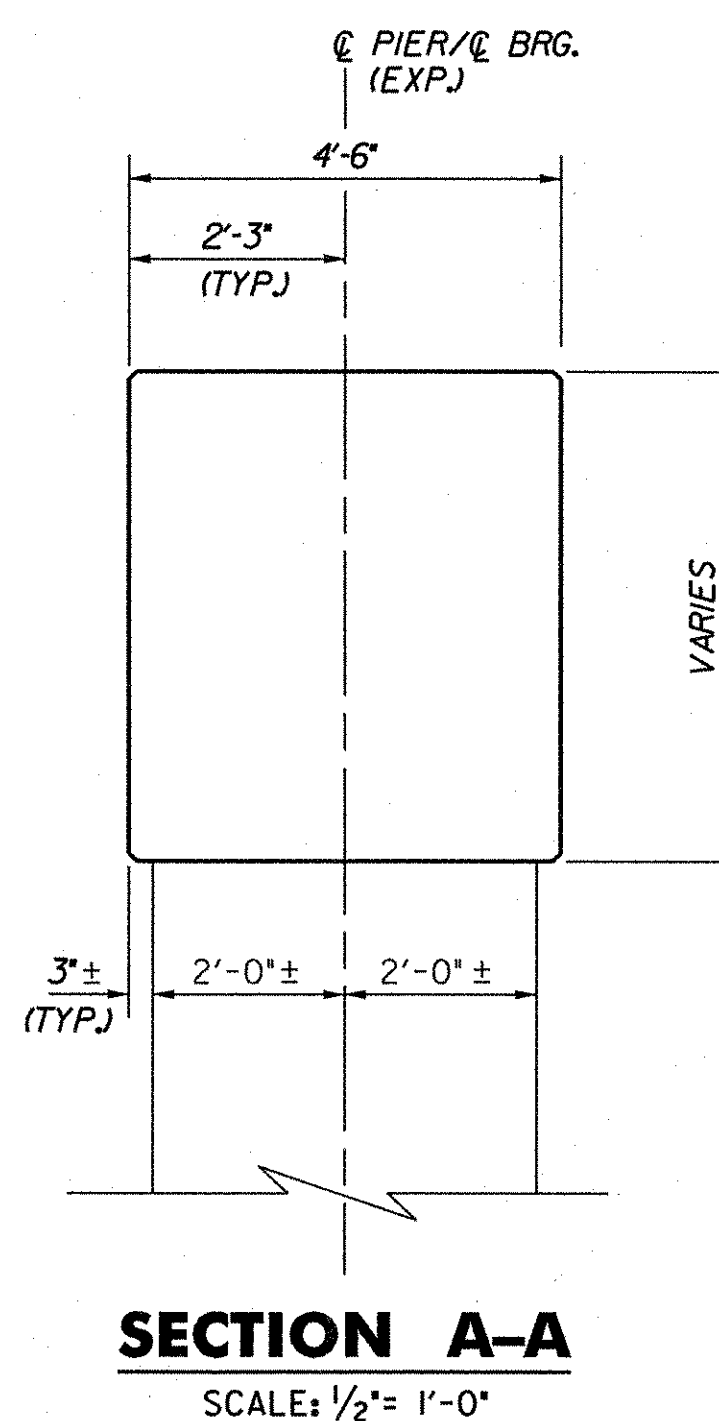
- REPAIR ALL EXISTING SPALLED AND DELAMINATED AREAS ON PIERS. SEE EXISTING SUBSTRUCTURE CONDITION (3S), BRIDGE SHEETS BR161 AND BR162, FOR APPROXIMATE CONDITION OF EXISTING SUBSTRUCTURE. FOR CONCRETE REPAIR DETAILS, SEE SUBSTRUCTURE REPAIR DETAILS (3N&S), BRIDGE SHEET BR151.
- STEPS ON PIER CAP SEAT SHALL BE EQUIDISTANT BETWEEN GIRDERS.
- BRIDGE SEATS SHALL BE SLOPED 1/2" PER FOOT EXCEPT UNDER BEARING PLATES WHERE THE SURFACE SHALL BE LEVEL.
