STATE OF VERMONT
DEPARTMENT OF STATE BUILDINGS
AGENCY OF ADMINISTRATION
MONTPELIER, VERMONT

REST AREA REHABILITATION
LYNDON I-91 SOUTHBOUND
MISCELLANEOUS DETAILS

DATE: JUNE 9, 1986	SCALE: AS NOTED	REVISIONS:	DRAWING NO: 10
DRAWN BY: RWF	PROJECT NO: JM-BLDG(2)	APPROVED BY: JBA	SHEET: 12 OF 29

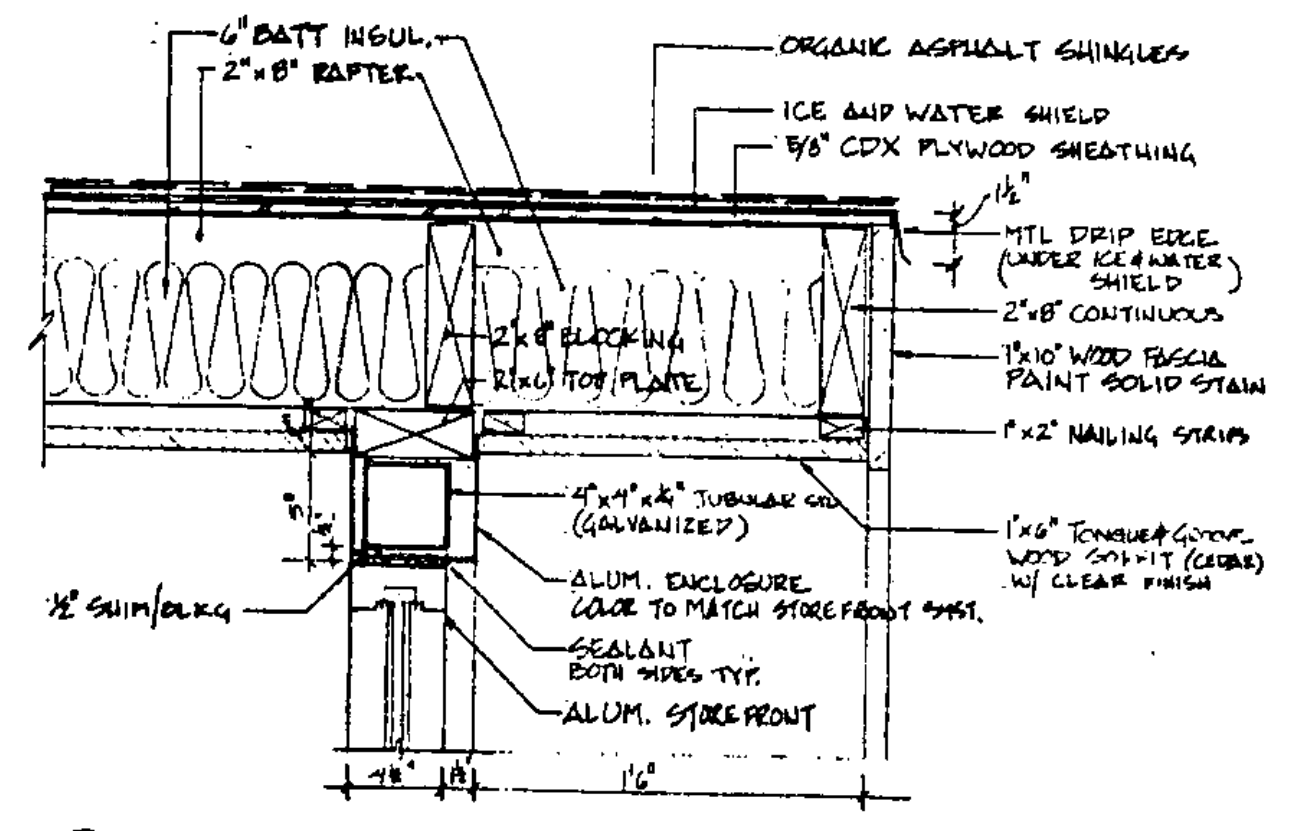
01 CONNECTION - STOREFRONT/ROOF VESTIBULE 1 1/2\"/>

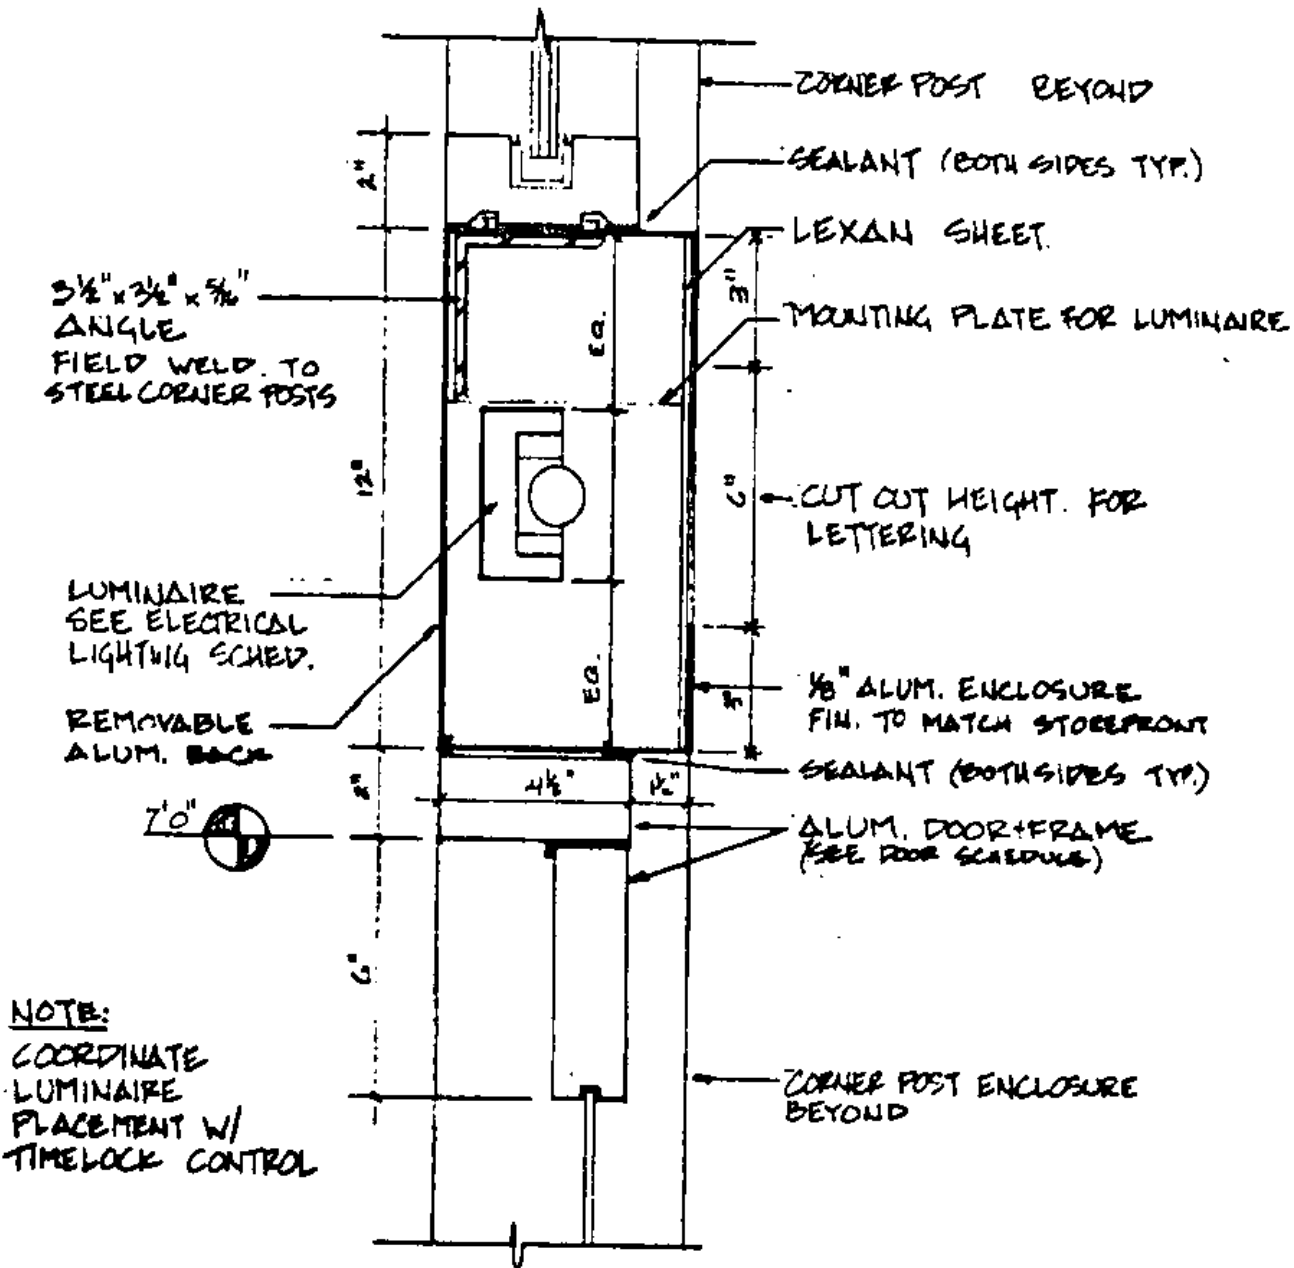
02 ENTRY - BACKLIT SIGN & DOOR HEAD VESTIBULE 3\"/>

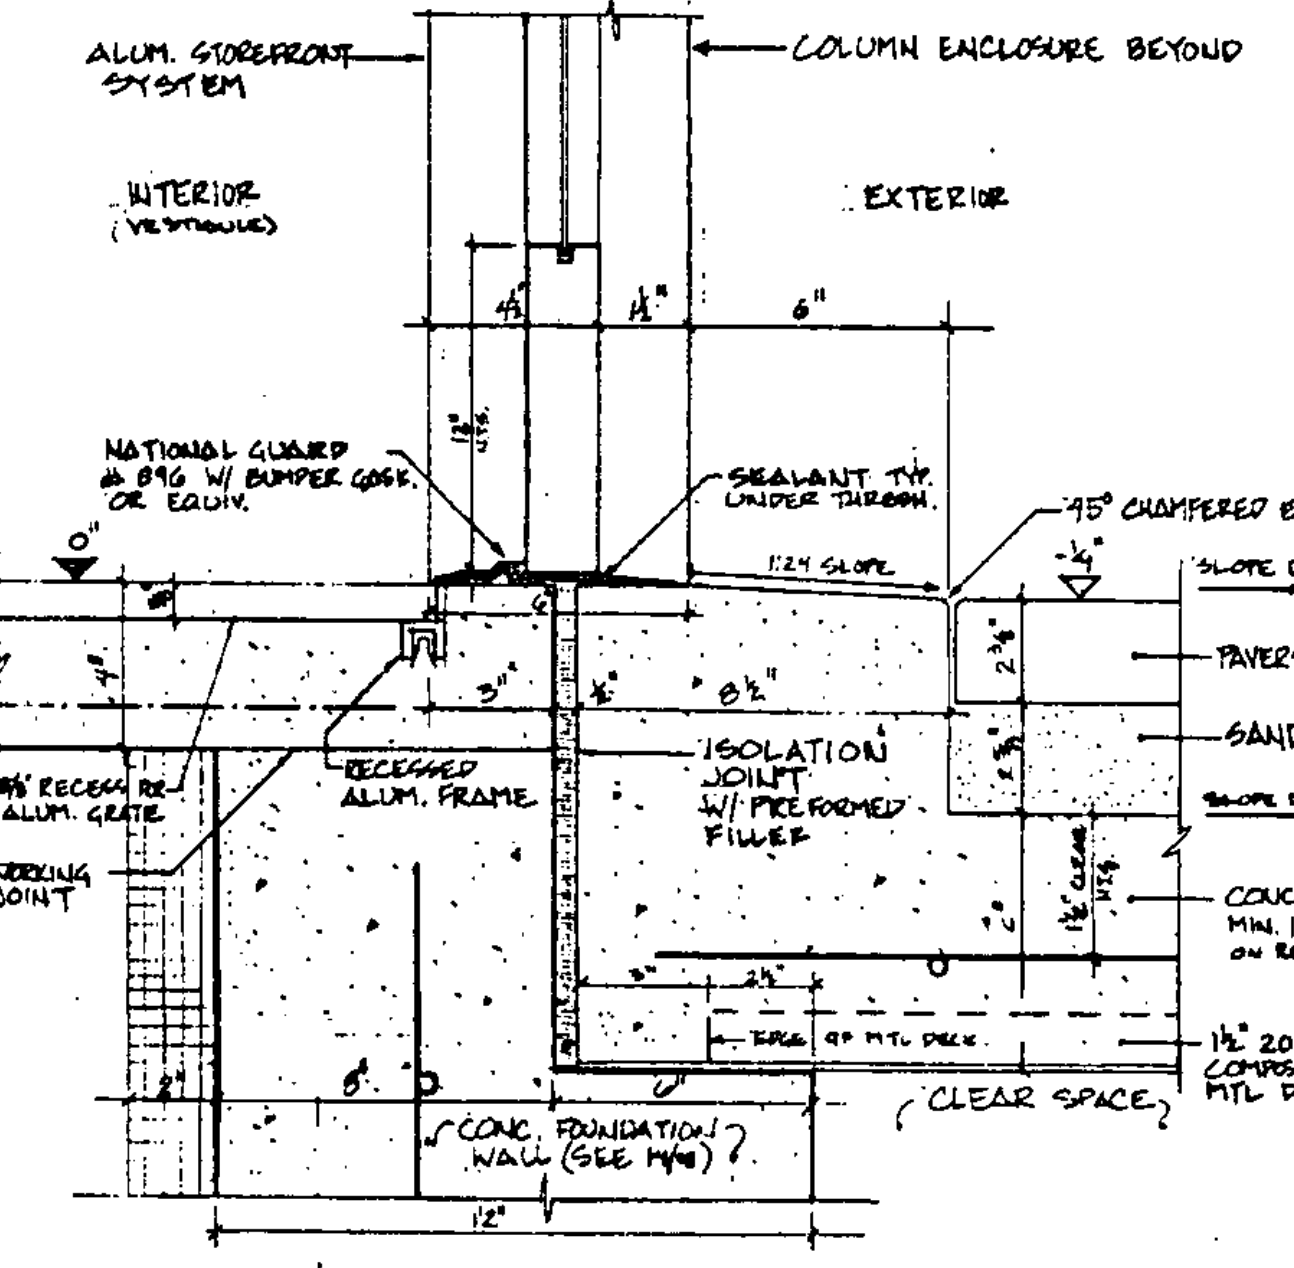
03 ENTRY - THRESHOLD SECTION VESTIBULE DOOR #101 3\"/>

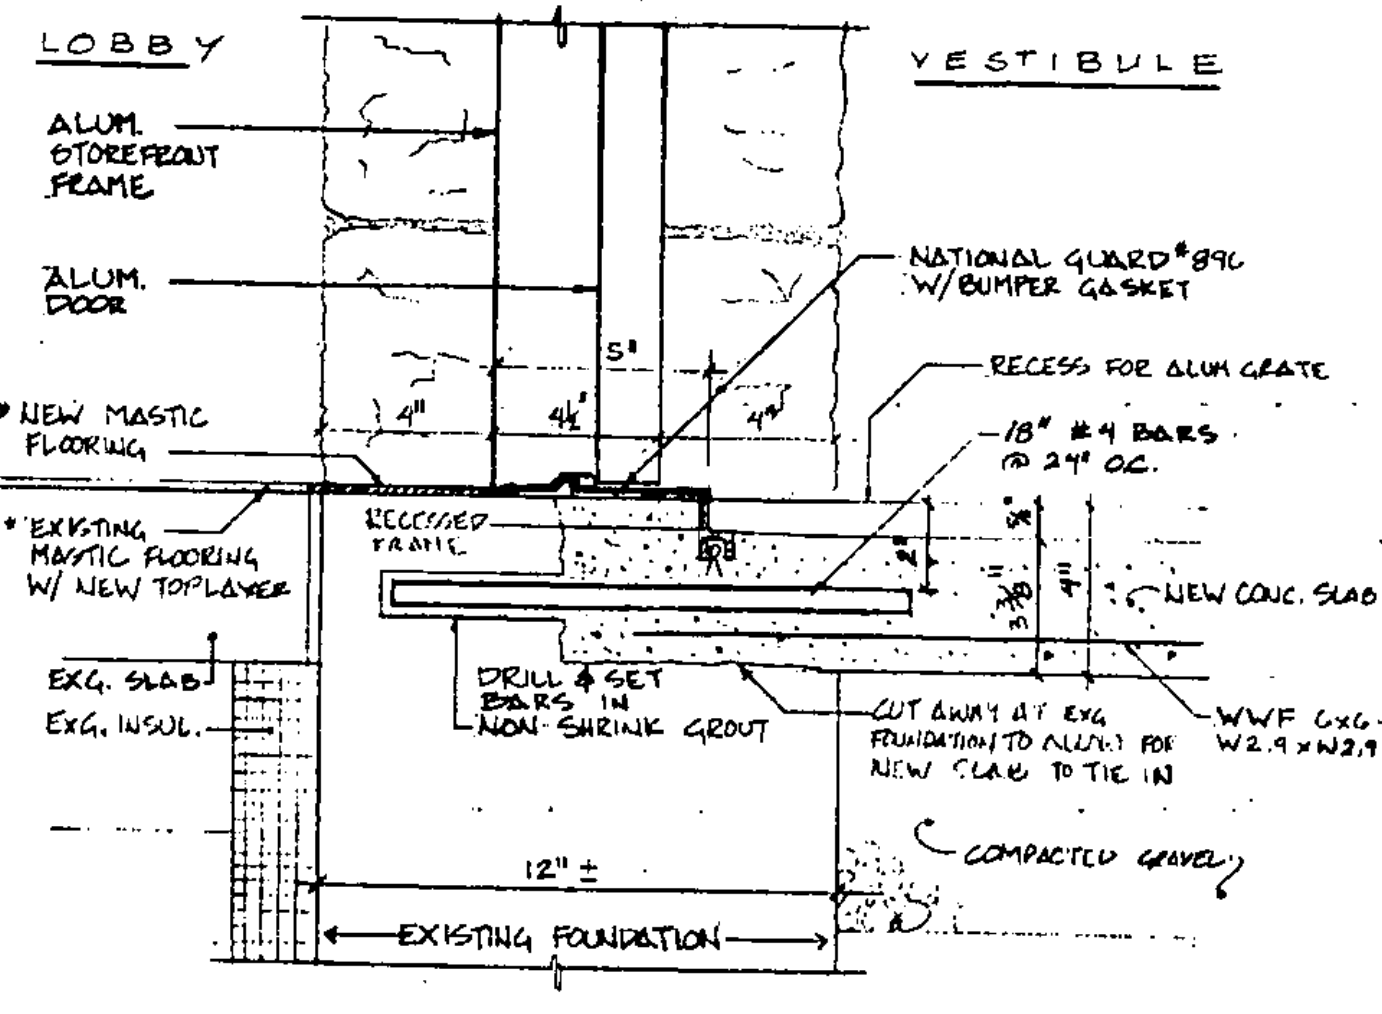
05 2ND ENTRY THRESHOLD VESTIBULE DOOR #102 3\"/>

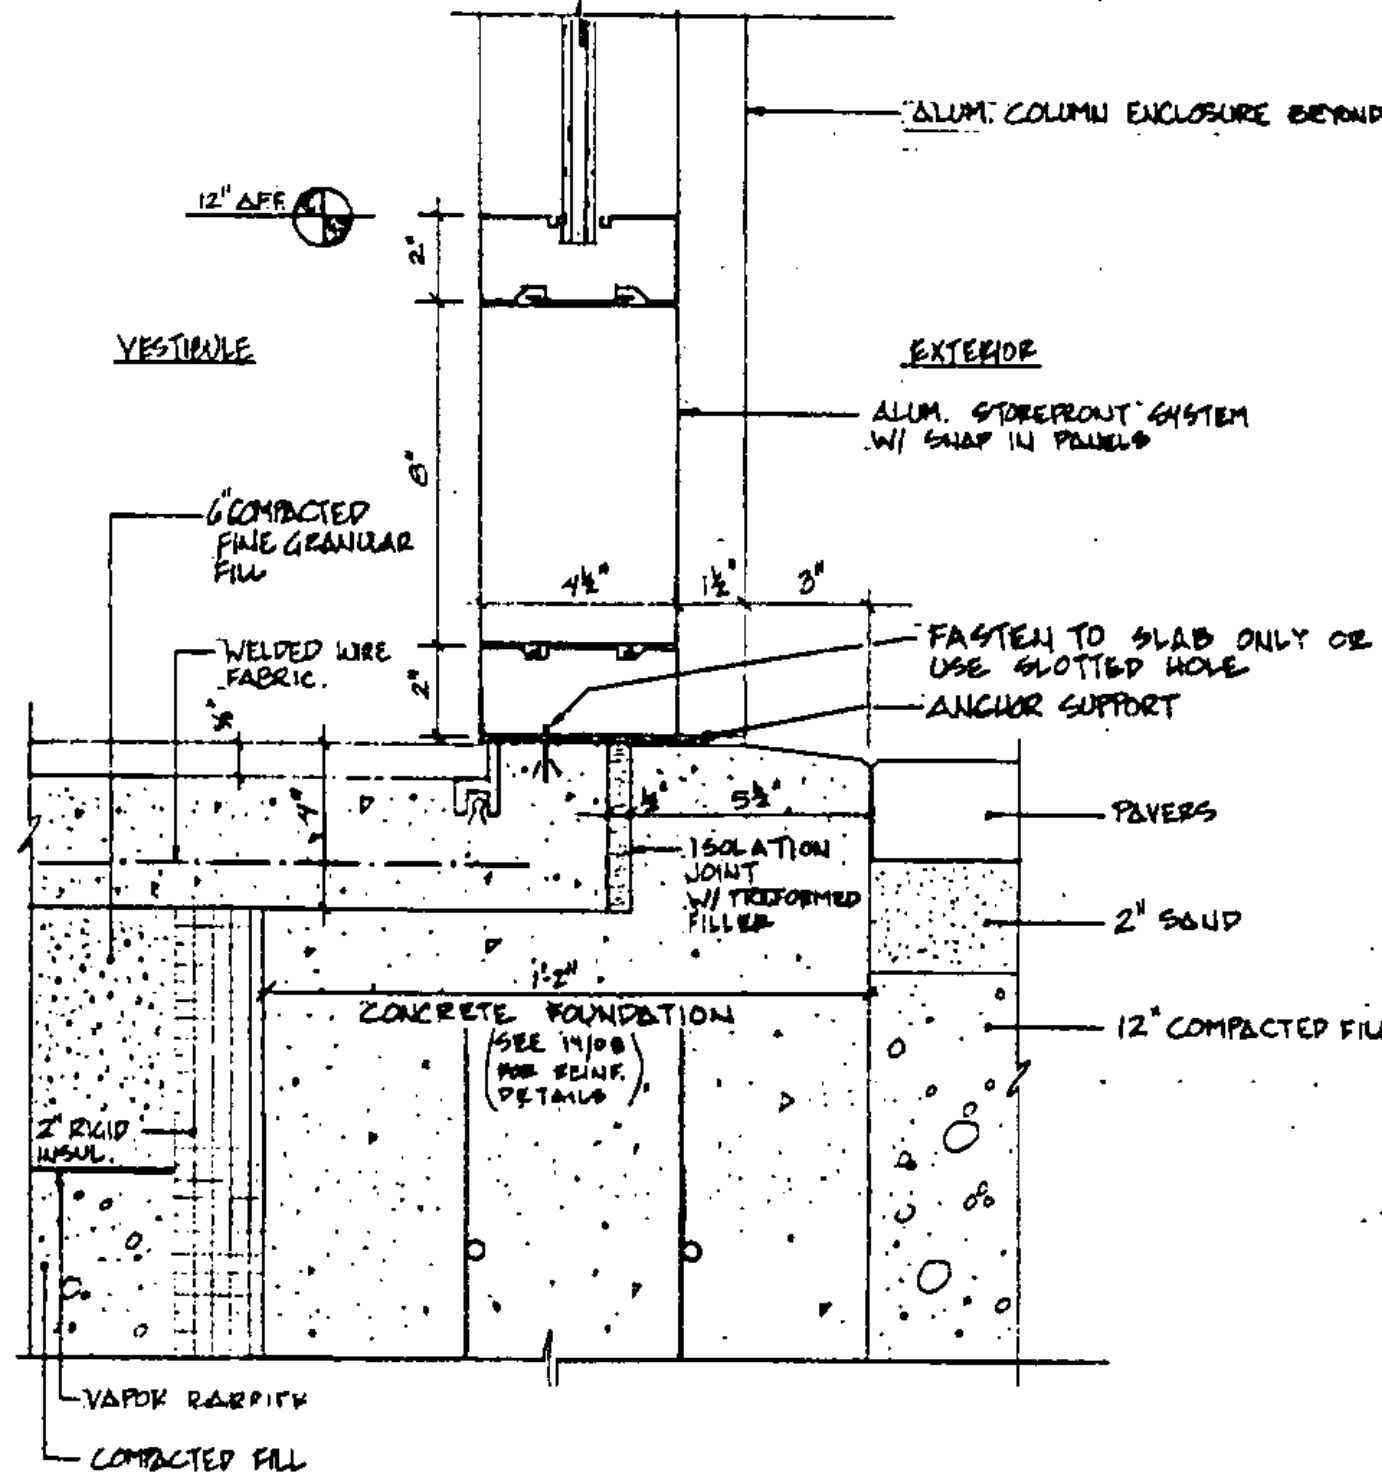
04 EXTERIOR STOREFRONT SILL VESTIBULE 3\"/>

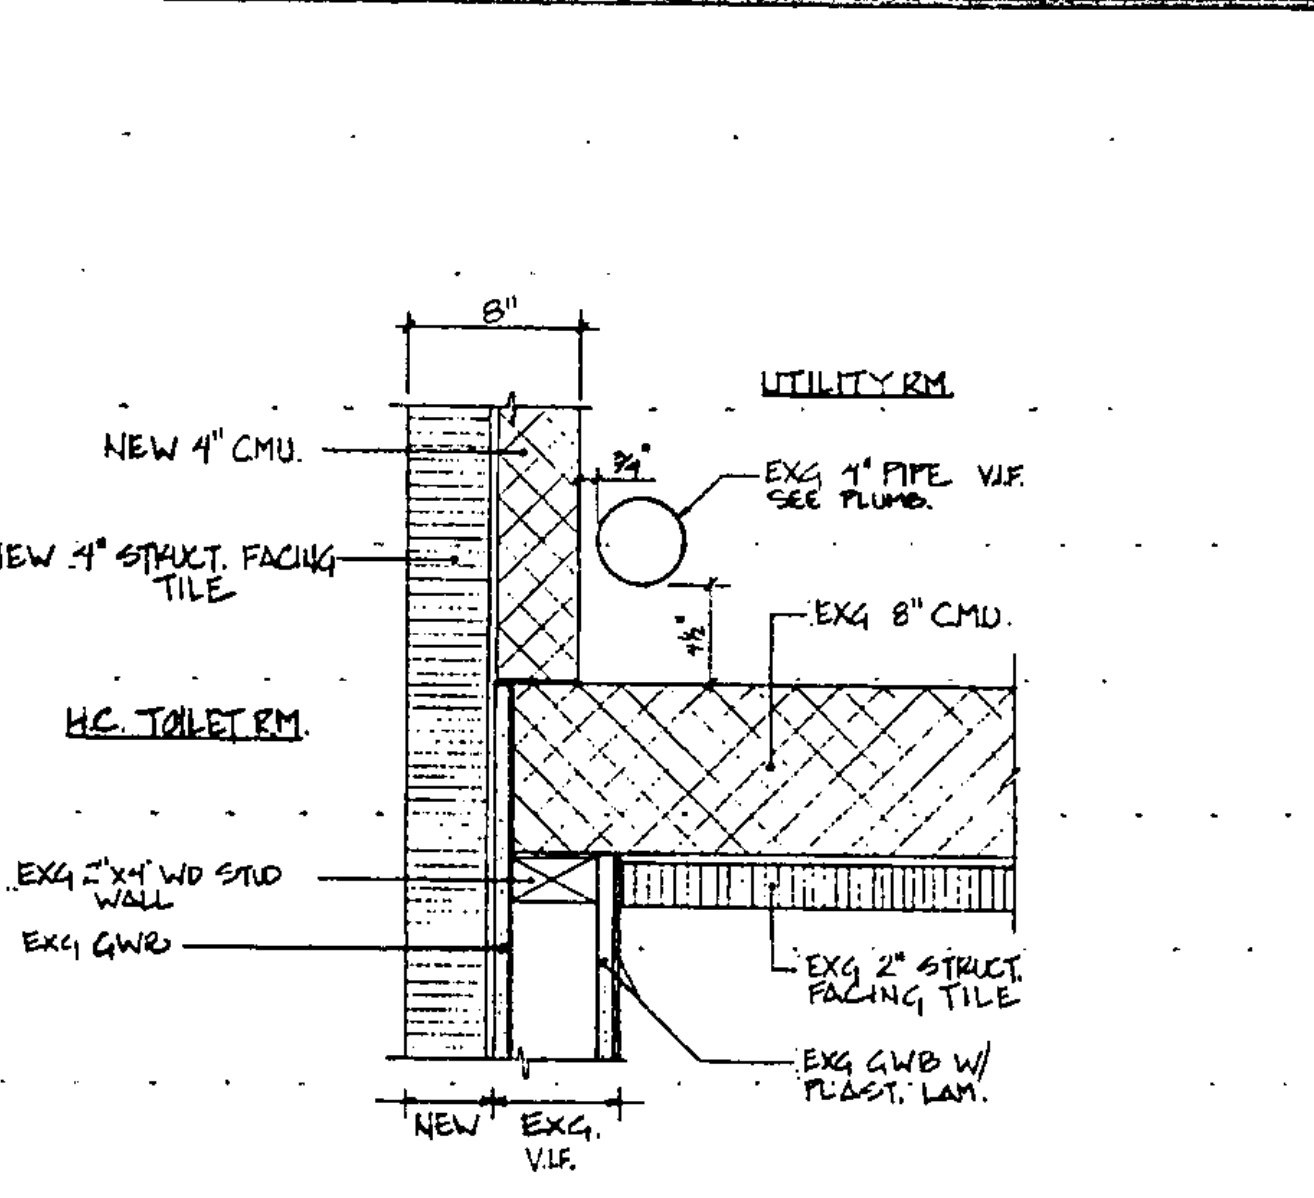
08 CONNECTION - WOMENS RESTRM / UTIL. RM / UNISEX RESTRM 1 1/2\"/>

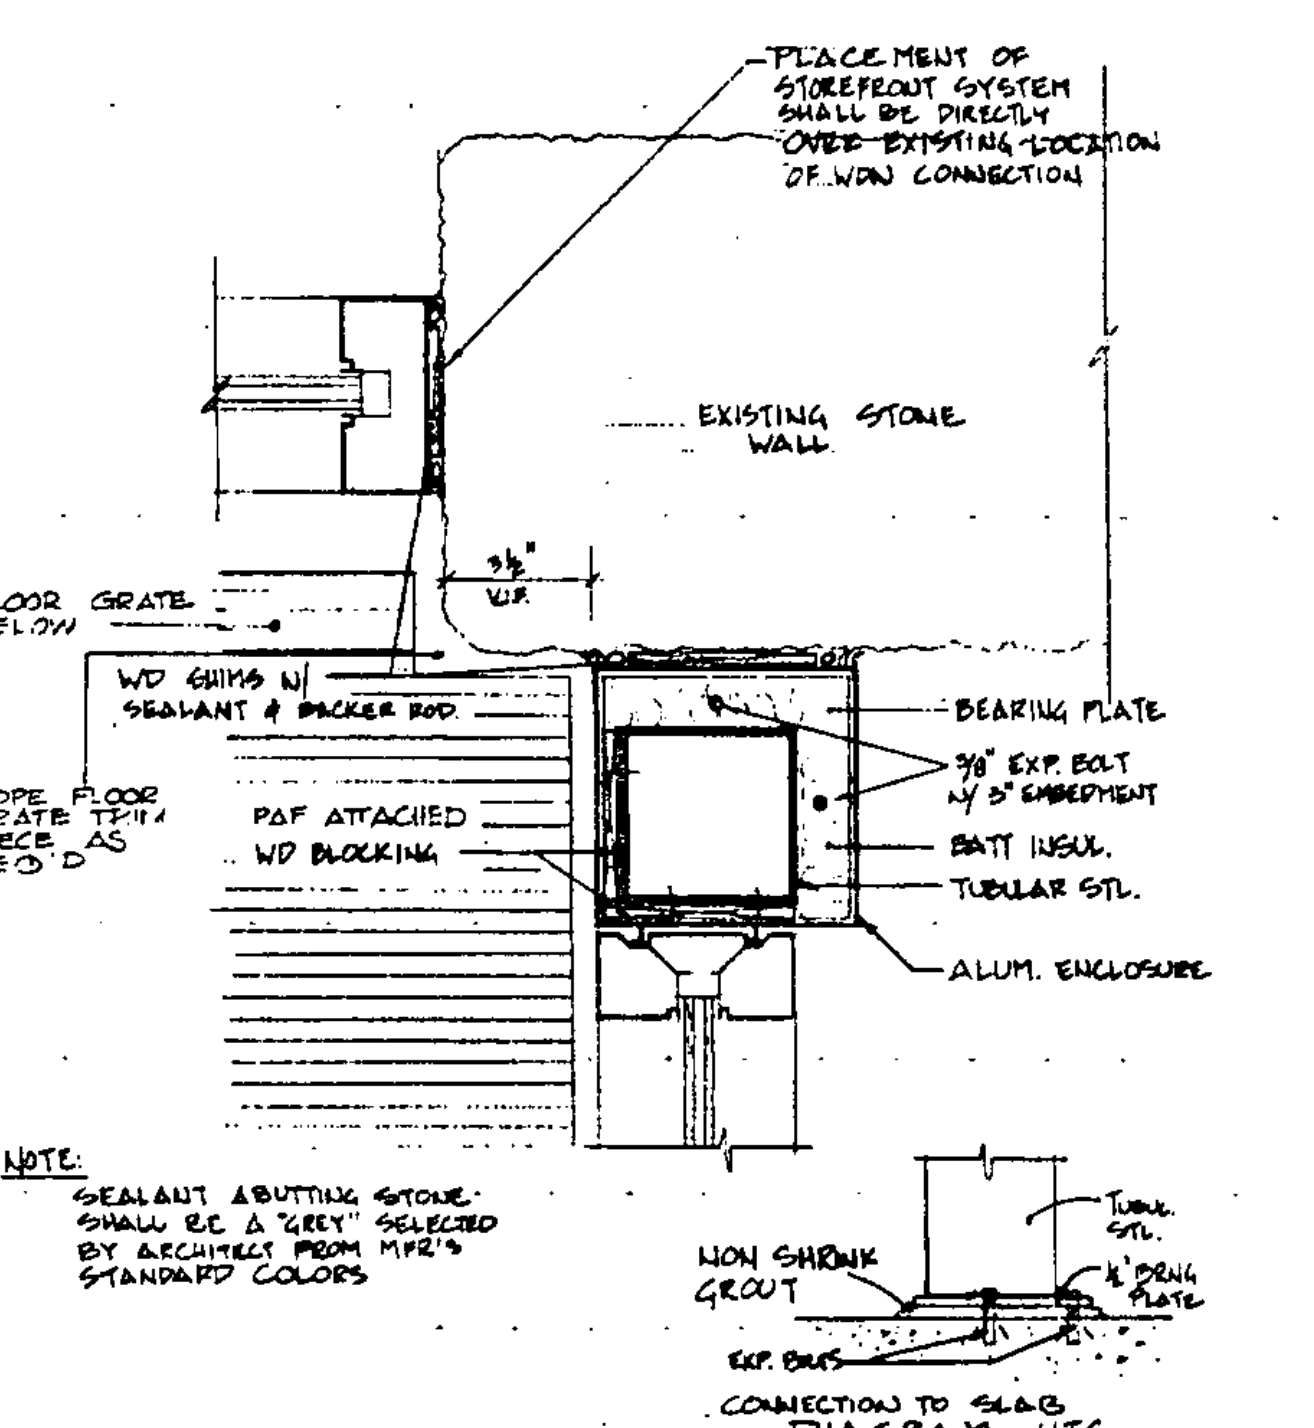
07 CONNECTION - STOREFRONT & EXISTING STONE WALL VESTIBULE 3\"/>

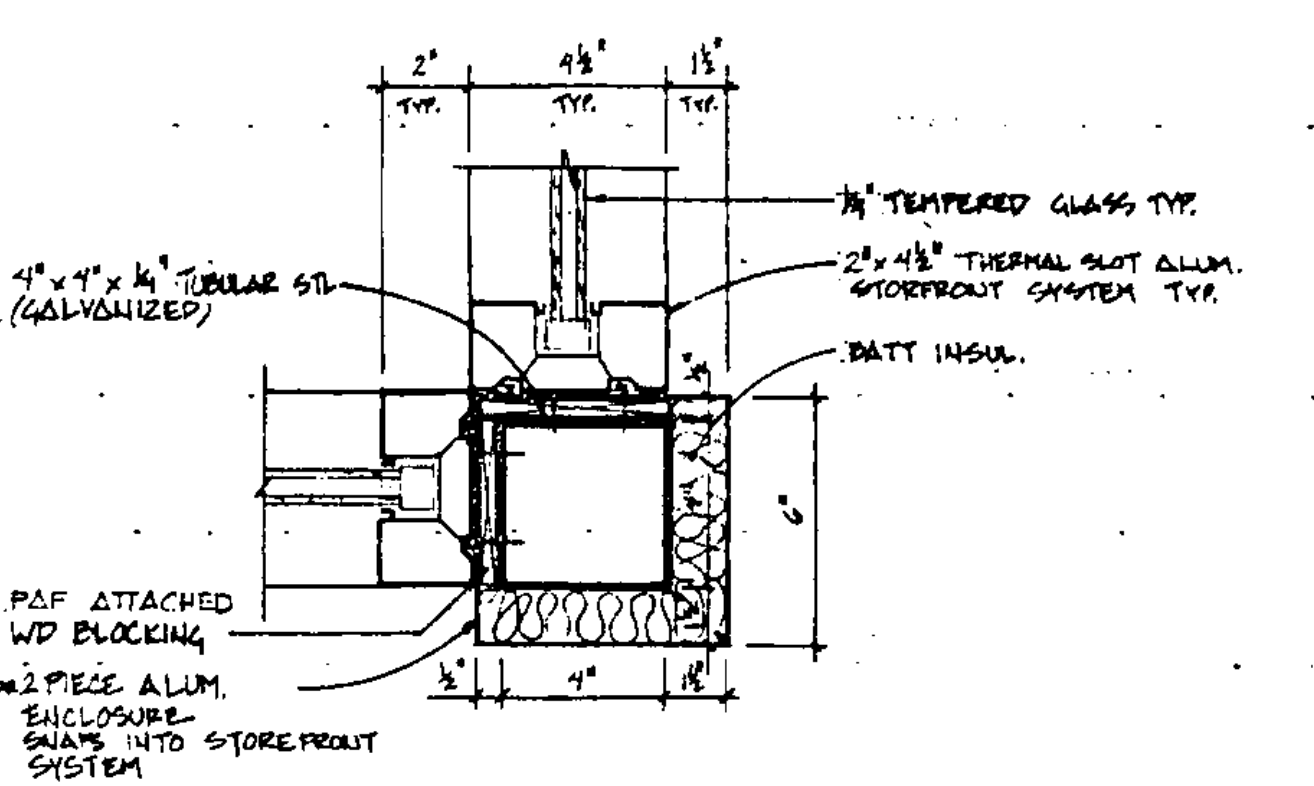
06 CORNER ENCLOSURE VESTIBULE 3\"/>

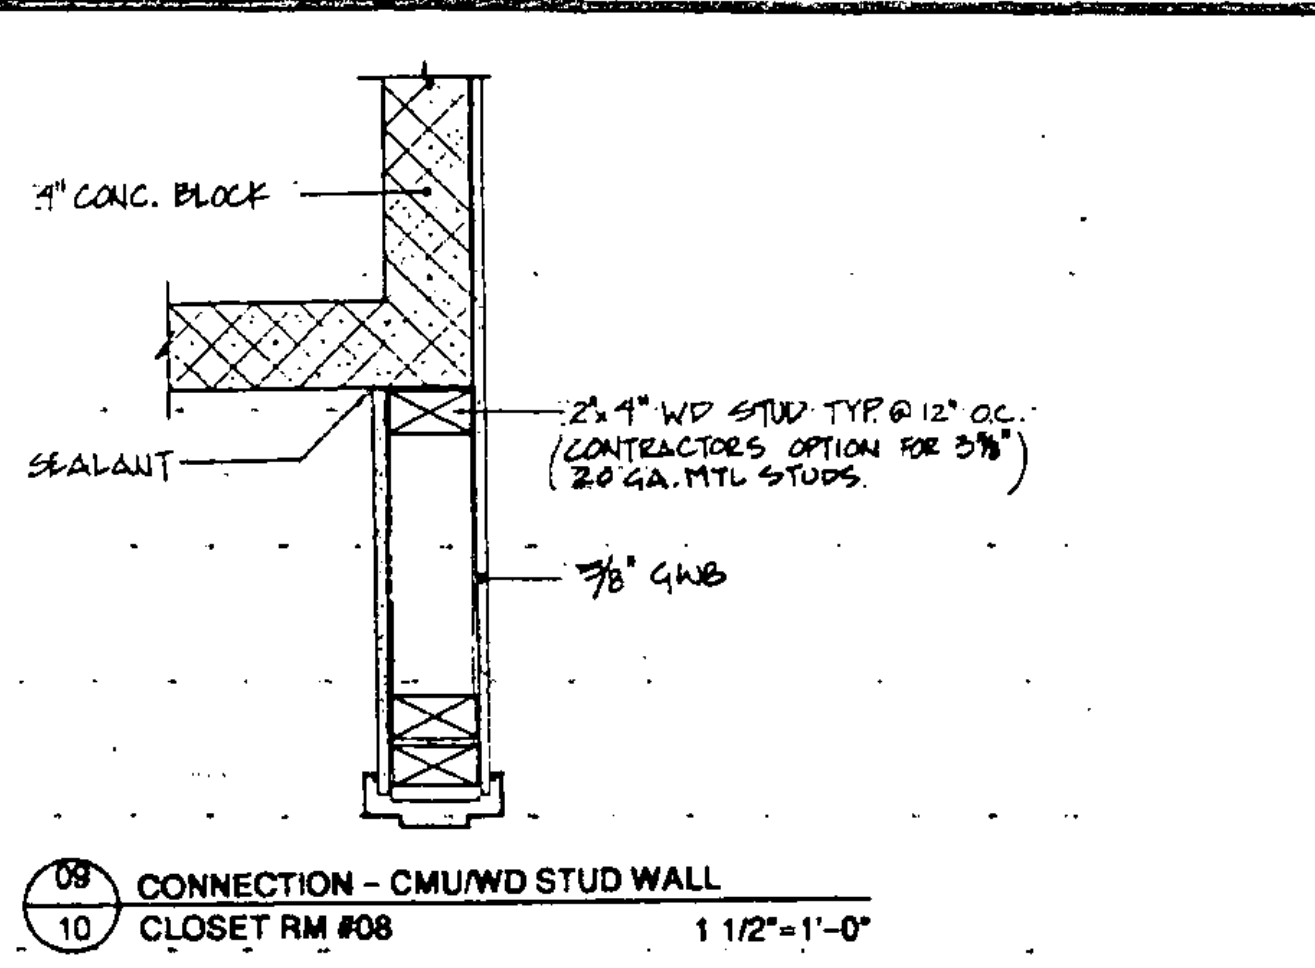
09 CONNECTION - CMU/WD STUD WALL CLOSET RM #08 1 1/2\"/>

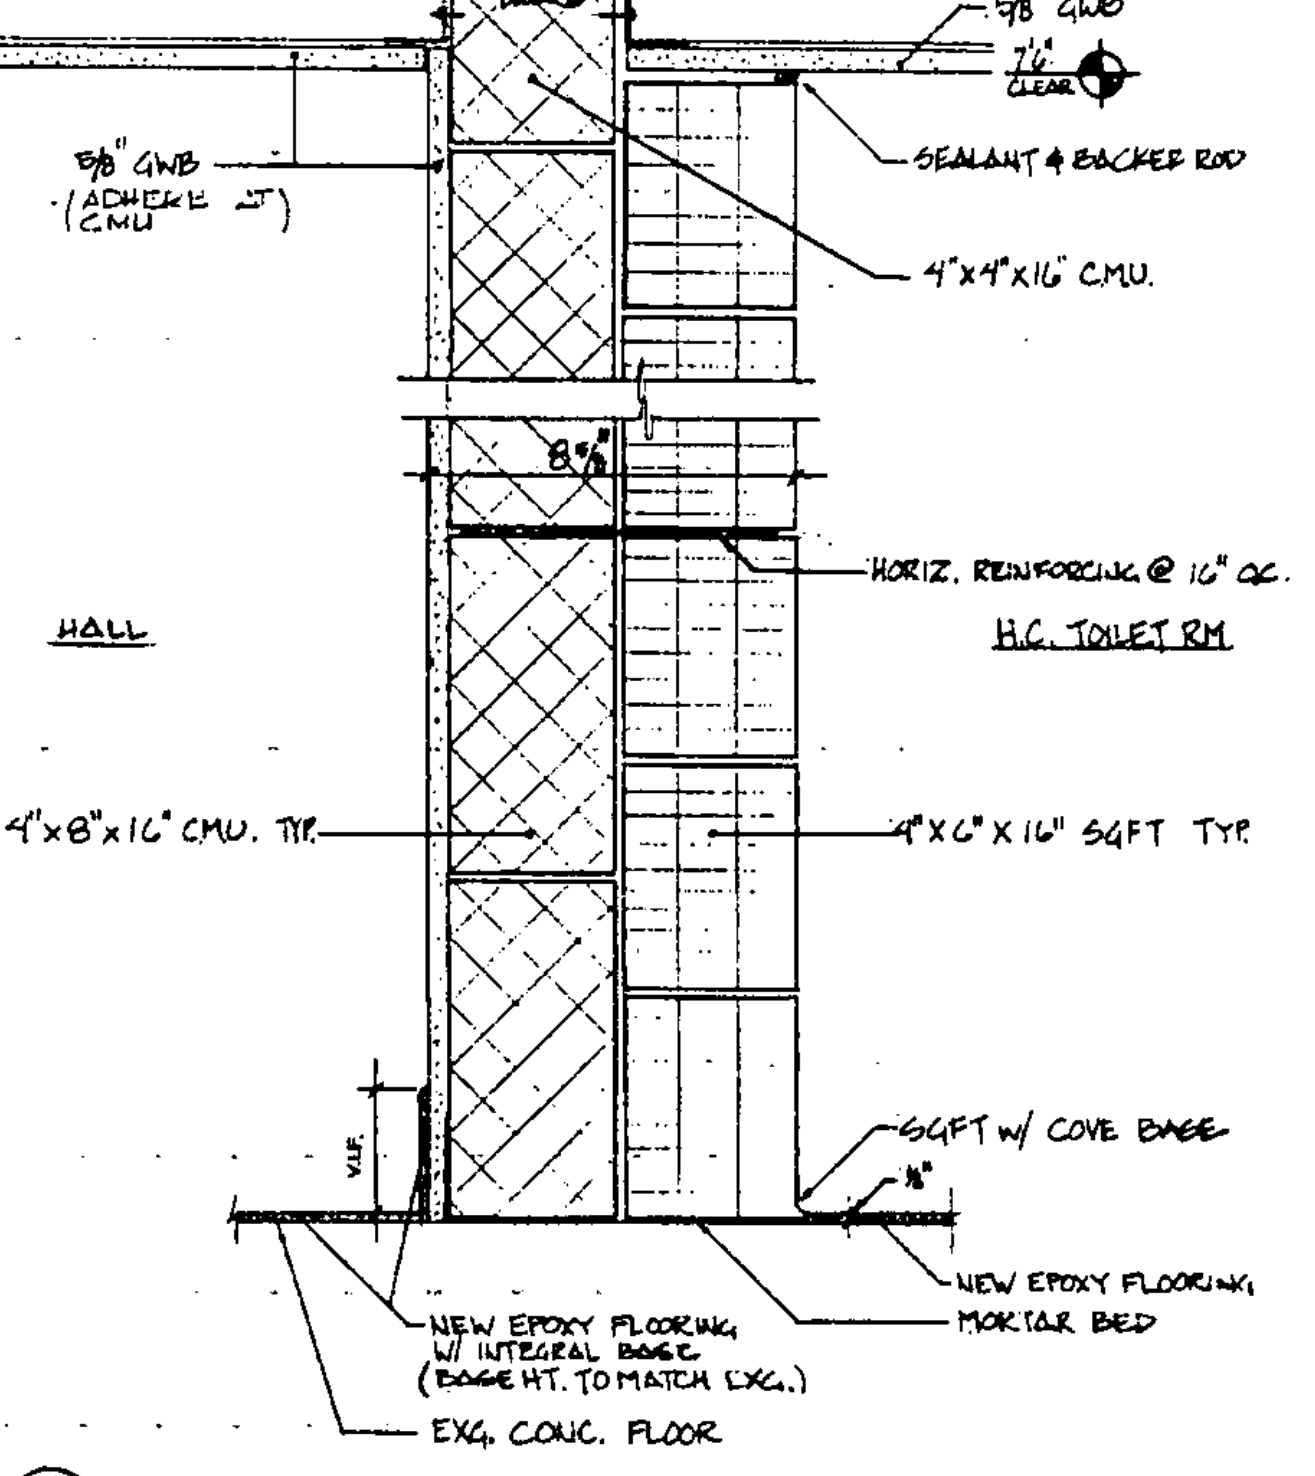
10 SECTION THROUGH WALL UNISEX TLT 3\"/>

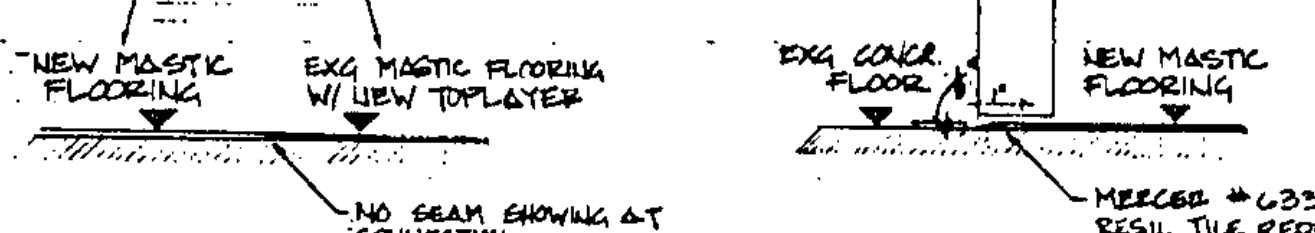
11 CONNECTION - NEW / EXG FLOORING VESTIBULE NO SCALE
