SURVEYED BY Epstein DATE 9-82
 DRAWN BY Neuman DATE 11-82
 TRACED BY Neuman DATE 11-82
 PROJ. GROTON NO. F 026-1 (27) S
 SHEET 29 of 131

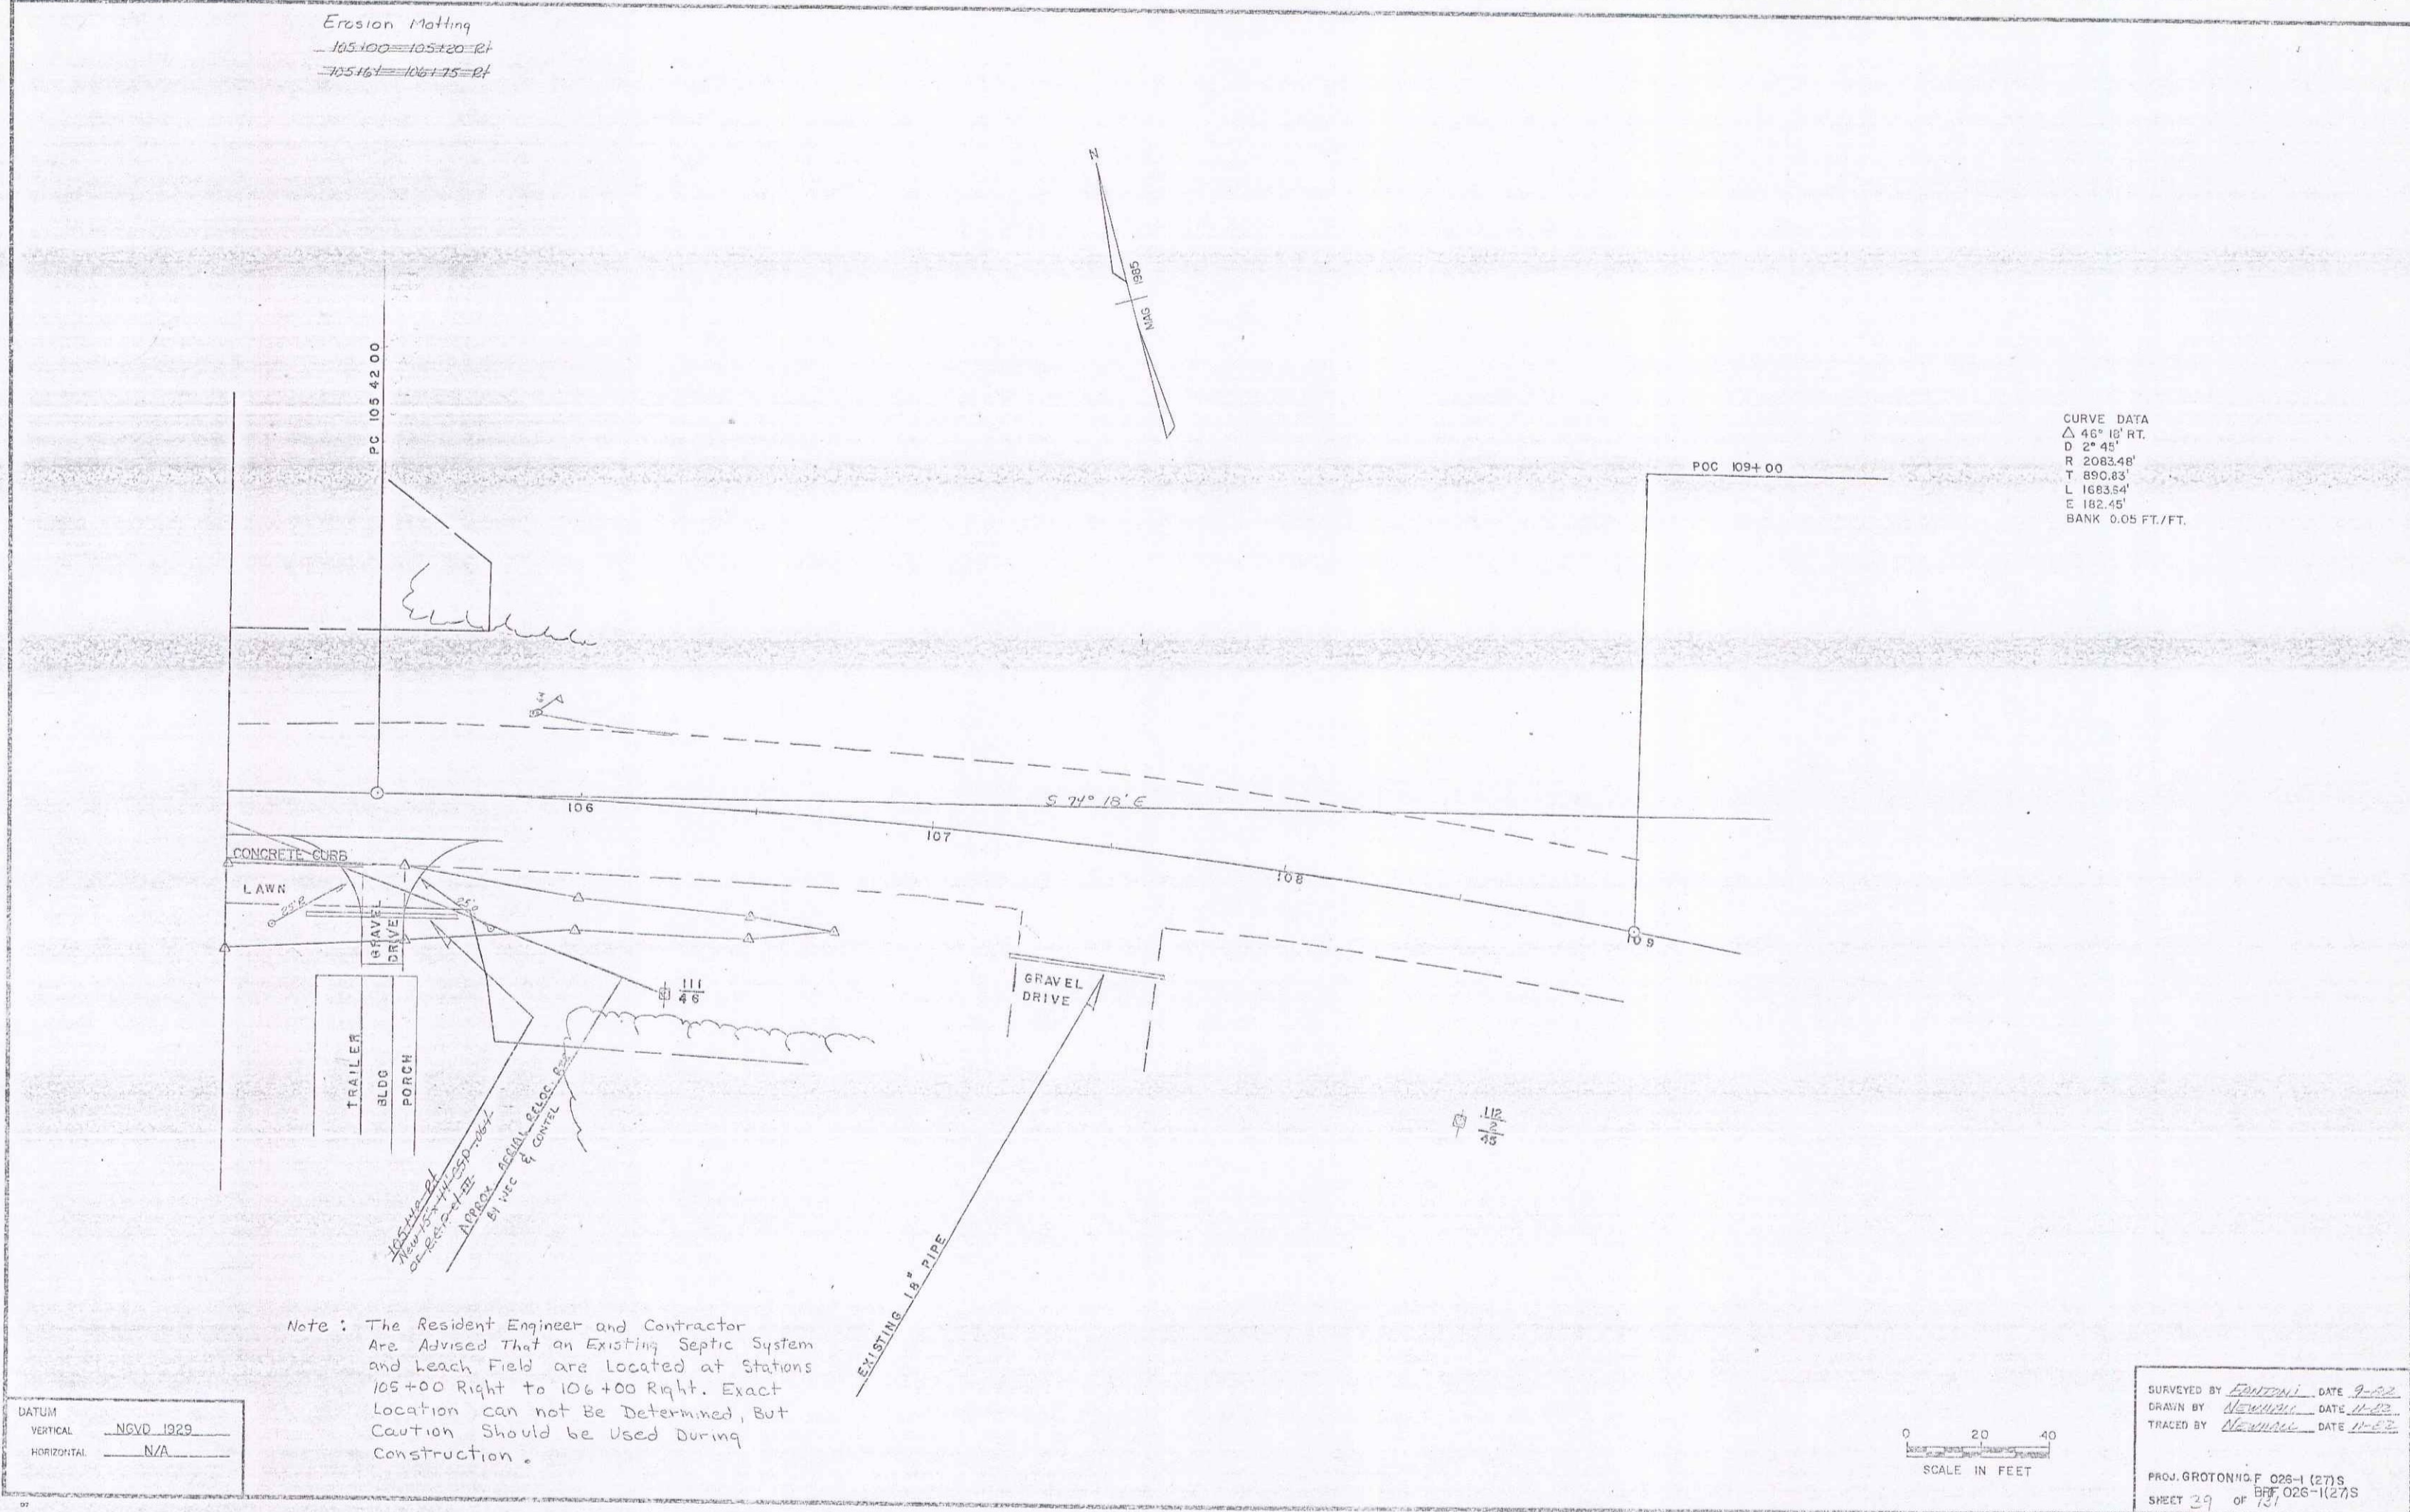
Erosion Matting
 -105+00=105+20=RT
 -105+16=106+75=RT

CURVE DATA
 Δ 46° 15' RT.
 D 2° 45'
 R 2083.48'
 T 890.83'
 L 1683.54'
 E 182.45'
 BANK 0.05 FT./FT.

Note: The Resident Engineer and Contractor
 Are Advised That an Existing Septic System
 and Leach Field are Located at Stations
 105+00 Right to 106+00 Right. Exact
 Location can not Be Determined, But
 Caution Should be Used During
 Construction.
