STEEL BRIDGE TOWER  
 1876+00  
 1876+10  
 1876+20  
 1876+30  
 1876+40  
 1876+50  
 1876+60  
 1876+70  
 1876+80  
 1876+90  
 1877+00  
 1877+10  
 1877+20  
 1877+30  
 1877+40  
 1877+50  
 1877+60  
 1877+70  
 1877+80  
 1877+90  
 1878+00

ROCKINGHAM (26)  
 Surveyed from 1871+00  
 Dotted & Taped  
 Sheet 14 of 176

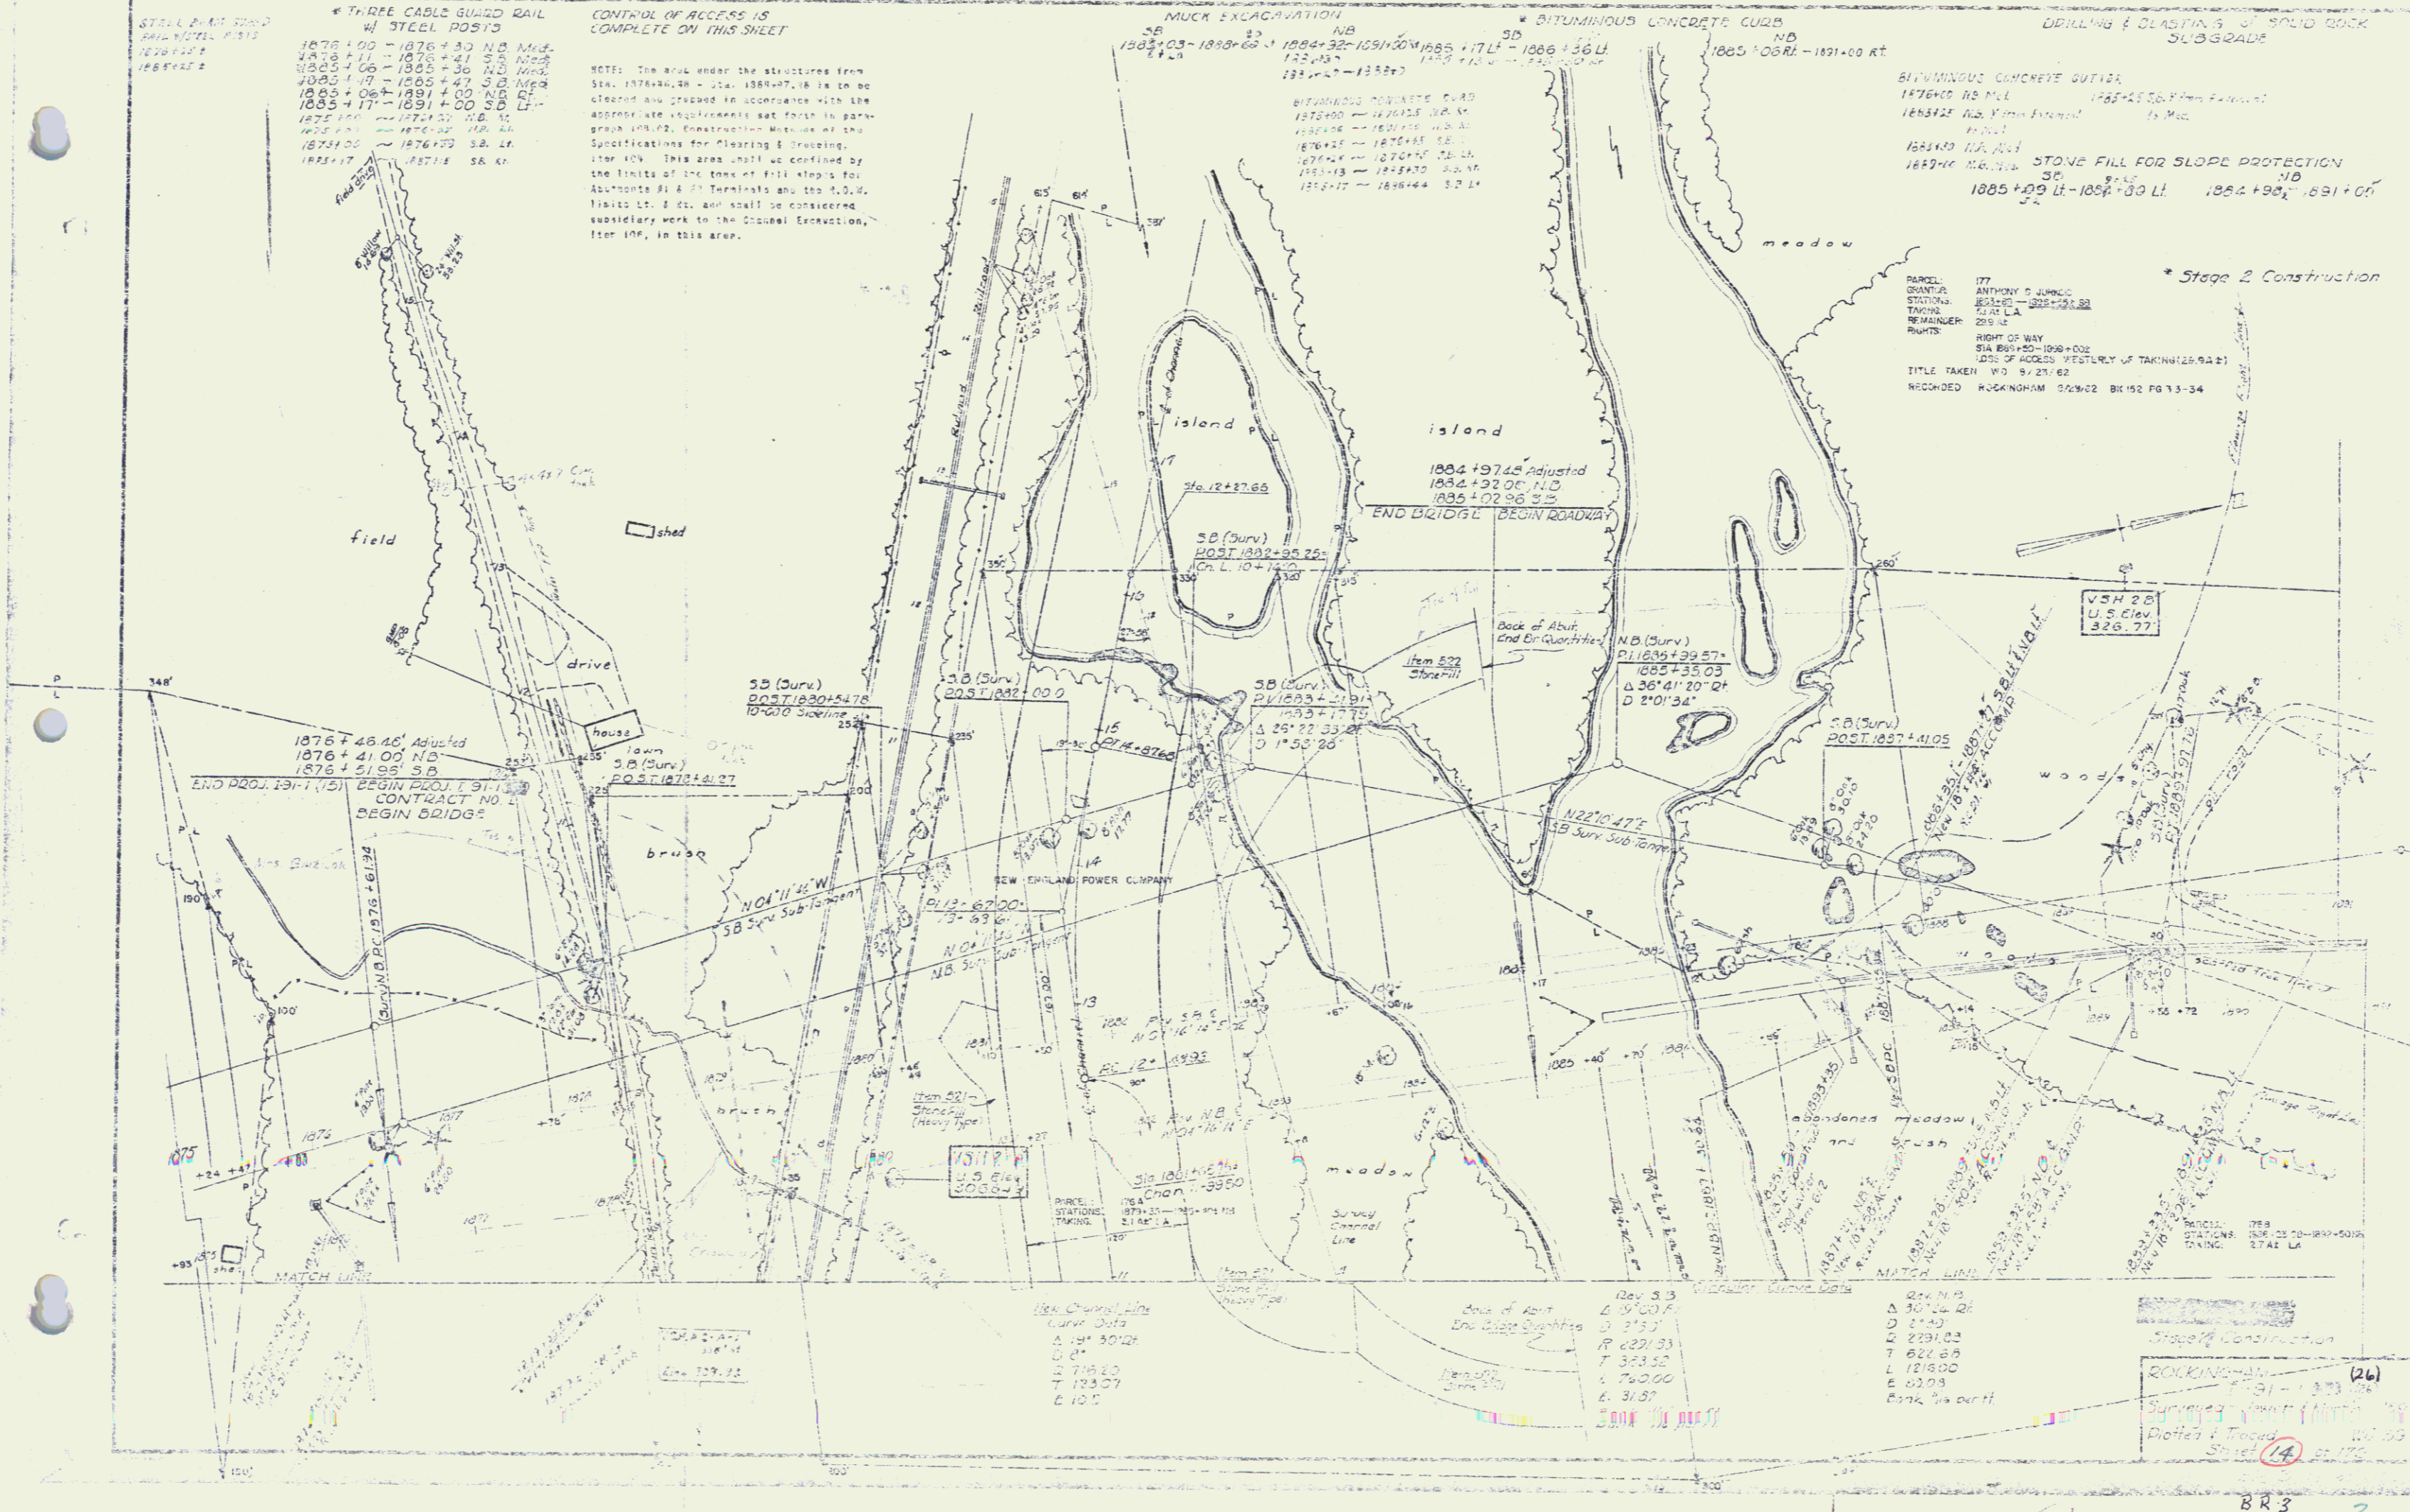
NOTE: The area under the structures from Sta. 1876+00 to Sta. 1884+00 is to be cleared and grubbed in accordance with the appropriate requirements set forth in paragraph 104.02, Construction Methods of the Specifications for Clearing & Grubbing, Item 104. This area shall be confined by the limits of the lines of fill slabs for Abutments #1 & #2. Thereafter and the T.O.W. limits to the right, all shall be considered subsidiary work to the Original Excavation, Item 104, in this area.

MUCK EXCAVATION

SB 1883+03 - 1888+00  
 NB 1884+32 - 1891+00  
 SB 1885+17 - 1891+00

BITUMINOUS CONCRETE CURB

1885+08 RL - 1891+00 RT

STONE FILL FOR SLOPE PROTECTION

1885+09 Lt - 1887+00 Lt  
 1884+98 Lt - 1891+00 Lt

188' Channel Line  
 Curve Data  
 Δ 181° 30' 12"  
 D 111'  
 T 718.20  
 E 123.07  
 C 10.5

End of Abut  
 End Bridge Sightline  
 Rev 5/3  
 Δ 10' 12.20'  
 D 1' 43"  
 T 2291.02  
 E 621.68  
 L 1218.00  
 E 621.68  
 Bank 1/2 on left
