NORWICH

PROJ. NO. 041-8(3)  
SHEET 323 OF 323

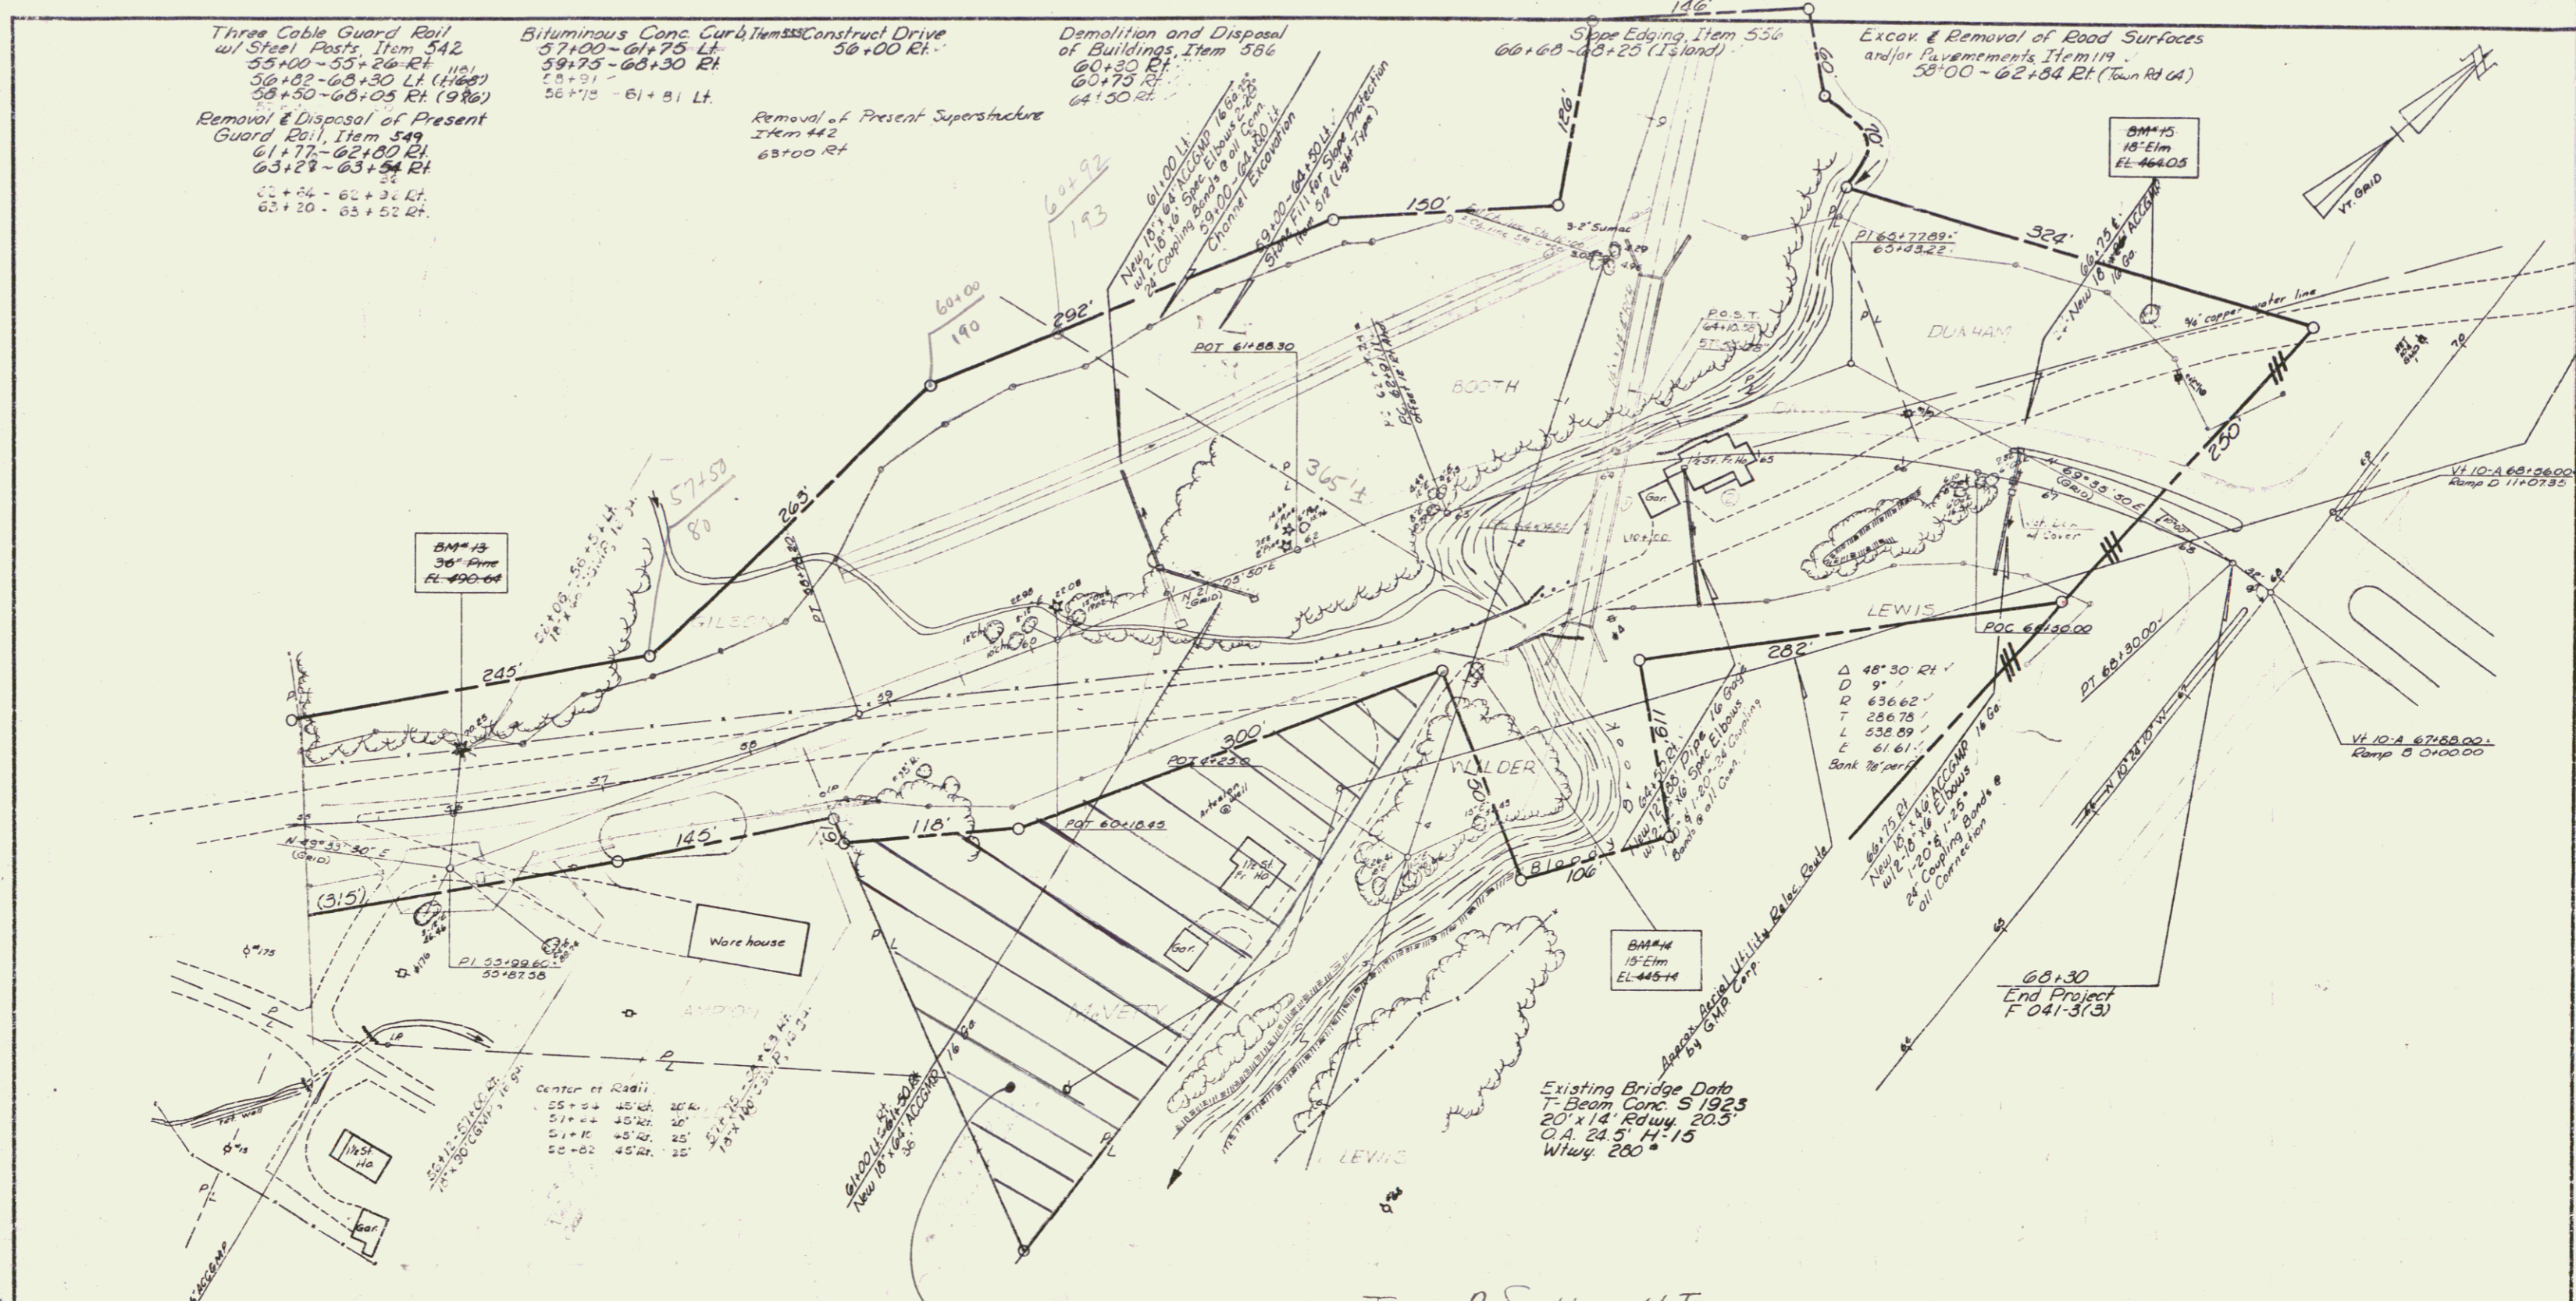
Three Cable Guard Rail  
w/ Steel Posts, Item 542  
55+00 - 55+20 Rt. 110'  
56+25 - 60+30 Lt. (1460)  
58+50 - 60+05 Rt. (986)

Removal & Disposal of Present  
Guard Post, Item 549  
61+77 - 62+00 Lt.  
63+29 - 63+54 Rt.

Bituminous Conc. Curbs, Item 558  
57+00 - 61+75 Lt.  
59+75 - 60+30 Rt.  
61+75 - 61+81 Lt.

Demolition and Disposal  
of Buildings, Item 556  
60+30 Rt.  
60+75 Rt.  
64+30 Rt.

Removal of Present Superstructure  
Item 442  
65+00 Rt.

Slope Edging, Item 554  
66+60 - 68+25 (Island)

Excav. & Removal of Road Surfaces  
and/or Pavements, Item 119  
58+00 - 62+84 Rt. (Town Rd. 64)

Δ 48° 30' Rt.  
D 9'  
R 636.62  
T 286.78  
L 538.89  
E 61.61'

Existing Bridge Data  
T-Beam Conc. S 1923  
20' x 14' Rdwy. 20.5'  
O.A. 24.5' H. 15'  
Wt. 200'
