**ONE - GIRDER - 1G1A (DEVELOPED)**

REV.	DATE	REMARKS	DWN	CHK	APVL	SHOP
0						
						MAY 23 2012
MATERIAL:		SURFACE PREP. & PAINT:		HOLES:		SHOP BOLTS:
M270-50W (UN)		SEE DWG GNI		15/16" Ø (UN)		NONE
DESCRIPTION: GIRDER - 1G1A						
CASCO BAY STEEL STRUCTURES, INC.						
1 WALLACE AVE.			PHONE (207) 780-6722		SOUTH PORTLAND, ME 04106	
			FAX. (207) 780-6726		TENSOR 3124	
STRUCTURE: THETFORD				DRAWN:	DATE:	
VT. RTE 132 OVER THE WEST BRANCH				JTB	05/16	
OF OMPOMPANNOUSUC RIVER				CHKD:	DATE:	
				DBH	05/21	
LOCATION: THETFORD, VT				JOB NO.	DWG NO.	
PROJ NO. BHF 0177(9)				518	1	
CUSTOMER: A.L. ST. ONGE CONTRACTING					REV. 1

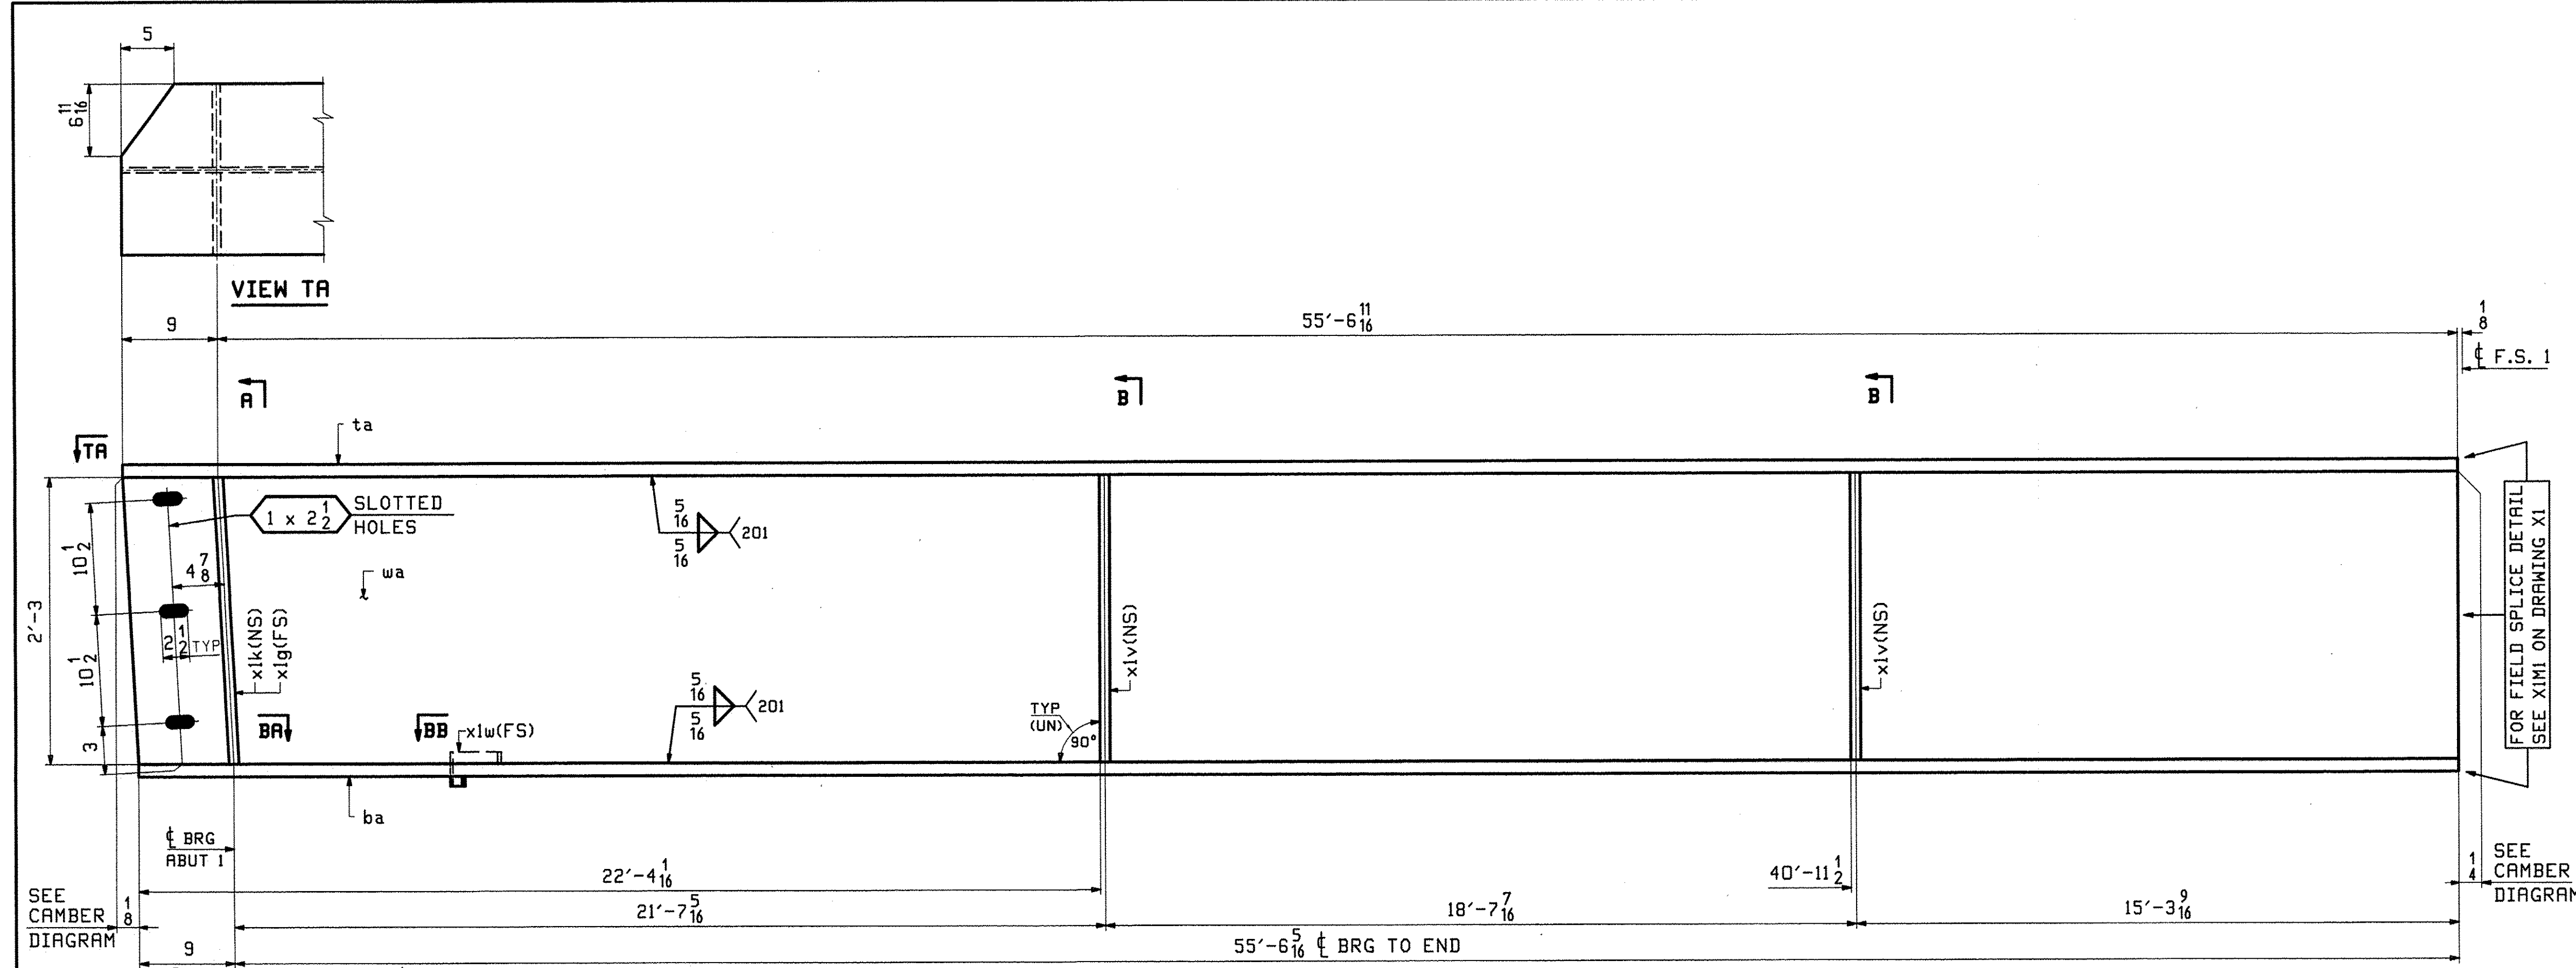
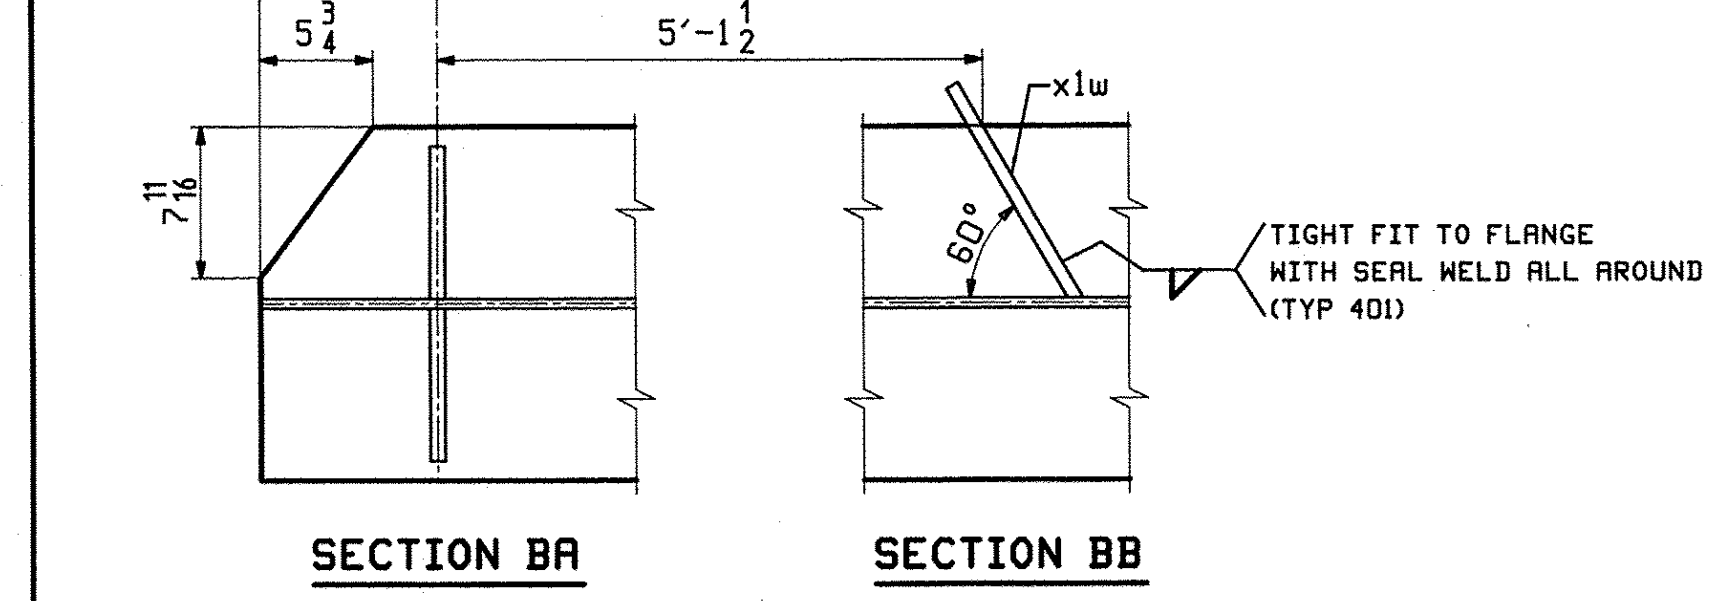
FOR GIRDER STANDARD DETAILS SEE DRAWING XI.  
 FOR CAMBER DIAGRAMS SEE DRAWING C1.  
 FOR FLANGE DIAGRAMS SEE DRAWING F1.  
 FOR GENERAL NOTES SEE DRAWING GNI.  
 T2 DENOTES MATERIAL SUBJECT TO CHARPY V-NOTCH TESTING.
