CAMBER DIAGRAM FOR GIRDERS 1G1A, 2G2A, 3G3A, 4G4A & 5G5A

FLANGE DIAGRAM FOR GIRDERS 1G1A, 2G2A, 3G3A, 4G4A & 5G5A

DESCRIPTION: CAMBER & FLANGE DIAGRAMS					
CASCO BAY STEEL STRUCTURES, INC.					
1 WALLACE AVE.		PHONE (207) 780-6722		TENSOR SUBC	
SOUTH PORTLAND, ME 04106		FAX. (207) 780-6726			
STRUCTURE:	VT 100 OVER LAHOILLE RIVER	DRAWN:	EEO	DATE:	08/21
	MORRISTOWN, VT LAHOILLE COUNTY	CHKD:	SOB	DATE:	08/27
	STP F 029-1 (2) C/1				
LOCATION:	MORRISTOWN, VT	JOB NO.:	521	DWG NO.:	C1
PROJ NO.:	STP F 029-1(2)C/1			REV.:	
CUSTOMER:	MINTERSET, INC.

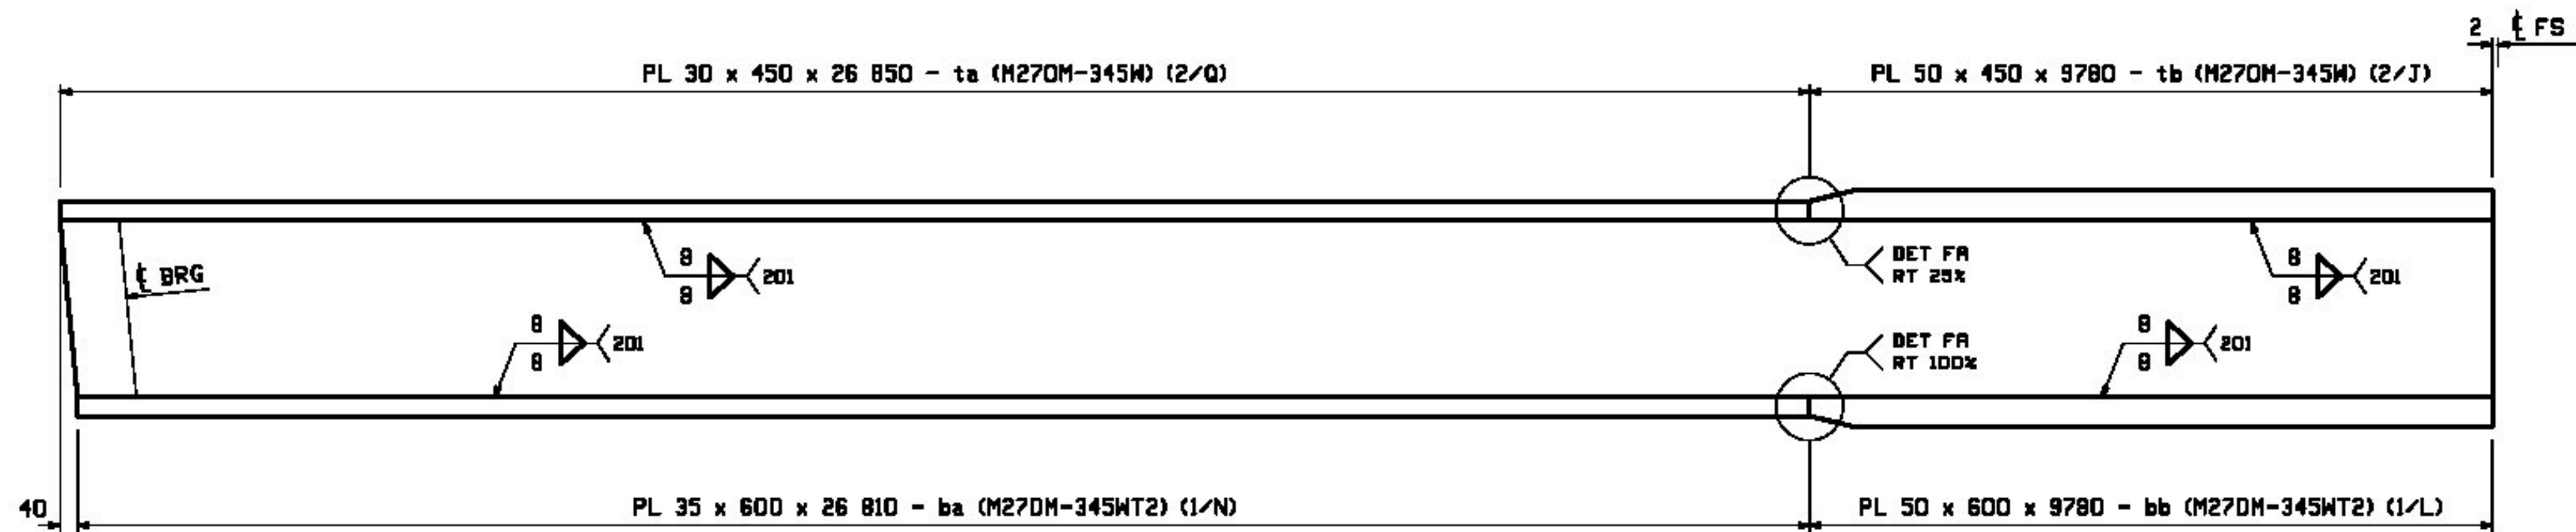
- NOTES:
 1. FOR GENERAL NOTES SEE DRAWING GNI.
 2. T2 - DENOTES MATERIAL SUBJECT TO CHARPY V-NOTCH TEST AT H FREQ. FOR ZONE 2.
