REPAIR OF DAMAGE THROUGH A CORED LAMINATE WITH ACCESS FROM BOTH SIDES

FIGURE 6.14

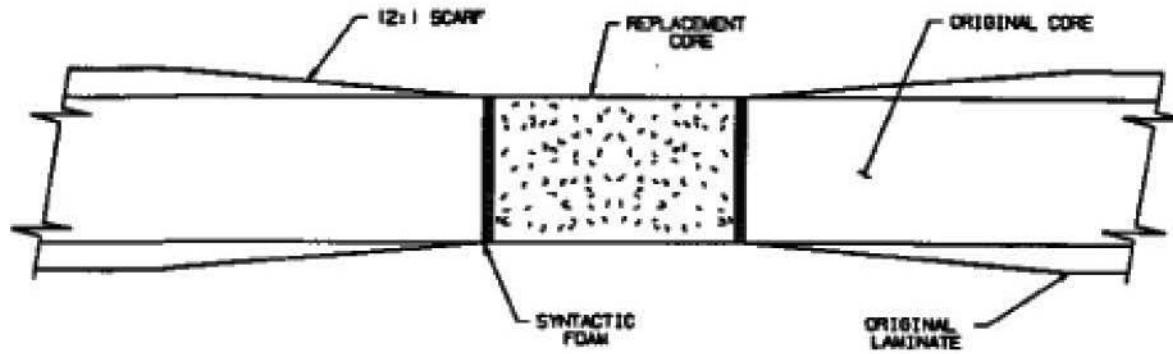
LAMINATE PREPARED FOR REPAIR

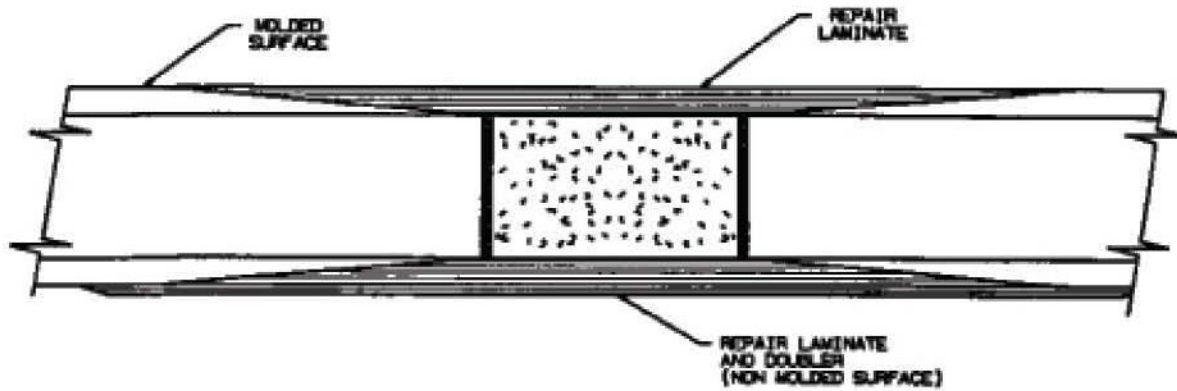
COMPLETED REPAIR
