PROJECT NAME: WOODSTOCK VILLAGE	
PROJECT NUMBER: BF 020-2(43)	
FILE NAME: s13j280bdr_util.dgn	PLOT DATE: 18-JUL-2017
PROJECT LEADER: R. YOUNG	DRAWN BY: S. COLEY
DESIGNED BY: S. COLEY	CHECKED BY: W. LAMMER
UTILITY LAYOUT	SHEET 14 OF 53

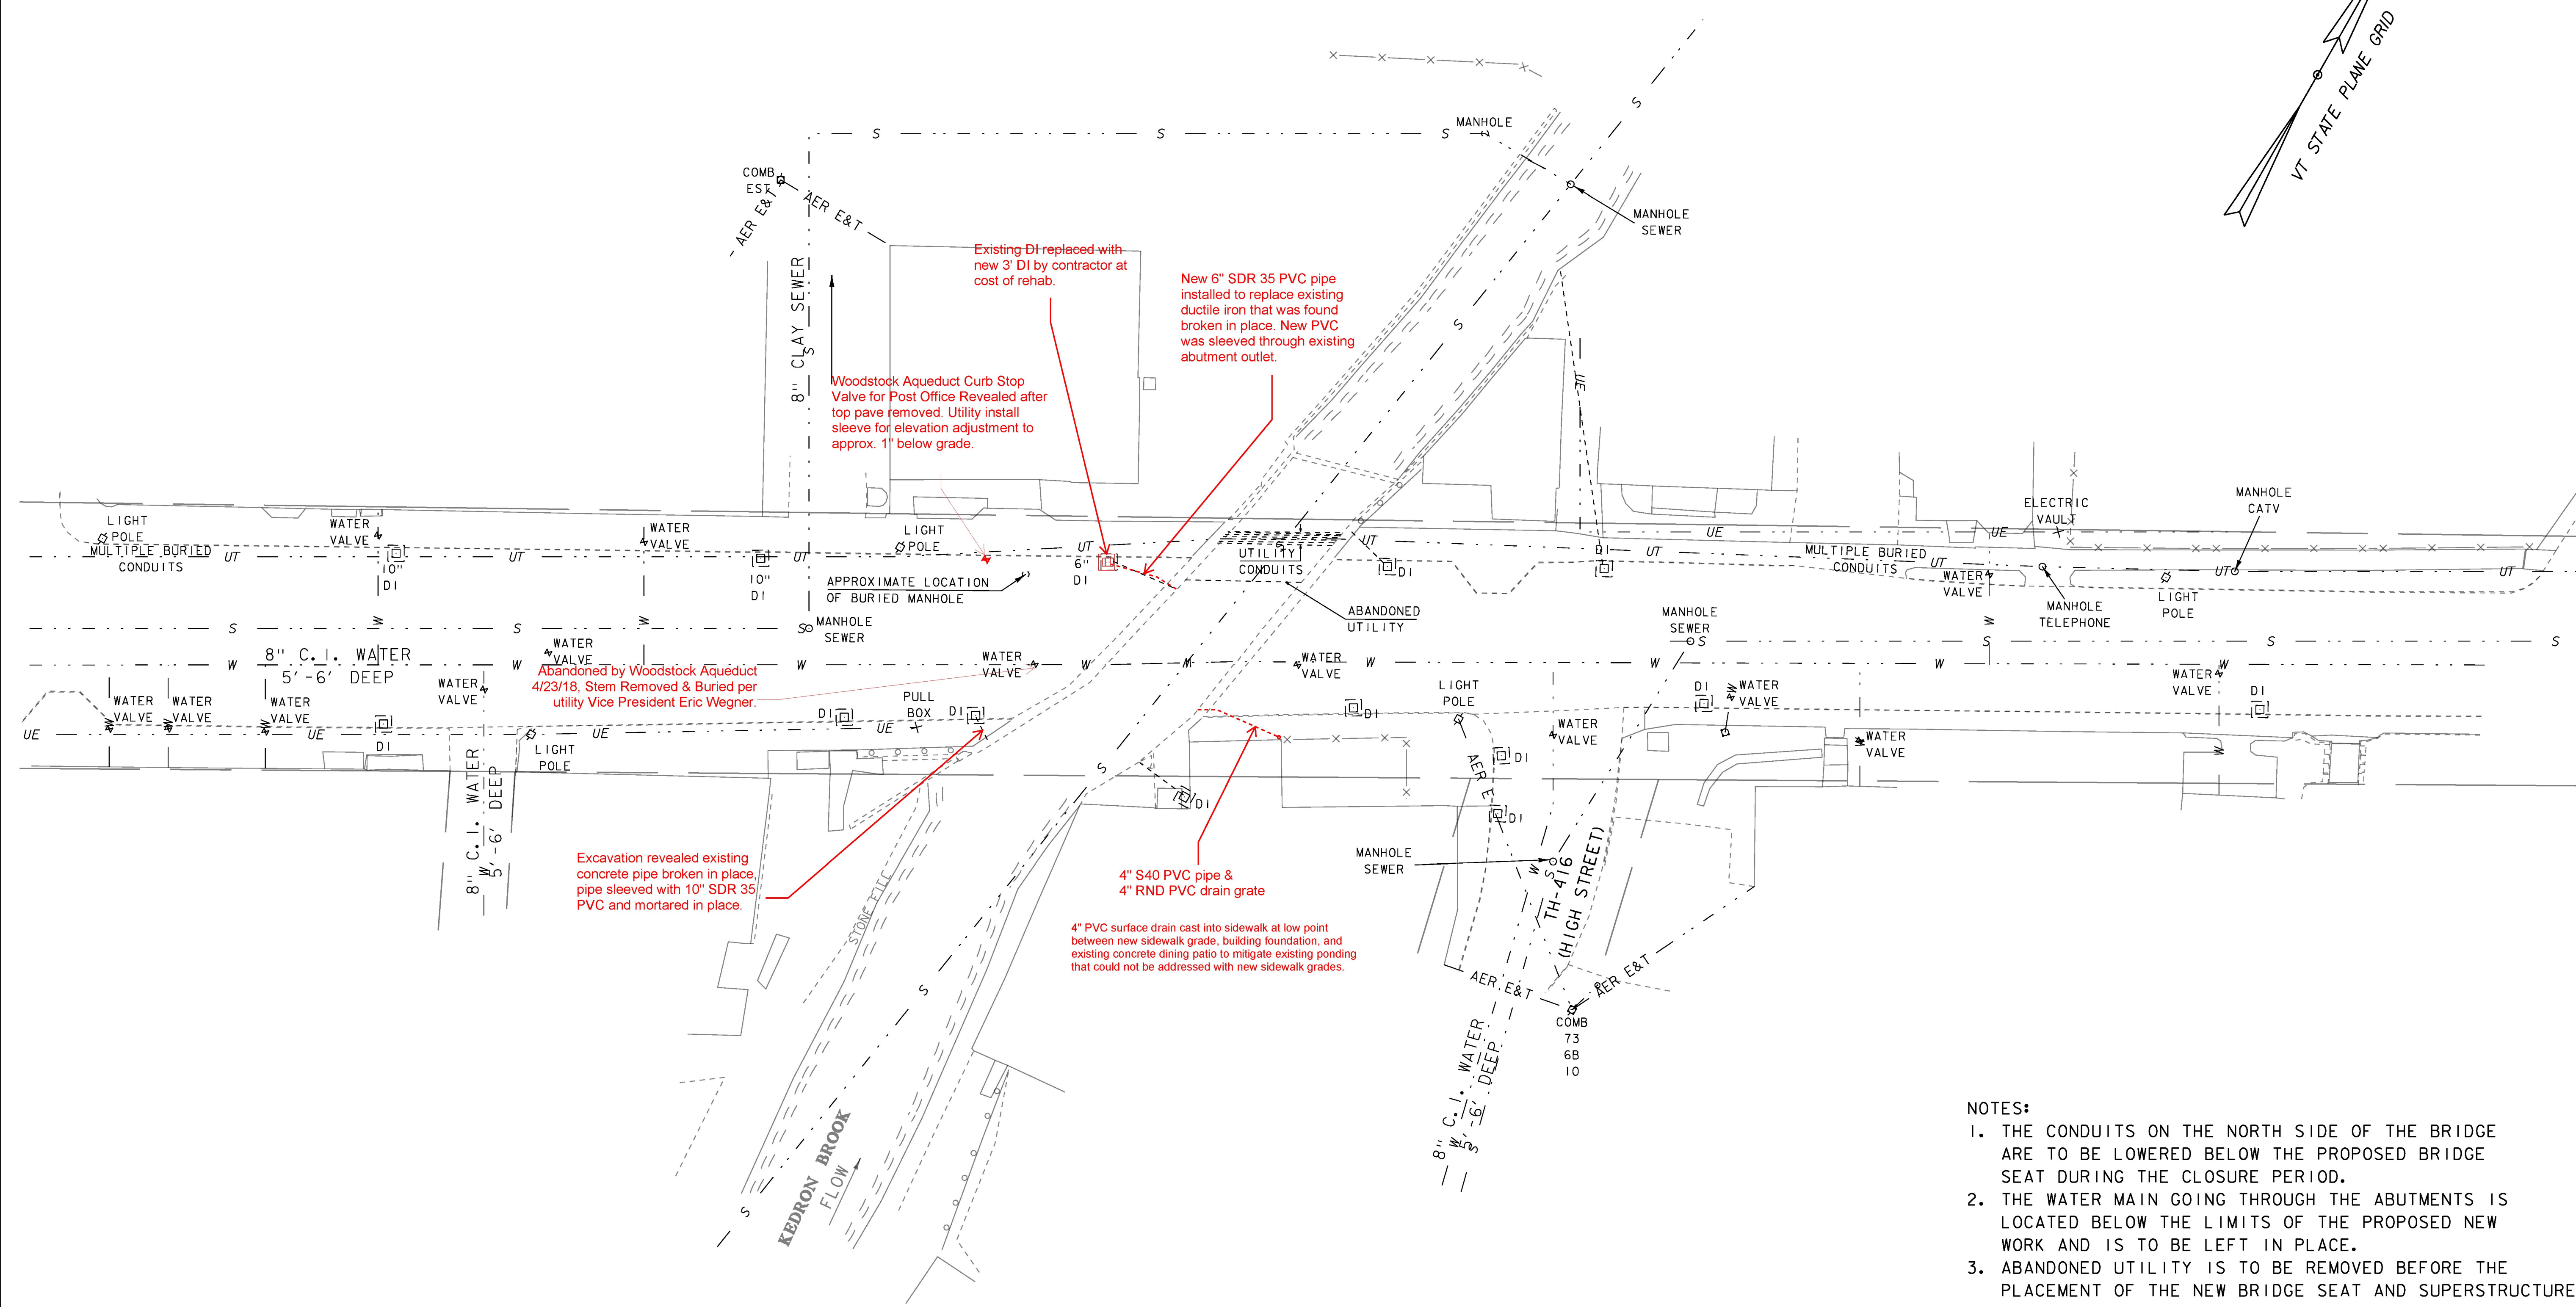
Existing DI replaced with new 3" DI by contractor at cost of rehab.

New 6" SDR 35 PVC pipe installed to replace existing ductile iron that was found broken in place. New PVC was sleeved through existing abutment outlet.

Woodstock Aqueduct Curb Stop Valve for Post Office Revealed after top pave removed. Utility install sleeve for elevation adjustment to approx. 1" below grade.

Abandoned by Woodstock Aqueduct 4/23/18. Stem Removed & Buried per utility Vice President Eric Wegner.

Excavation revealed existing concrete pipe broken in place, pipe sleeved with 10" SDR 35 PVC and mortared in place.

4" S40 PVC pipe & 4" RND PVC drain grate

4" PVC surface drain cast into sidewalk at low point between new sidewalk grade, building foundation, and existing concrete dining patio to mitigate existing ponding that could not be addressed with new sidewalk grades.
