GUARDRAIL REPLACEMENT GUIDELINES

PROJECT NAME:	RANDOLPH-BRAINTREE
PROJECT NUMBER:	STP FPAV(7)
FILE NAME: z16v028frm.dgn	PLOT DATE: 2/8/2017
PROJECT LEADER: P. SHEDD	DRAWN BY: S. GOODWIN
DESIGNED BY: N. LEMAY	CHECKED BY: P. SHEDD
GUARDRAIL REPLACEMENT DETAIL SHEET 2	SHEET 12 OF 24

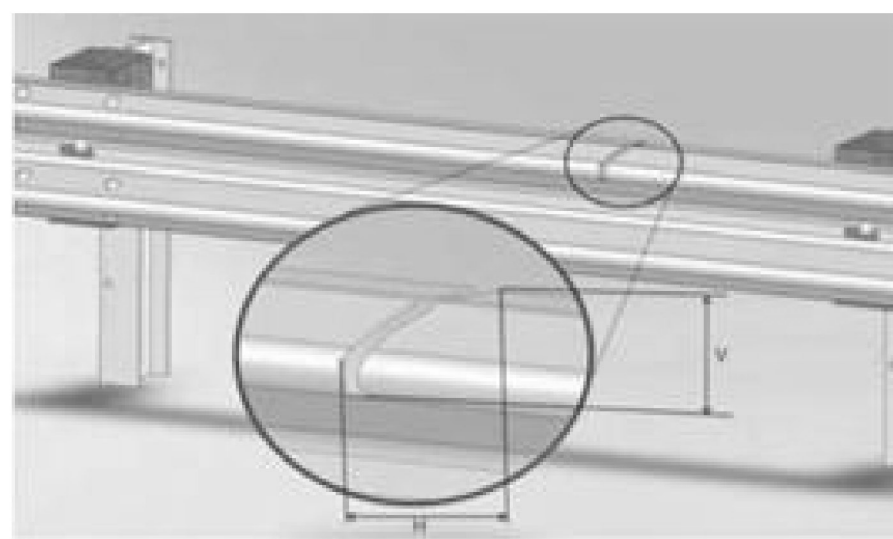
DAMAGE TYPE	REPAIR THRESHOLD	RELATIVE PRIORITY	MEASUREMENT
VERTICAL TEAR	ANY LENGTH VERTICAL (TRANSVERSE) TEAR	HIGH

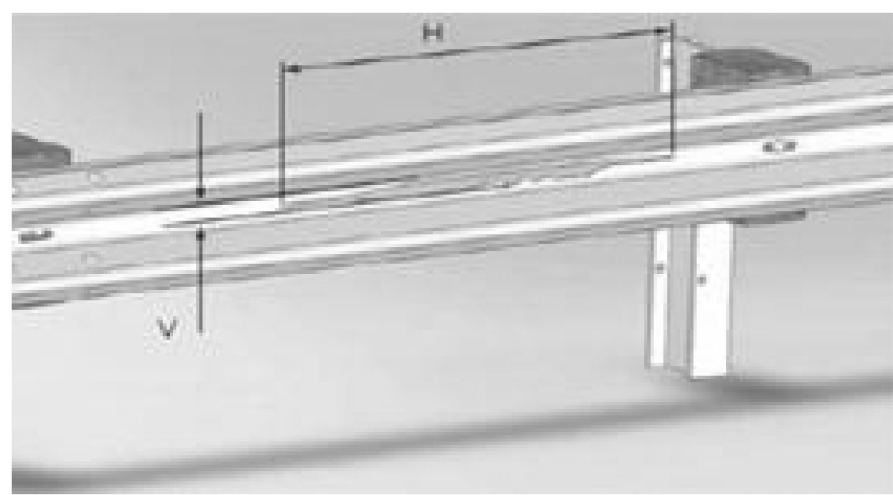
HORIZONTAL TEAR	HORIZONTAL (LONGITUDINAL) GREATER THAN 12 IN. LONG AND GREATER THAN 0.5 IN. WIDE NOTE: FOR HORIZONTAL TEARS LESS THAN 12 IN. IN LENGTH OR LESS THAN 0.5 IN. IN HEIGHT, USE THE NON-MANUFACTURED HOLES GUIDELINES	MEDIUM

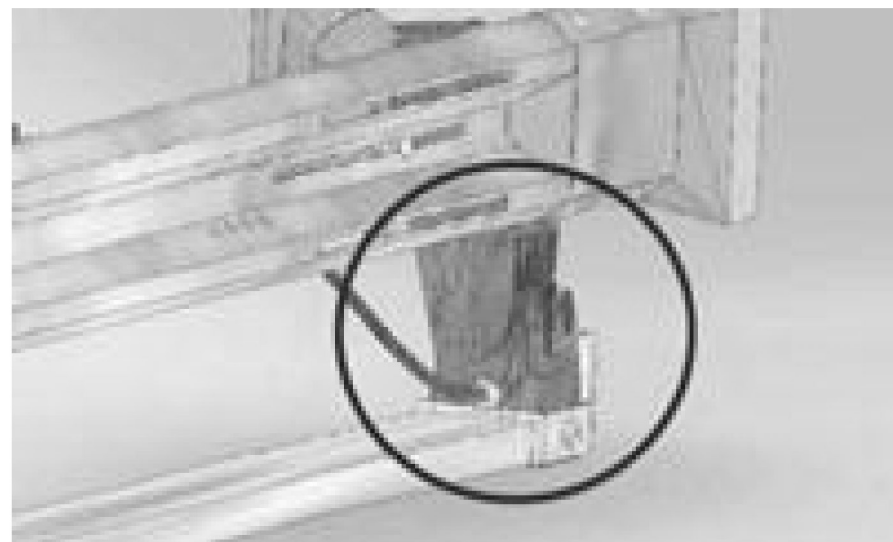
DAMAGE	REPAIR THRESHOLD	RELATIVE PRIORITY	MEASUREMENT
DAMAGED END POST	NOT FUNCTIONAL (SHEARED, ROTTED CRACKED ACROSS THE GRAIN)	HIGH

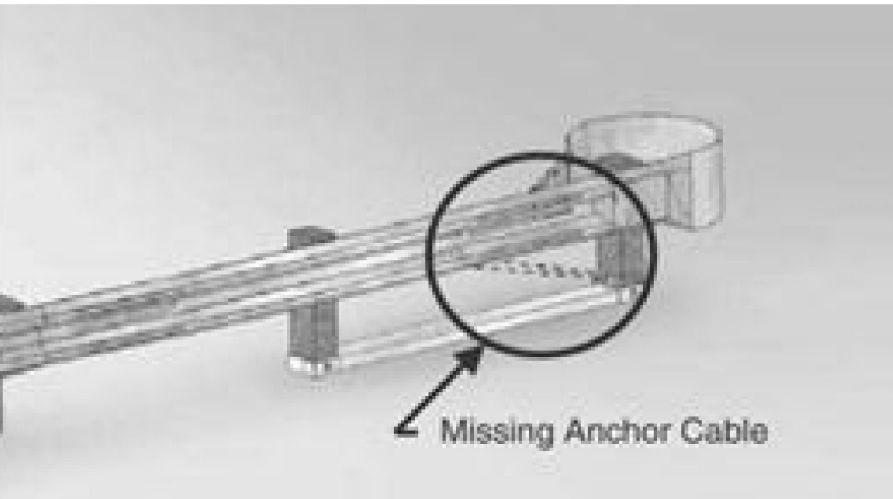
ANCHOR CABLE	MISSING	HIGH

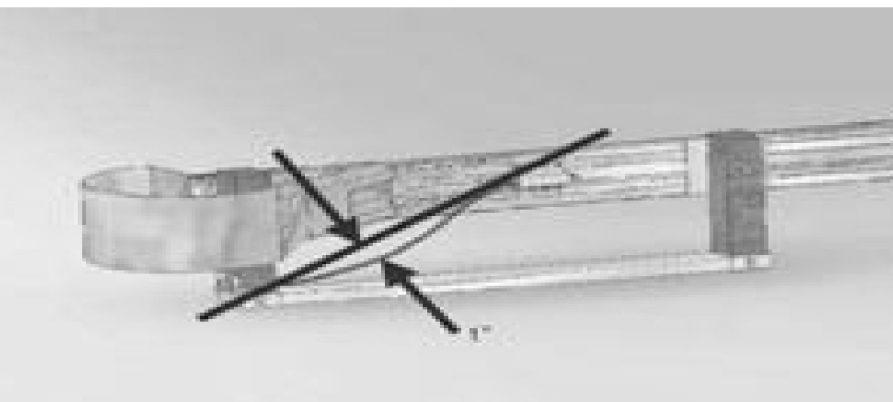
ANCHOR CABLE	LOOSE - MORE THAN 1IN. OF MOVEMENT WHEN PUSHED DOWN BY HAND	MEDIUM

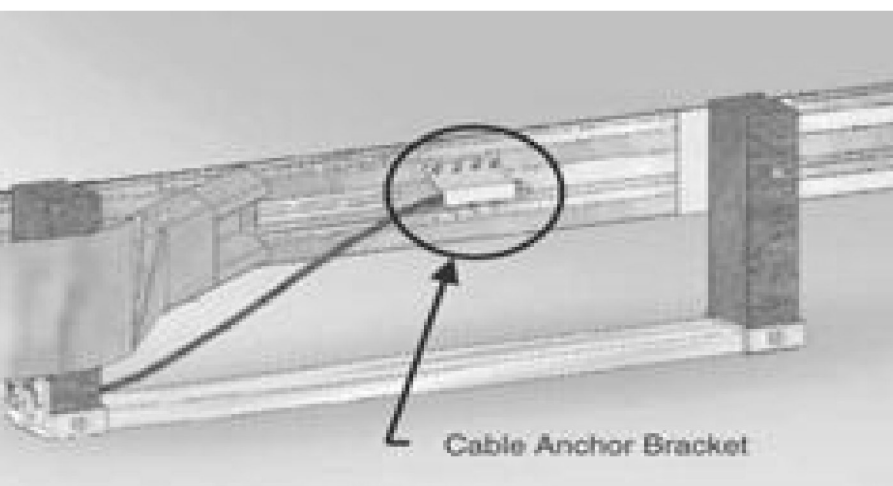
CABLE ANCHOR BRACKET	LOOSE OR NOT FIRMLY SEATED IN RAIL	MEDIUM

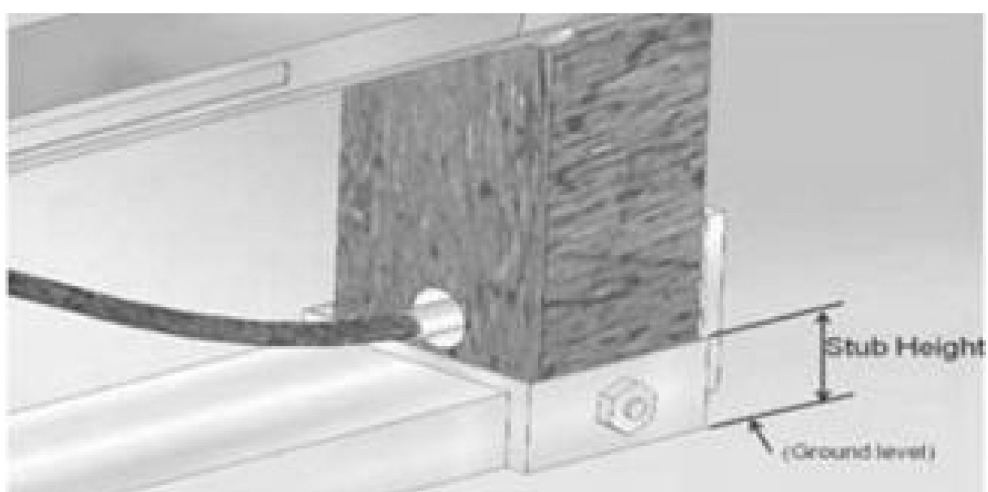
DAMAGE	REPAIR THRESHOLD	RELATIVE PRIORITY	MEASUREMENT
STUB HEIGHT	HEIGHT WHICH EXCEEDS 4 IN.	MEDIUM

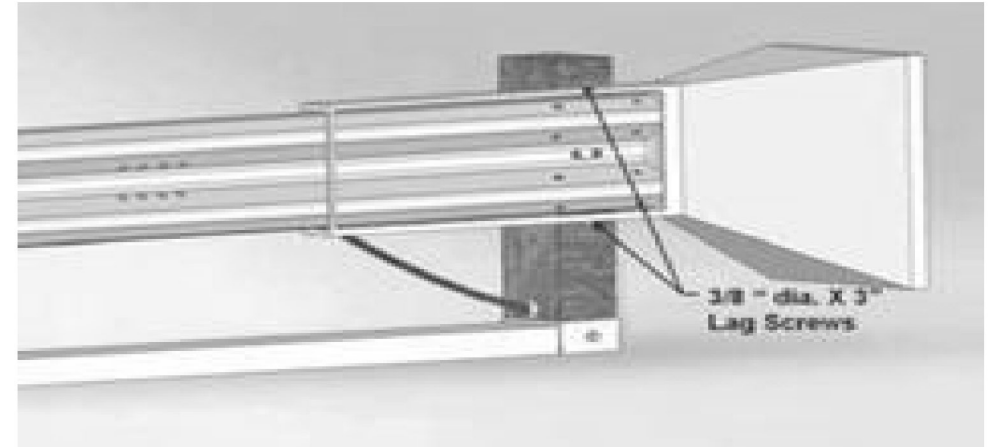
LAG SCREWS (ENERGY ABSORBING TERMINALS ONLY)	MISSING OR FAILED LAG SCREWS	HIGH

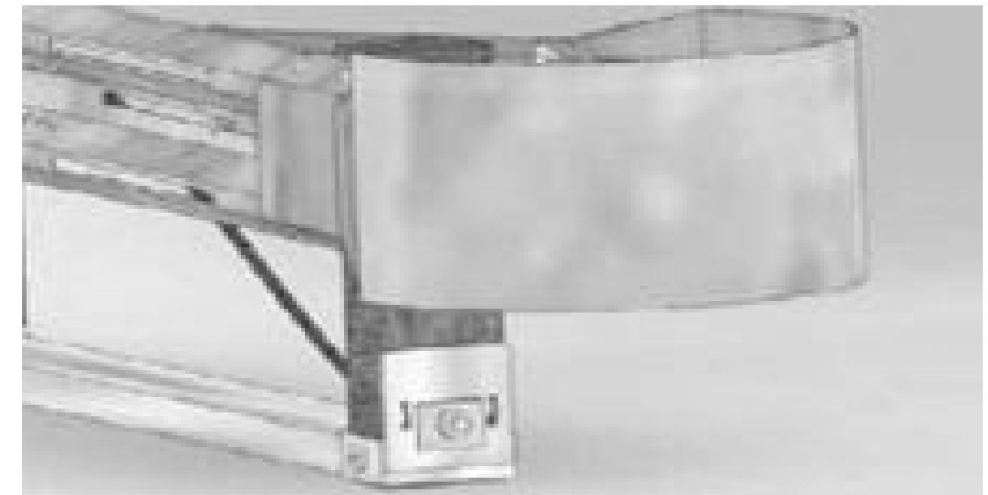
BEARING PLATE	LOOSE OR MISALIGNED	MEDIUM
