**STATE OF VERMONT
AGENCY OF TRANSPORTATION**

Town Of	HARTLAND	Bridge No.	60
Highway No.	U.S. ROUTE 5	Log Sta.	
		Surv. Sta.	
U.S. ROUTE 5 OVER LULLS BROOK

FINAL CONDITIONS SITE PLAN

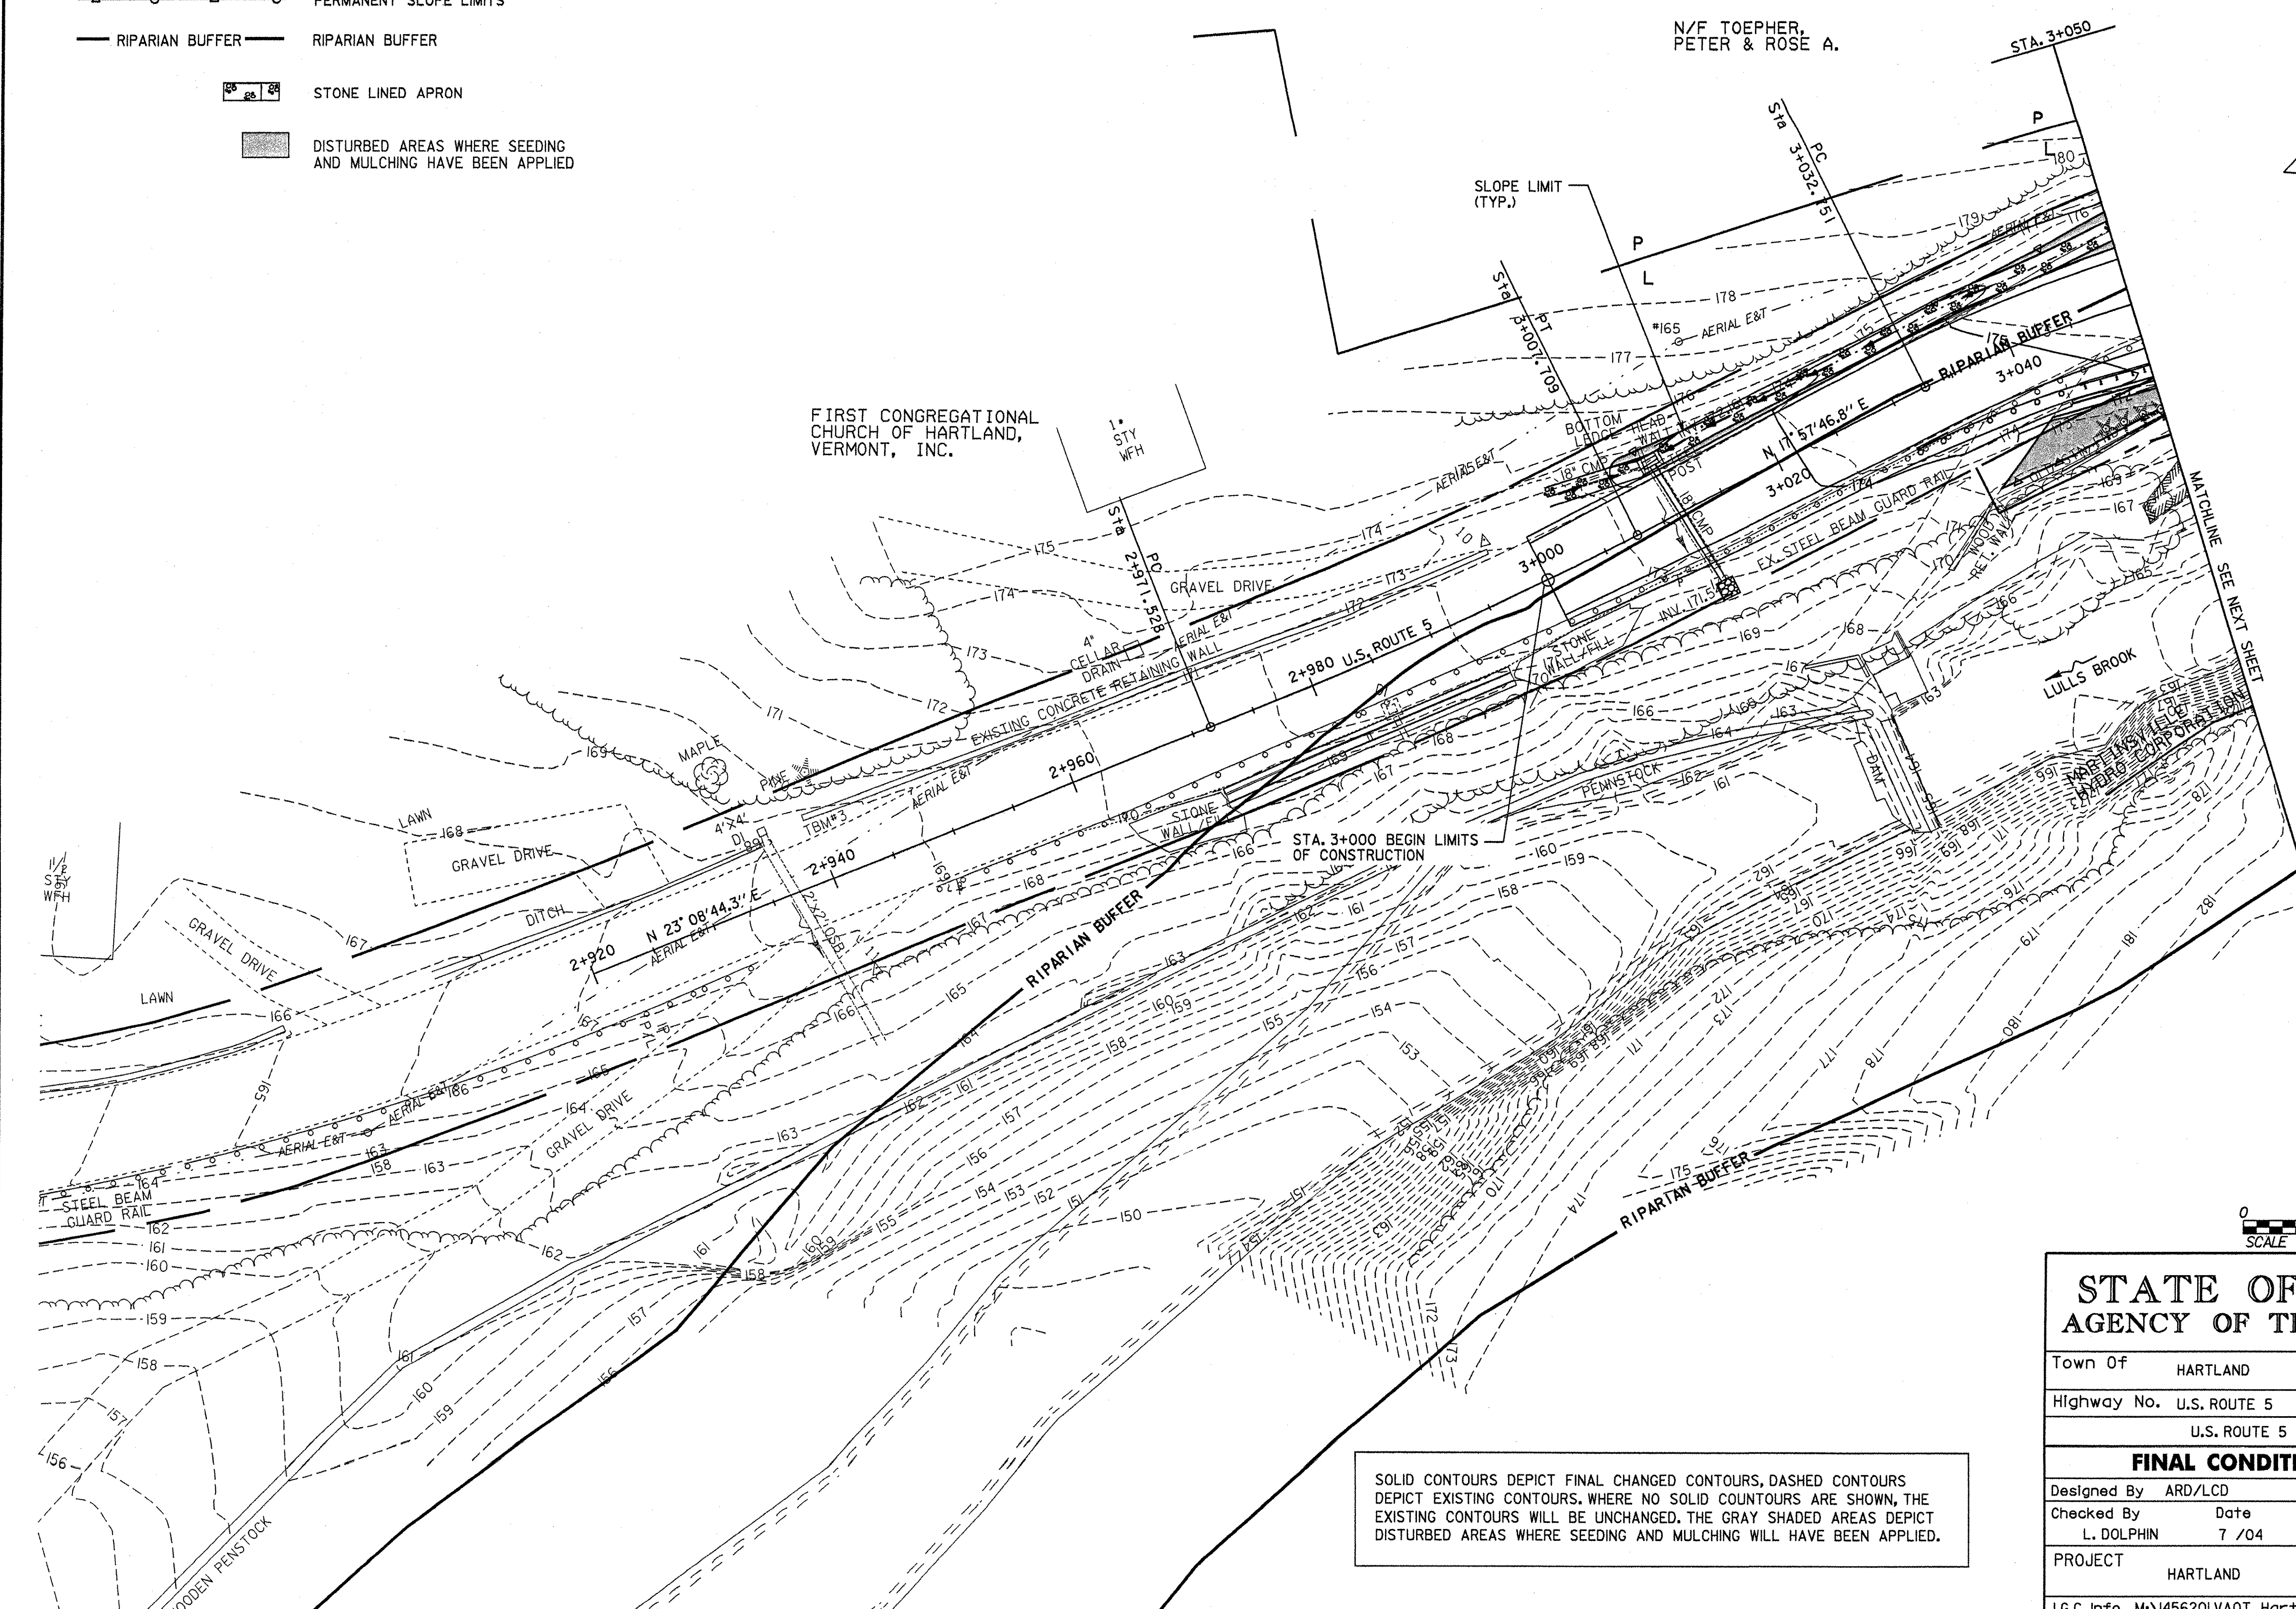
SOLID CONTOURS DEPICT FINAL CHANGED CONTOURS, DASHED CONTOURS DEPICT EXISTING CONTOURS. WHERE NO SOLID CONTOURS ARE SHOWN, THE EXISTING CONTOURS WILL BE UNCHANGED. THE GRAY SHADED AREAS DEPICT DISTURBED AREAS WHERE SEEDING AND MULCHING WILL HAVE BEEN APPLIED.
