ONE - BOTTOM CHORD - 3BC2W (CONTINUED)  
(L2-L2' WEST)

03/23/11	REVISED AS PER APPROVAL COMMENTS	JM	PWR		
02/28/11	REVISED AS PER APPROVAL COMMENTS	JM	PWR		
0					
REV. DATE	REMARKS	DWN	CHK	APVL	SHOP
MATERIAL: M270-50 (U.N.)		SURFACE PREP. & PAINT: SEE DWG GN1		HOLES: 1/8" (U.N.)	
SHOP BOLTS: AS NOTED		DESCRIPTION: BOTTOM CHORD 3BC2W			
CASCO BAY STEEL STRUCTURES, INC.					
75 SPRING HILL ROAD		SACO, MAINE 04072		PHONE (207) 282-7360 FAX. (207) 282-1179	
STRUCTURE: Vermont Route 100A	BRIDGE NO. 14	DRAWN: RB	DATE: 9/27/10		
Bridgewater		CHKD: WJL	DATE: 10/18/10		
County of Windsor		JOB NO. 454	DWG NO. 3BC		
LOCATION: BRIDGEWATER, VERMONT	PROJ NO. BRS 0149(4)	CUSTOMER: VT AOT	REV. 1

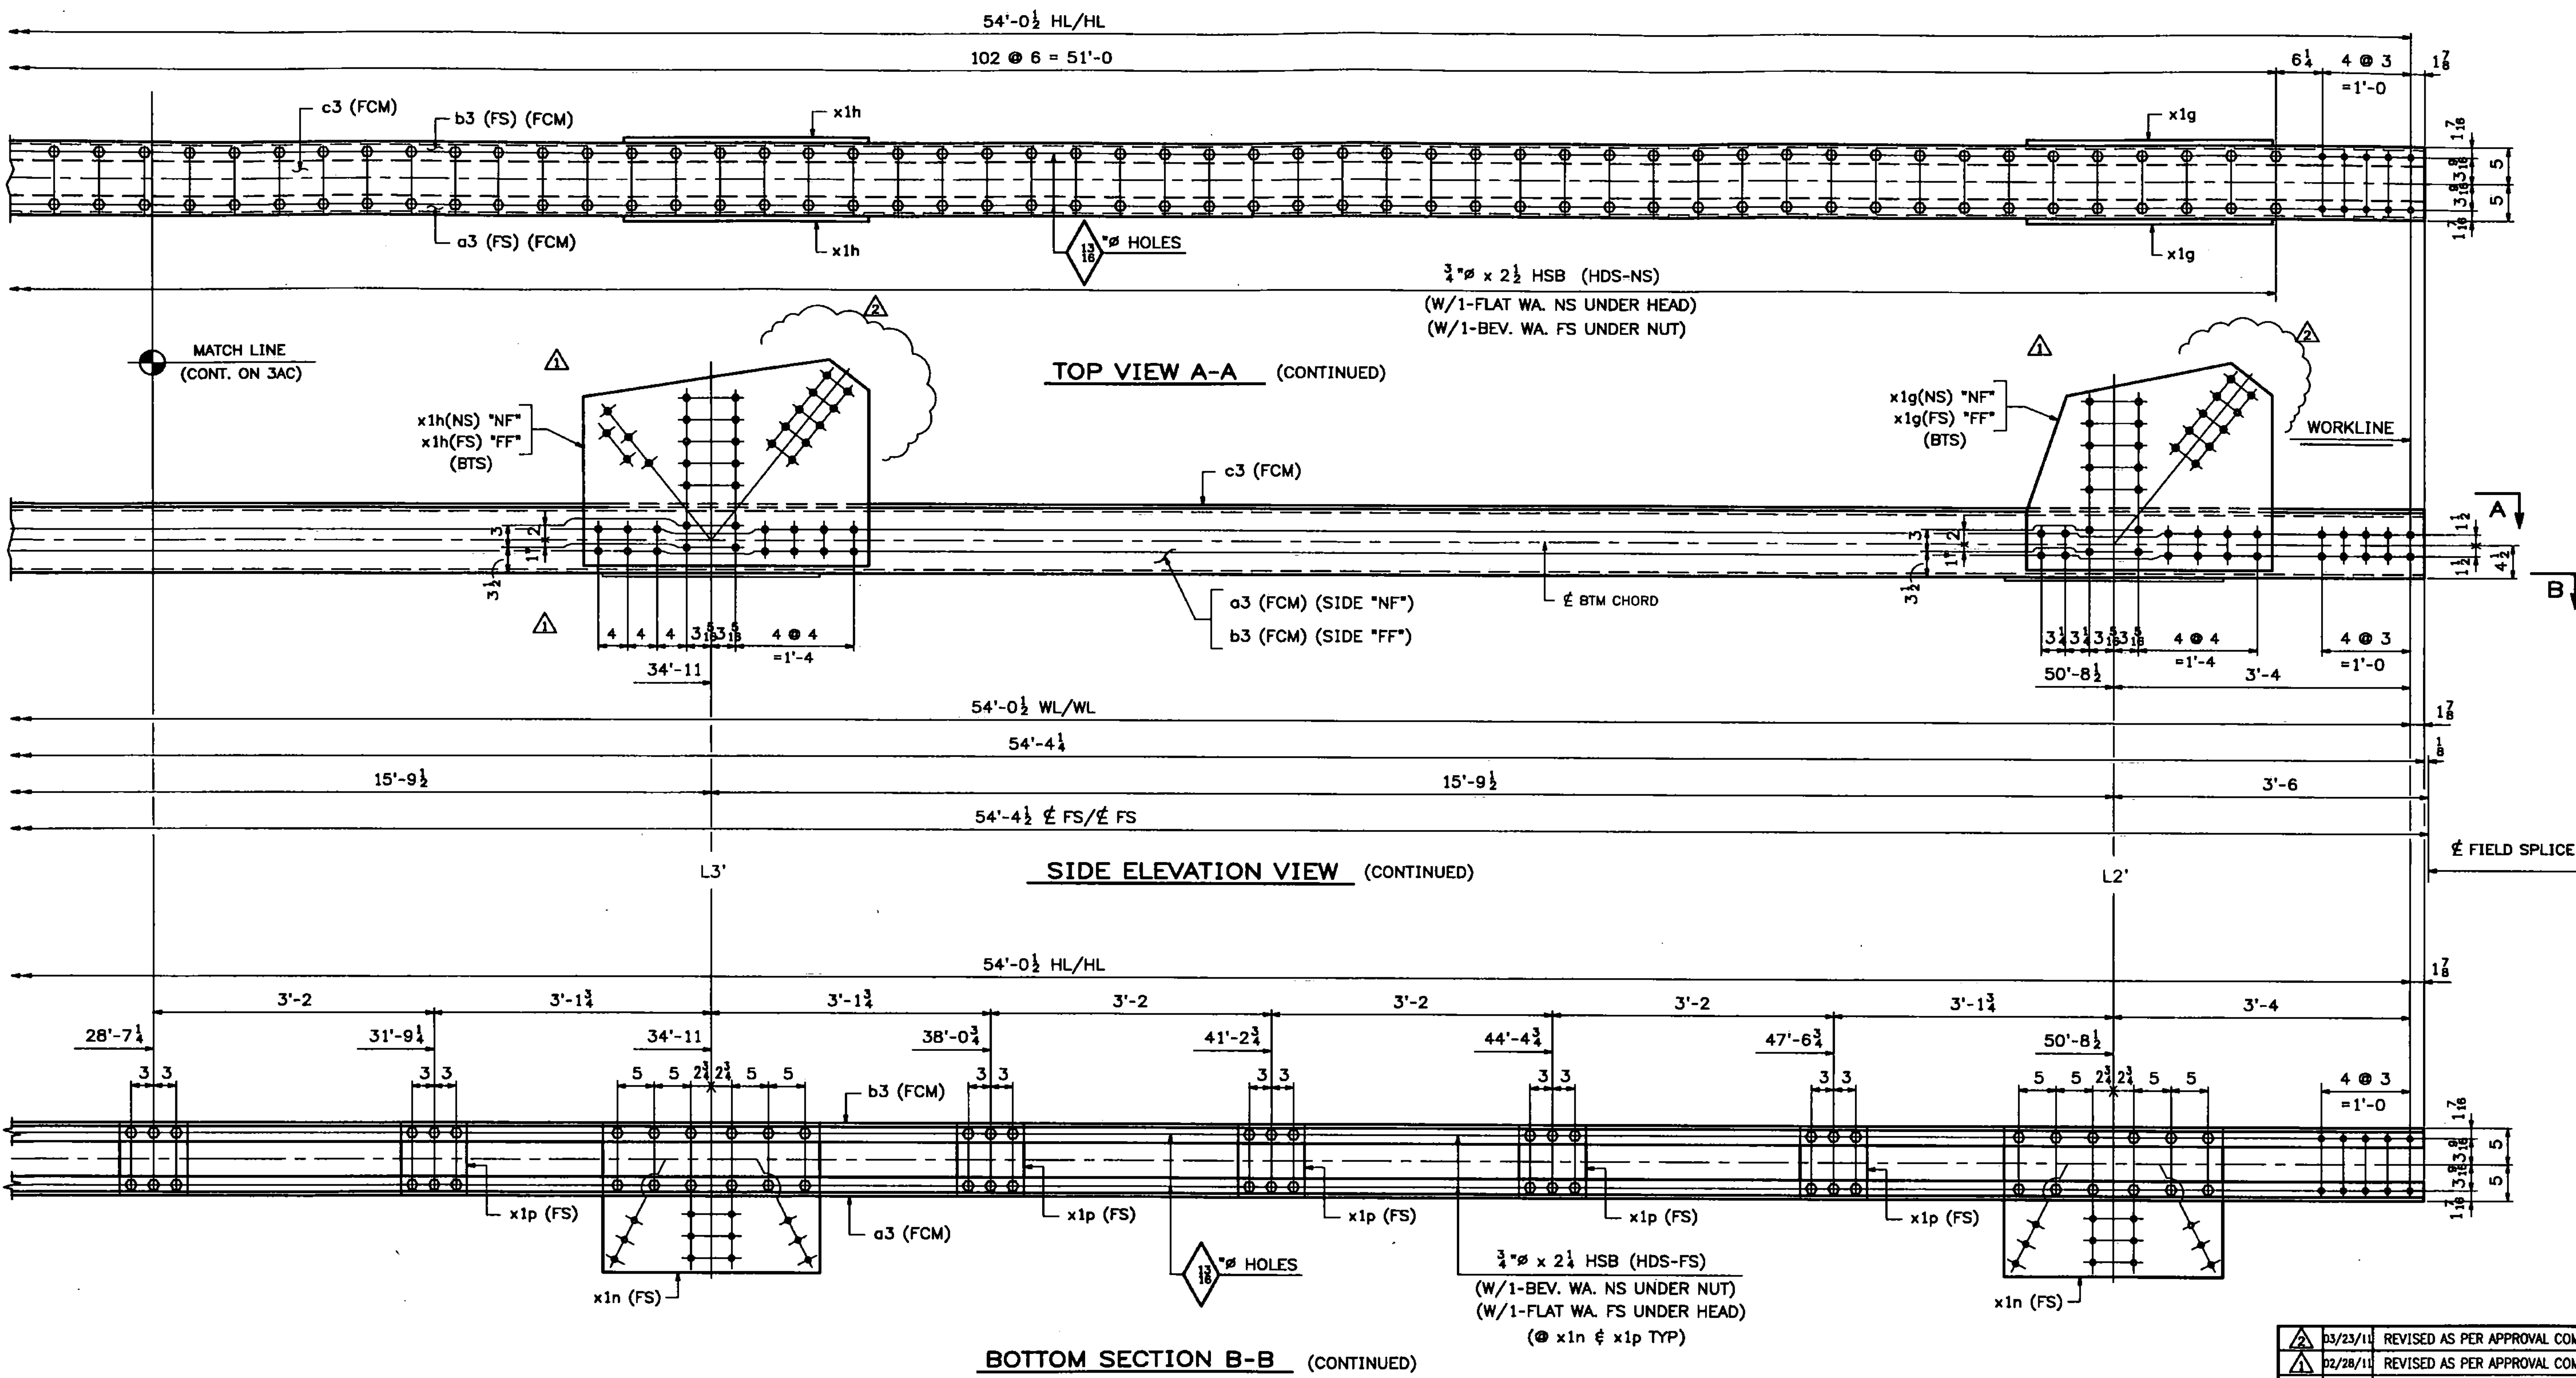
**SHOP NOTE:**  
ALL STEEL FOR BOTTOM CHORD ASSEMBLY SHALL BE GALVANIZED
