**PHASE CONSTRUCTION DETAILS
AT ABUTMENT NO. 1**

PROJECT NAME:	BRATTLEBORO	PLOT DATE:	06-FEB-2003
PROJECT NUMBER:	BHF 2000 (17)	DRAWN BY:	G. ROY
FILE NAME:	941078\Structures\sj078pod1	CHECKED BY:	T. SUMNER
PROJECT MANAGER:	R. R. WHITCOMB	SHEET	6 OF 71
DESIGNED BY:	T. SUMNER

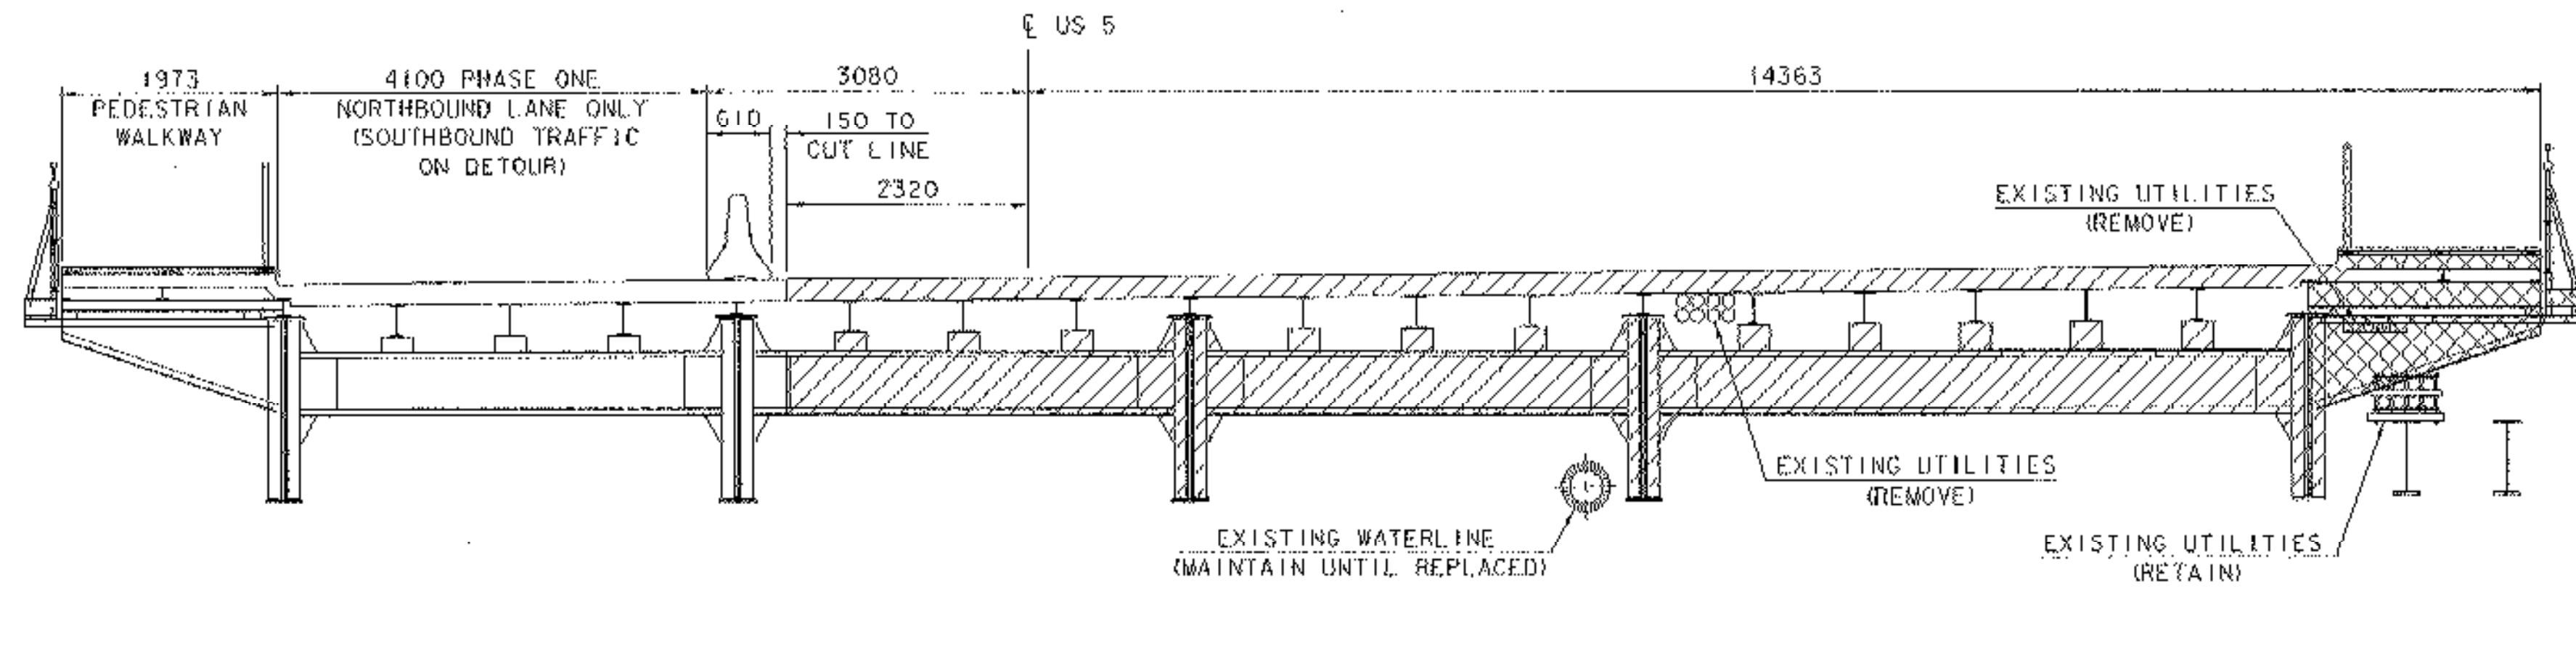
**PHASE ONE
ABUTMENT NO. 1**
(LOOKING BACK STATION)
(ALONG CENTERLINE OF BEARING)

INDICATES REMOVAL OF EXISTING BRIDGE.

INDICATES EXISTING SIDEWALK AND BRACING REMOVED BY PREVIOUS CONTRACT WITH VERIZON.

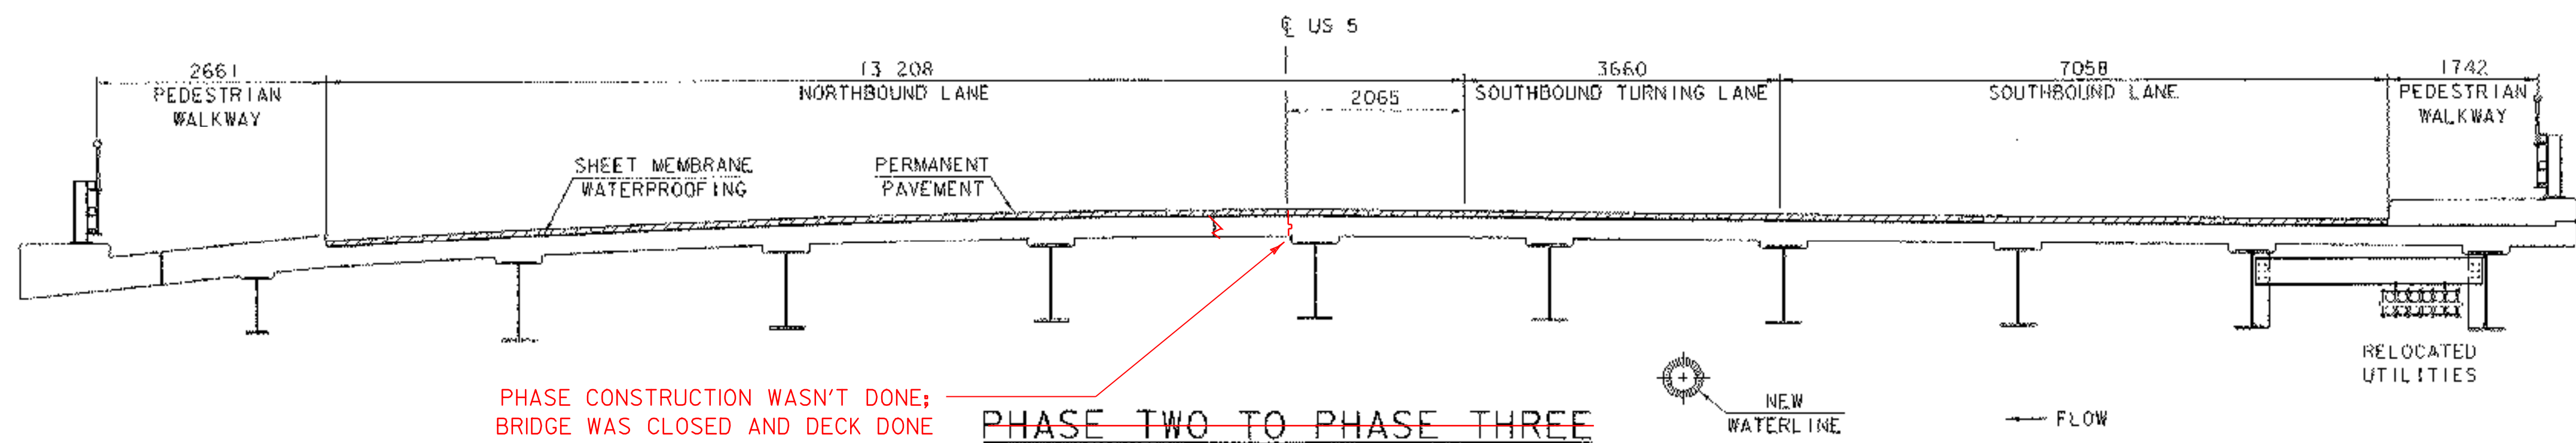
**PHASE TWO TO PHASE THREE
ABUTMENT NO. 1**
(LOOKING BACK STATION)
(ALONG CENTERLINE OF BEARING)

PHASE CONSTRUCTION WASN'T DONE;
BRIDGE WAS CLOSED AND DECK DONE
IN 2 POURS WITH CONSTRUCTION
JOINT @ CL (SEE CO #1, DATED 5-28-03)
