**PHASE CONSTRUCTION DETAILS
AT ABUTMENT NO. 1**

PROJECT NAME:	BRATTLEBORO	PLOT DATE:	06-FEB-2003
PROJECT NUMBER:	BHF 2000 (17)	DRAWN BY:	G. ROY
FILE NAME:	94J078\Structures\sj078ped.i	CHECKED BY:	T. SUMNER
PROJECT MANAGER:	R. R. WHITCOMB	SHEET	6 OF 7
DESIGNED BY:	T. SUMNER

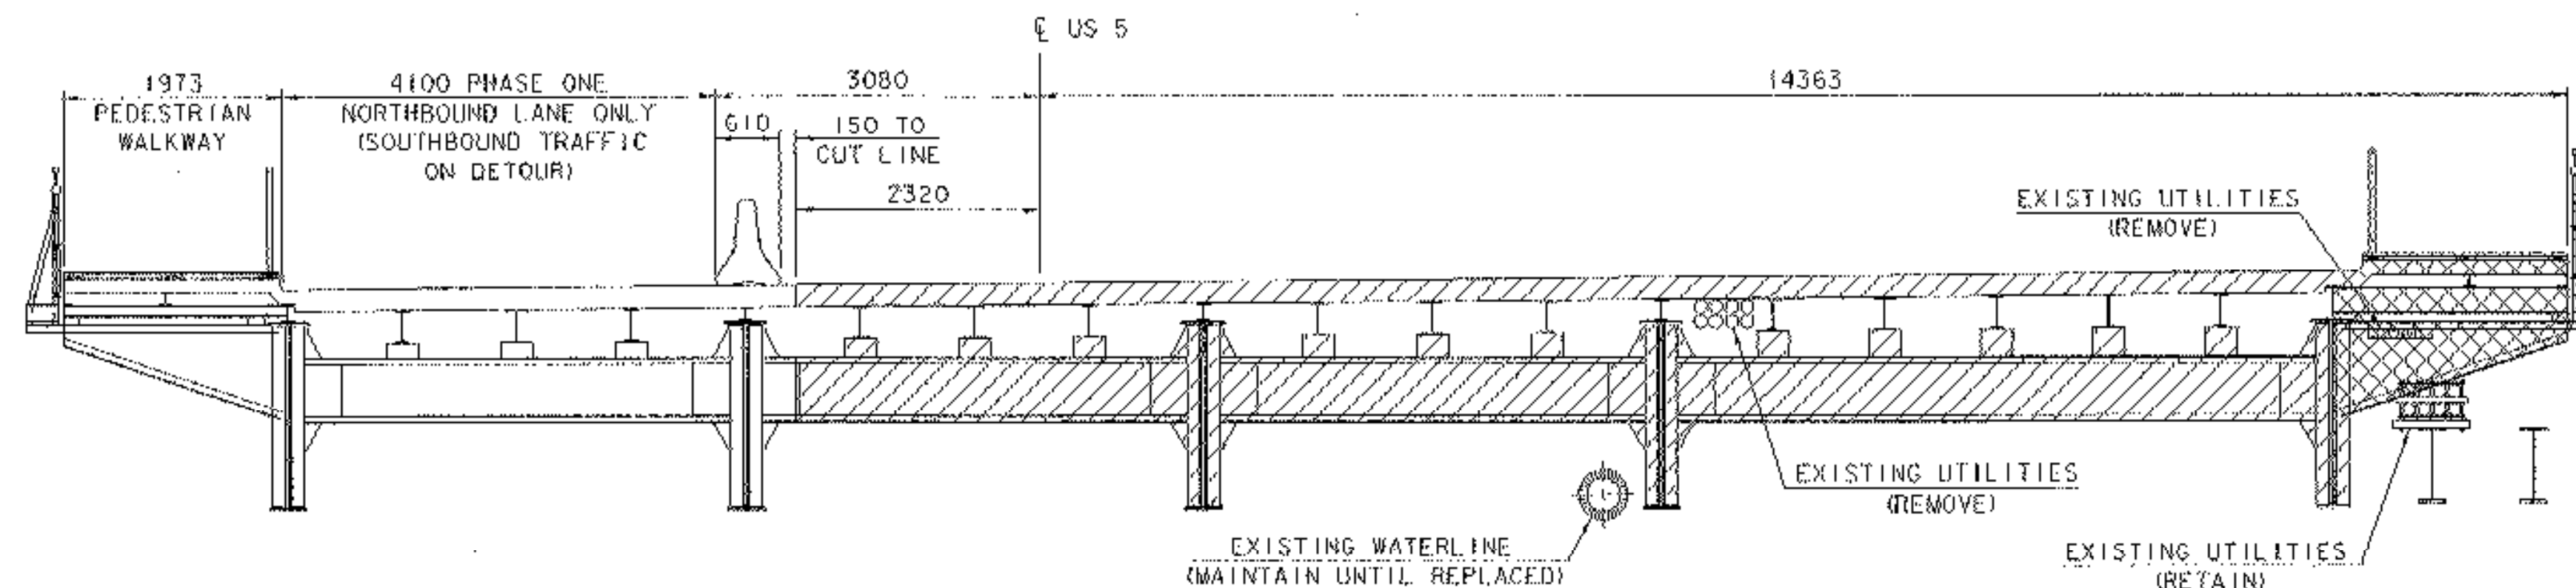
**PHASE ONE
ABUTMENT NO. 1**
(LOOKING BACK STATION)
(ALONG CENTERLINE OF BEARING)

INDICATES REMOVAL OF EXISTING BRIDGE.

INDICATES EXISTING SIDEWALK AND BRACING REMOVED BY PREVIOUS CONTRACT WITH VERIZON.

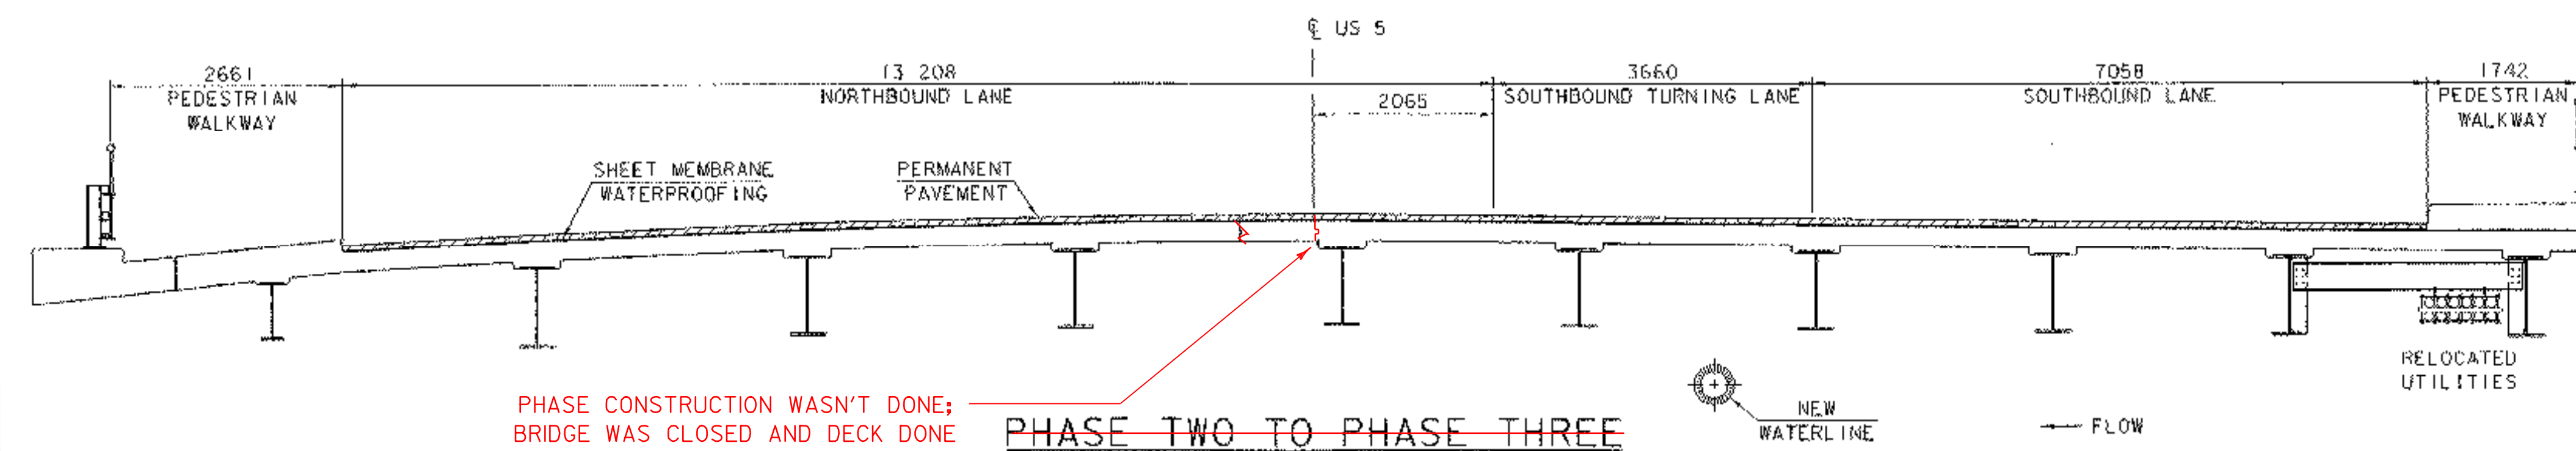
**PHASE TWO TO PHASE THREE
ABUTMENT NO. 1**
(LOOKING BACK STATION)
(ALONG CENTERLINE OF BEARING)

PHASE CONSTRUCTION WASN'T DONE;
BRIDGE WAS CLOSED AND DECK DONE
IN 2 POURS WITH CONSTRUCTION
JOINT @ CL (SEE CO #1, DATED 5-28-03)
