| STATE OF VERMONT<br>AGENCY OF TRANSPORTATION | |
| U.S. 2 OVER I-89 | |
| TELECOMMUNICATIONS RELOCATION | |
| Bridge Sheet No. T-9 OF 9 | Sheet 52 of 15 |

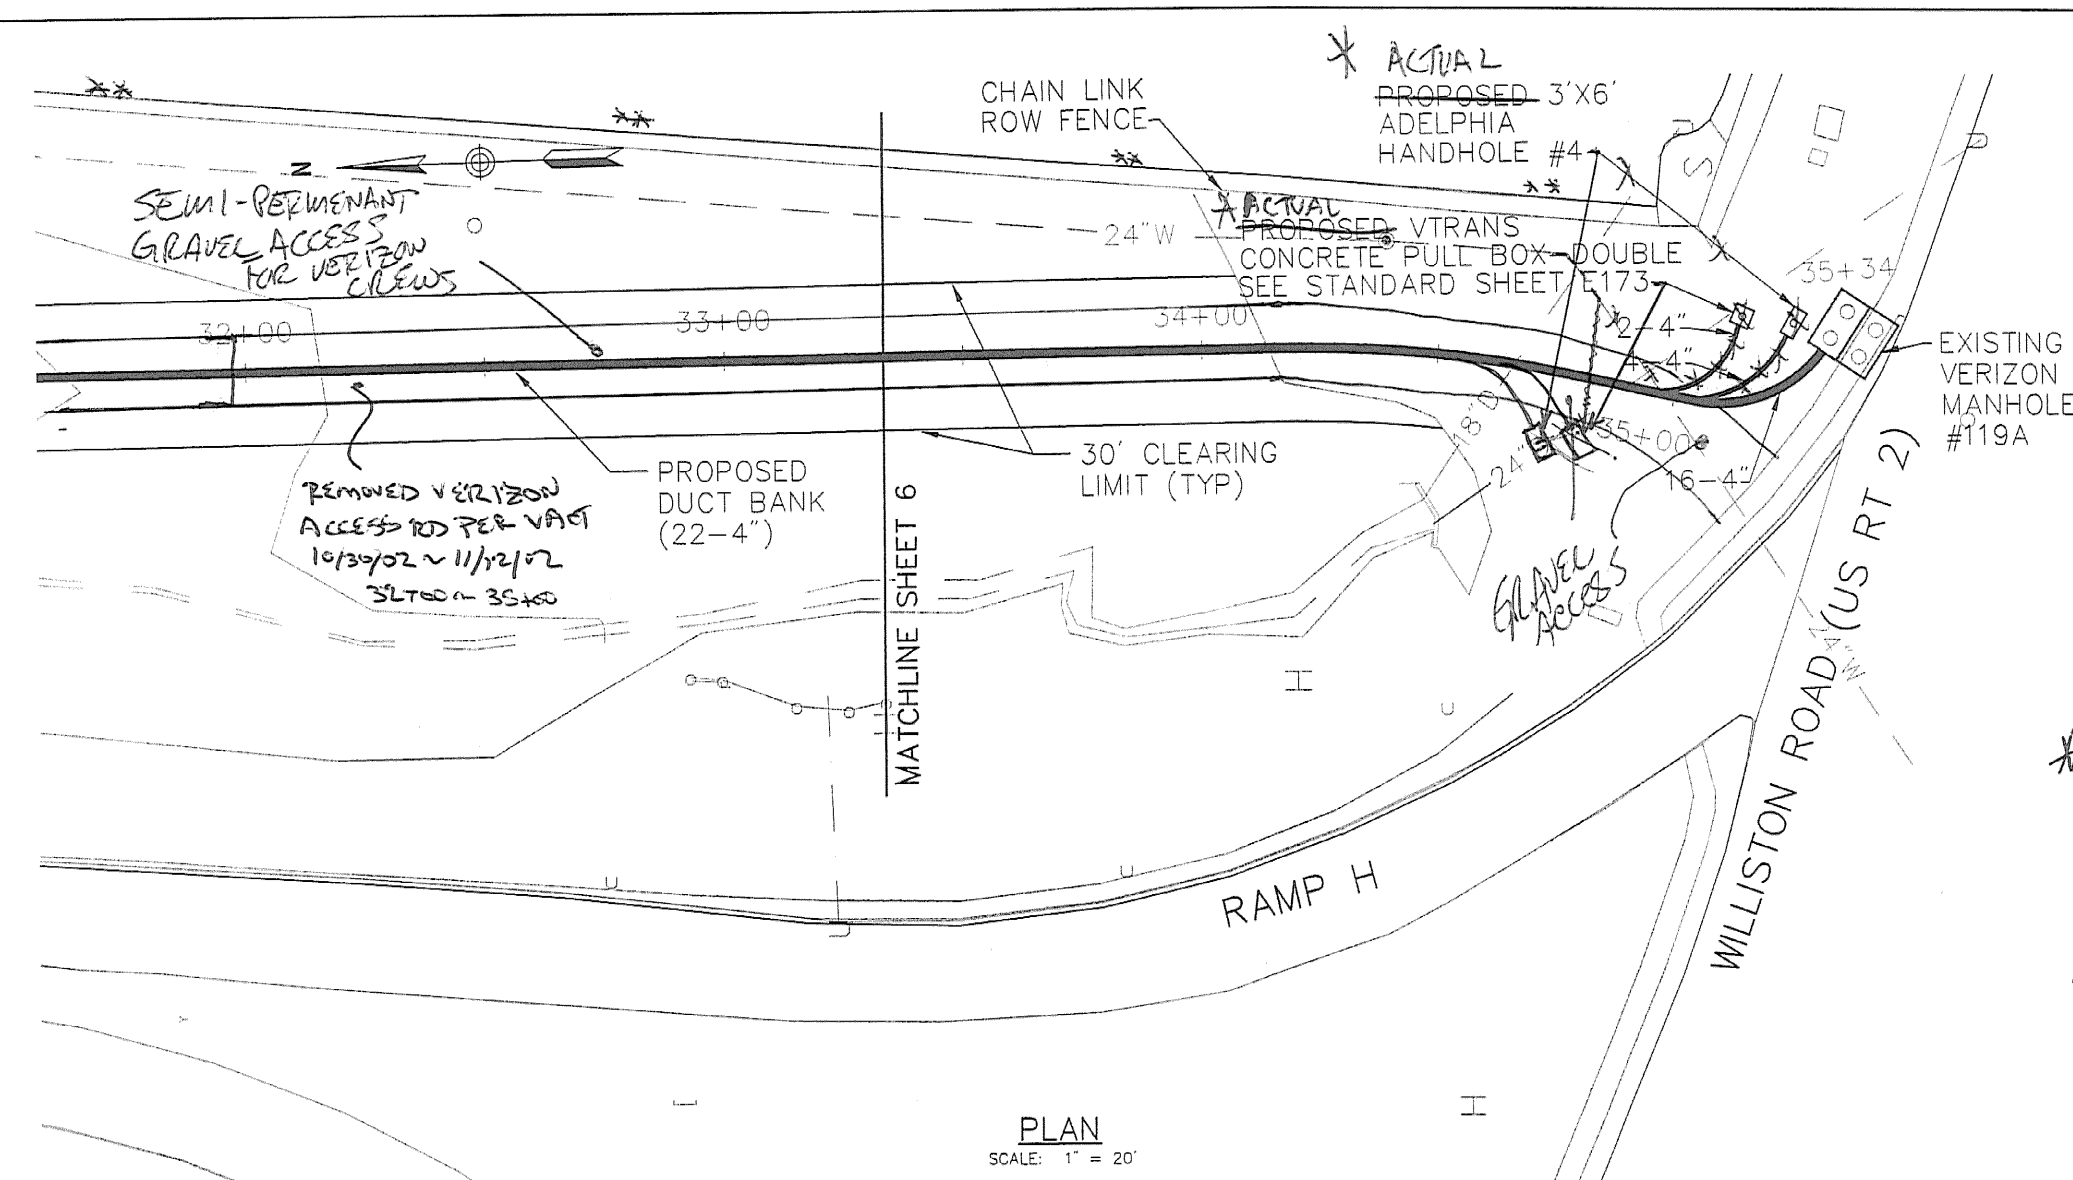
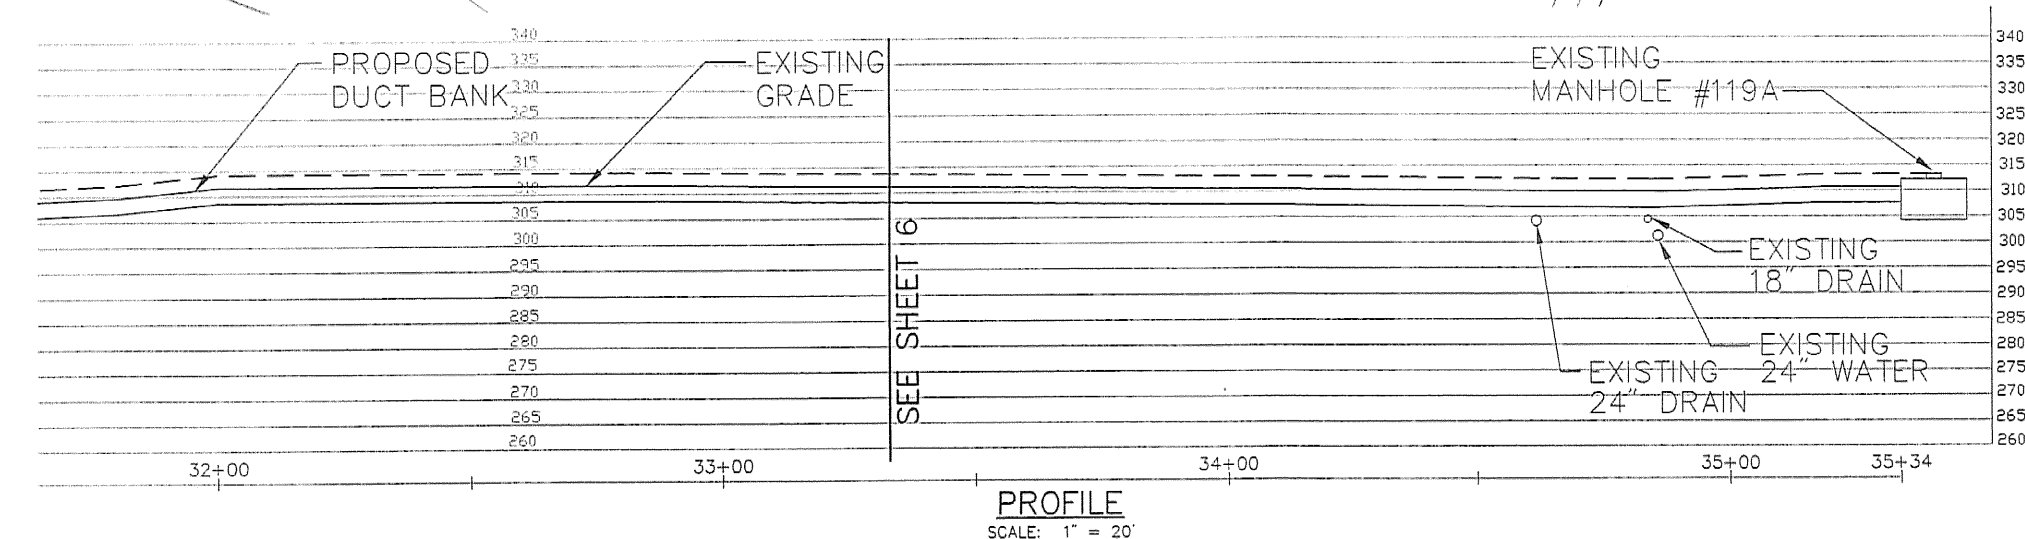
\* FIELD CONDITIONS GAVE RISE TO THE  
NEED TO RELOCATE THE CATV &  
VADT HANDHOLDS TO CLEAR  
EXISTING 8 CWD H<sub>2</sub>O LINE & OLD  
ABANDONED SHEET PILING. PLUS, A  
MASS OF EXISTING UNDERGROUND  
ELECTRIC CONDUITS WERE PRESENT.

\*\* Holiday Inn Maintenance Cleared brush along  
Row Fence 10/02. Saw Left Remainder  
of Maple logs from clearing operations for  
Holiday Inn @ their Request (11/12/02)
