STATE OF VERMONT AGENCY OF TRANSPORTATION	
Town Of SOUTH BURLINGTON	Bridge No. 68
Highway No. U.S. 2	Lot Site
	Date Site
U.S. 2 OVER I-89	
TELECOMMUNICATIONS RELOCATION	
Designed By: M. WATERS	Drawn By: M. WATERS
Checked By: S. JOHNSON	Bridge Design Supervisor
	Date
PROJECT	PROJECT NO.
SOUTH BURLINGTON	IM DECK(36)
Mill Log Drawn No. VTRANS-GEN	Date 10/21/01
Bridge Sheet No. 1 of 3	Sheet 5 of 15

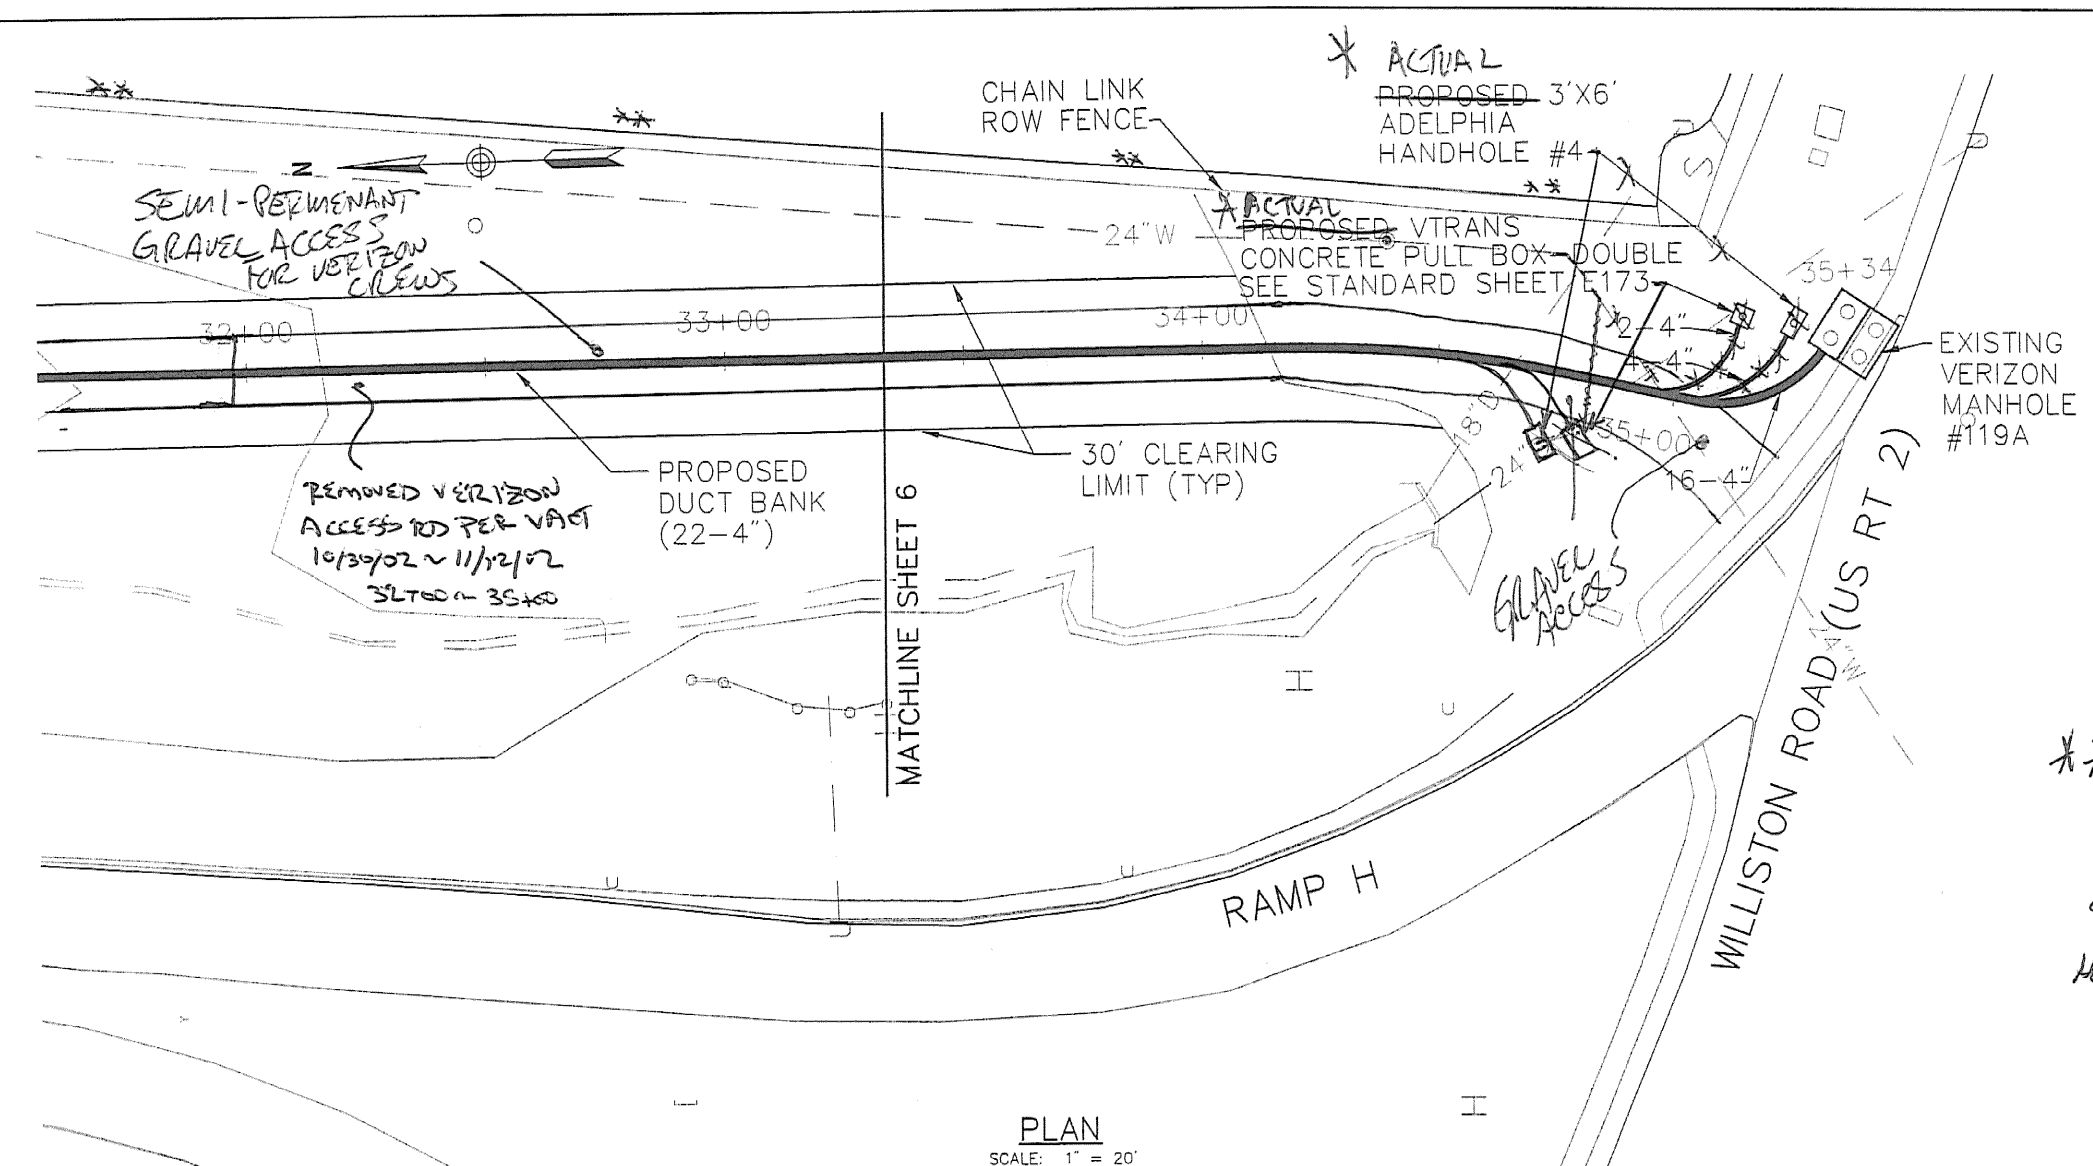
* FIELD CONDITIONS GVERNED THE NEED TO RELOCATE THE CATV & VAOT HANDHOLDS TO CLEAR EXISTING & CWD H₂O LINE & OLD ABANDONED SHEET PILING. PLUS, A MASS OF EXISTING UNDERGROUND ELECTRIC CONDUITS WERE PRESENT.

** Holiday Inn Maintenance Cleared brush along Row Fence 10/02. Saw Left Remainder of Maple logs from clearing operations for Holiday Inn @ their Request (11/12/02)
