PLAN - EXISTING CONDITIONS

PROJECT:	HARTLAND	BHO 1444 (54)
DESIGN FILE NAME:	G:\...\Hartlanddetails.dgn	
IPARM FILE NAME:	Hartlanddetails.i	
DESIGNED BY:	J. WEAVER	PLOT DATE: 03-OCT-2008
DRAWN BY:	WEEBER	CHECKED BY: J. WEAVER
DETAIL SHEET		SHEET: 5 OF 5

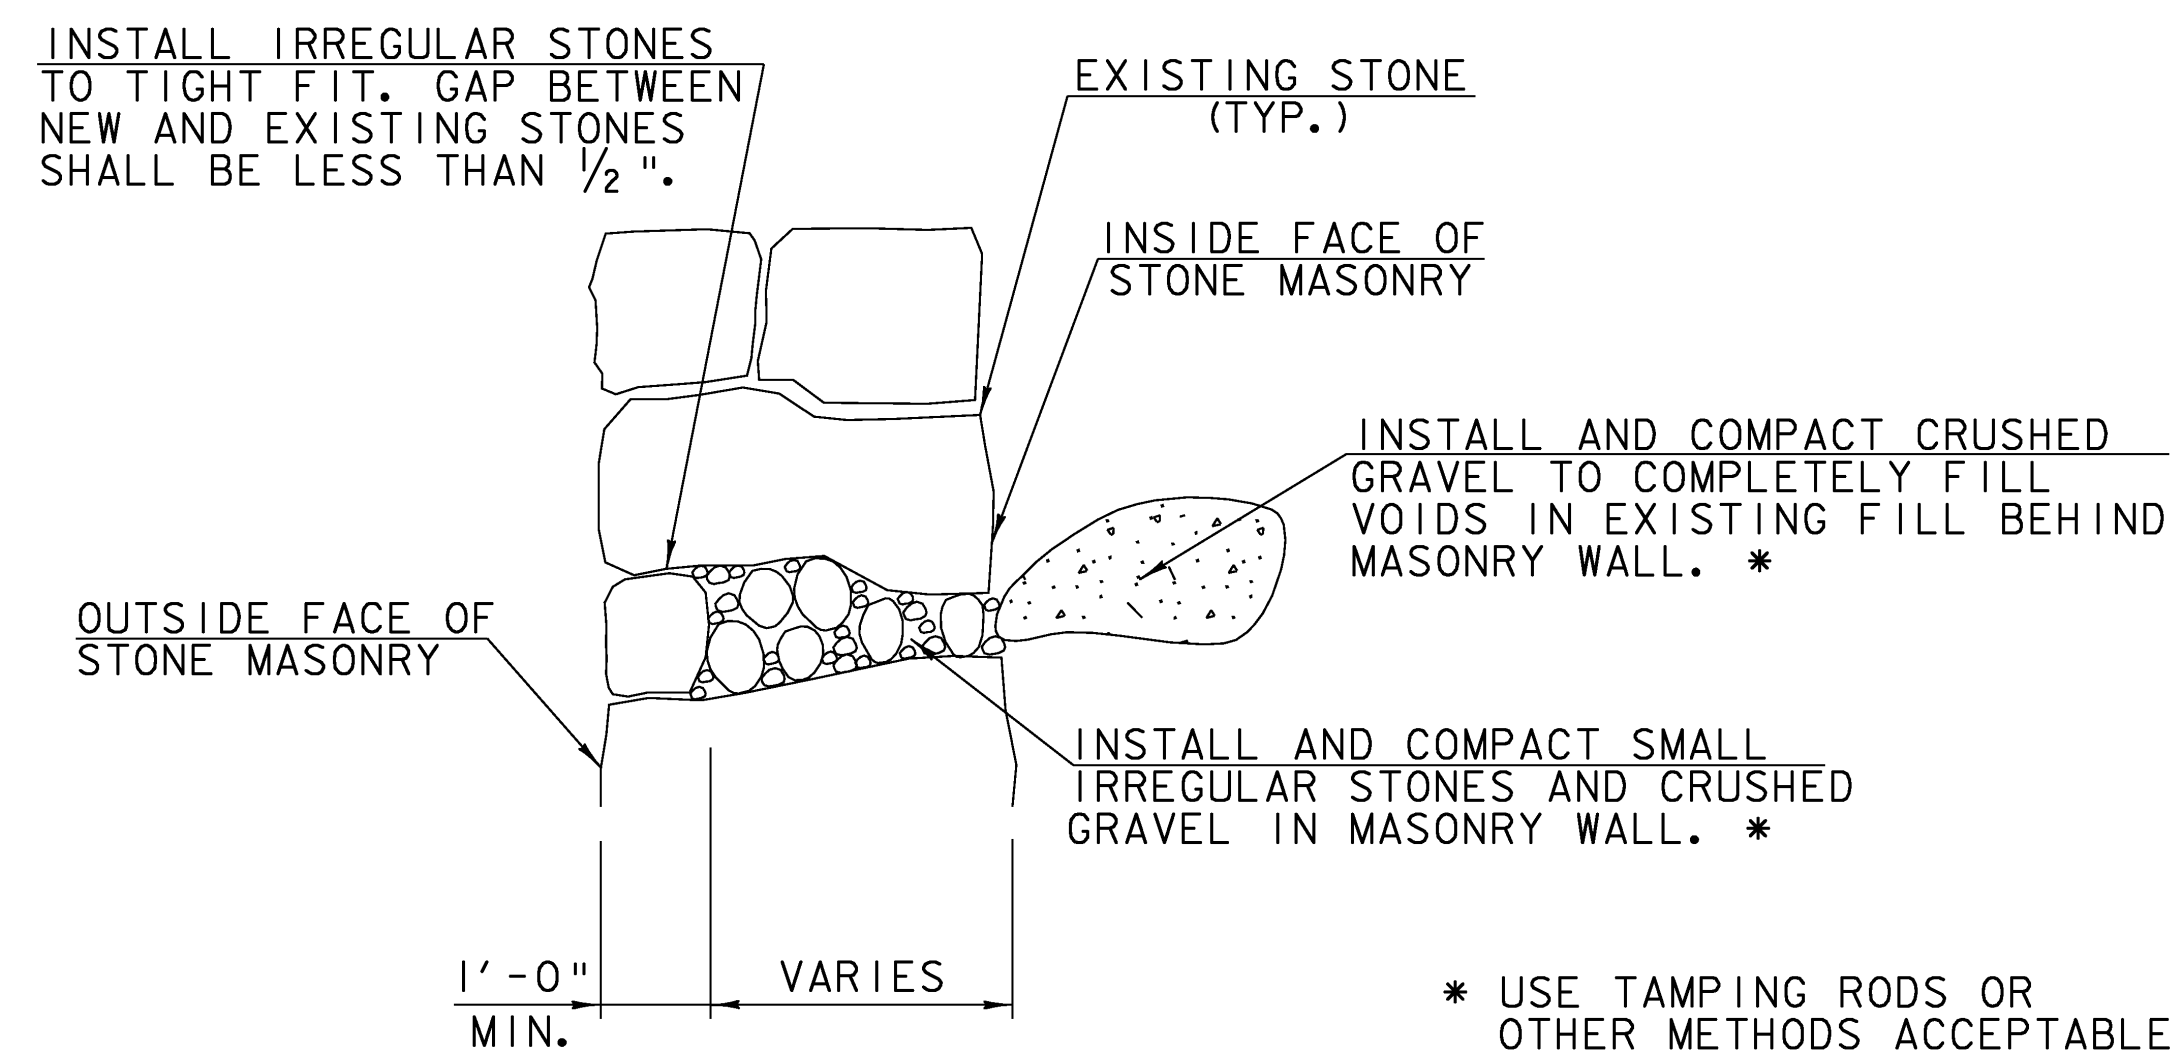
REPAIRING STONE MASONRY DETAIL **
not to scale

* USE TAMPING RODS OR OTHER METHODS ACCEPTABLE TO THE ENGINEER.

** FOR FURTHER INFORMATION SEE SECTION 900 OF THE PROJECT SPECIAL PROVISIONS.
