ONE - GIRDER - 3G4

REV.	DATE	REMARKS	DWN	CHK	APVL	SHOP
MATERIAL:		SURFACE PREP. & PRINT:		HOLES:		SHOP BOLTS:
M270M-345K(UN)		SEE DWG GNI		15-ø 16		NONE
DESCRIPTION: GIRDER - 3G4						
CASCO BAY STEEL STRUCTURES, INC.						
1 WALLACE AVE.			PHONE (207) 780-6722		TENOR	
SOUTH PORTLAND, ME 04106			FAX (207) 780-6726		SHEP	
STRUCTURE: READSBORO VI. ROUTE TH-2 OVER WEST BRANCH OF DEERFIELD RIVER				DRWN:	JTB	DATE: 06/23
LOCATION: READSBORO, VERMONT				CHKD:	WJL	DATE: 07/10
PROJ NO.	BRF 0105(3)	JOB NO.	519	DWG NO.	3	REV. Δ
CUSTOMER:	RENAUD BROS.

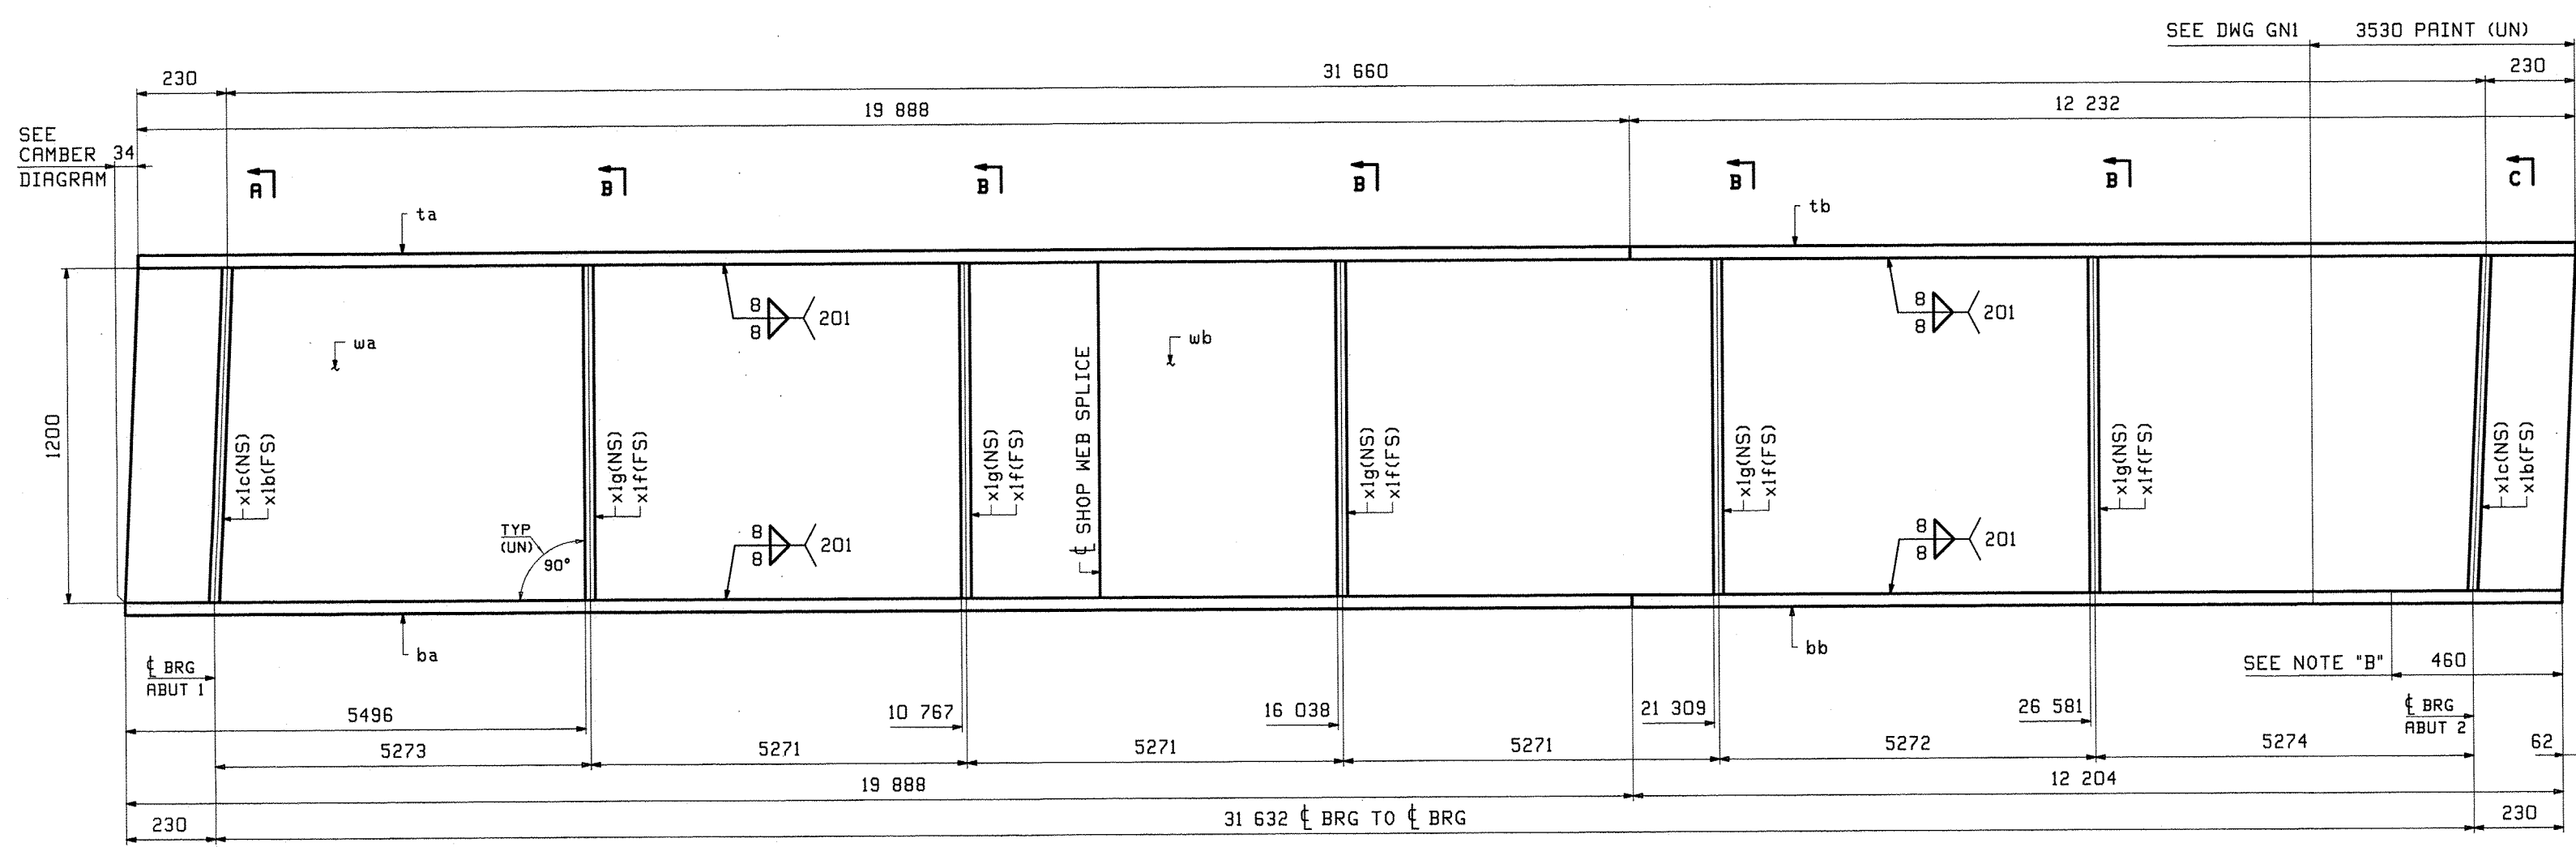
FOR GIRDER STANDARD DETAILS SEE DRAWING XI.
 FOR CAMBER & FLANGE DIAGRAMS SEE DRAWING CI.
 FOR GENERAL NOTES SEE DRAWING GNI.
 T2 DENOTES MATERIAL SUBJECT TO CHAPPY V-NOTCH TESTING.

NOTE "B"
 NO PRINT AREA ALONG BOTTOM FLANGE.
 (FIELD WELDED SOLE PLATE) (SEE SECTION P ON GNI).
