**CAMBER DIAGRAM FOR 1S1 THRU 2S4**

| DESCRIPTION: CAMBER DIAGRAM | | | | | | |
| BRIDGE NO: BR 34 | | | | | JTB | 10/14 |
| PROJ NO. STP BRO 1447(22) (RE-ADVERTISED) | | | | | 380 | C1 |

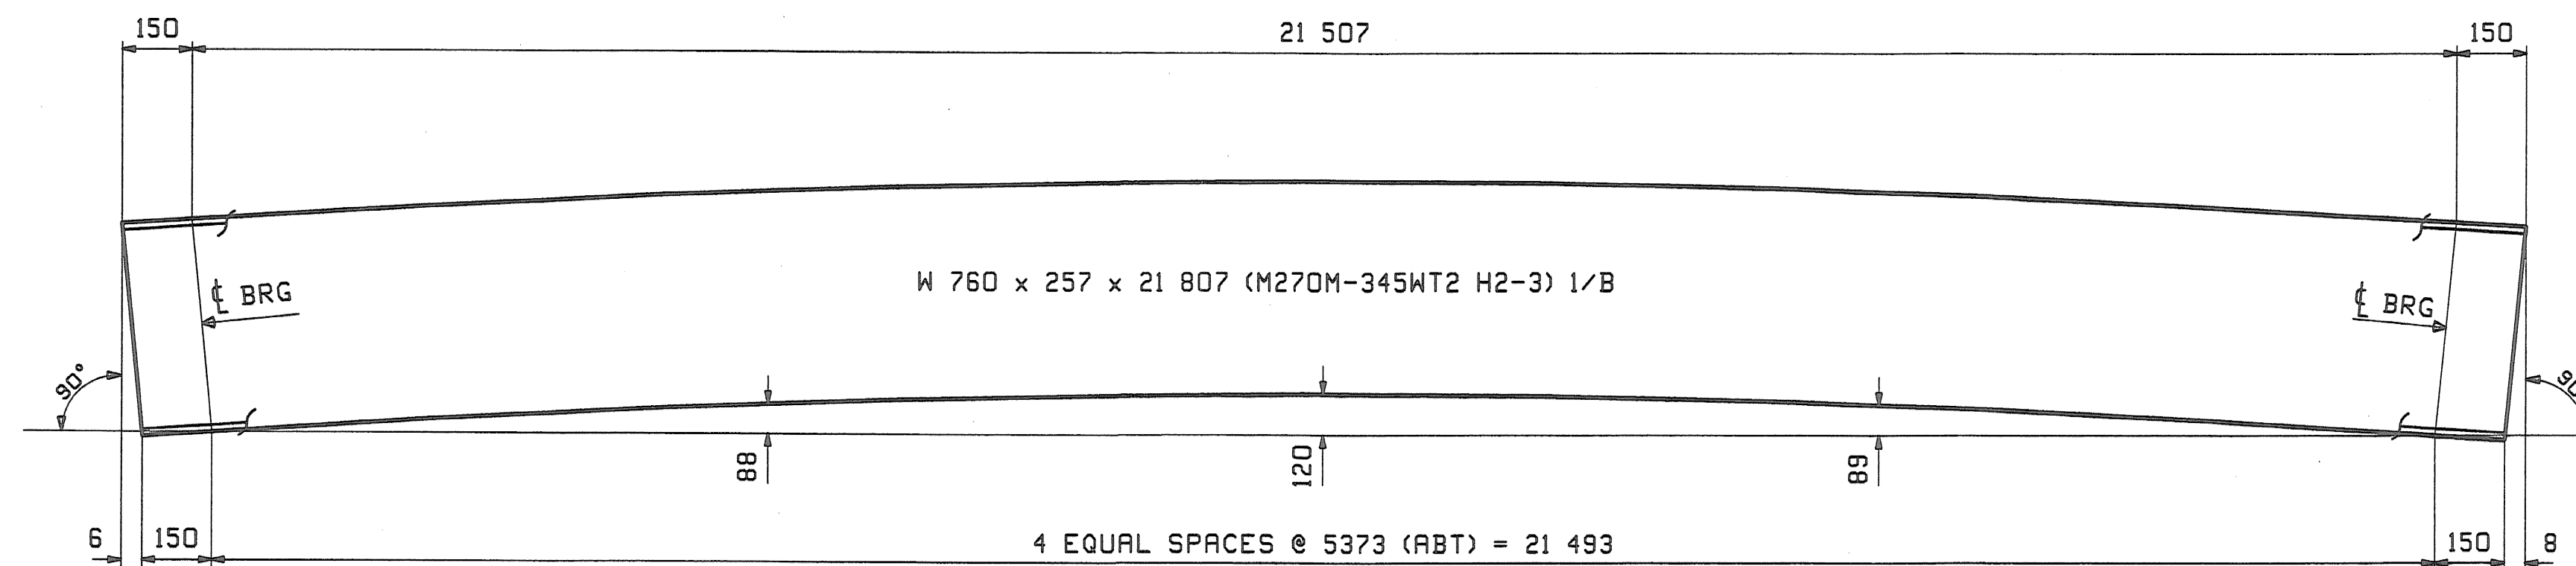
1. FOR GENERAL NOTES SEE DRAWING GN1.
2. H2-3 DENOTES MATERIAL SUBJECT TO CHARPY V-NOTCH TEST AT H FREQ. FOR ZONE 2
