EXISTING CONDITIONS

PROJECT NAME: MENDON	PLOT DATE: 18-NOV-2005
PROJECT NUMBER: BRO 1443(35)	DRAWN BY: G. Shangraw
FILE NAME: /str5/95j290/soils.dgn	CHECKED BY:
PROJECT LEADER: C. Keller	SHEET 32 OF 94
DESIGNED BY: G. Shangraw	
sj290soils.i

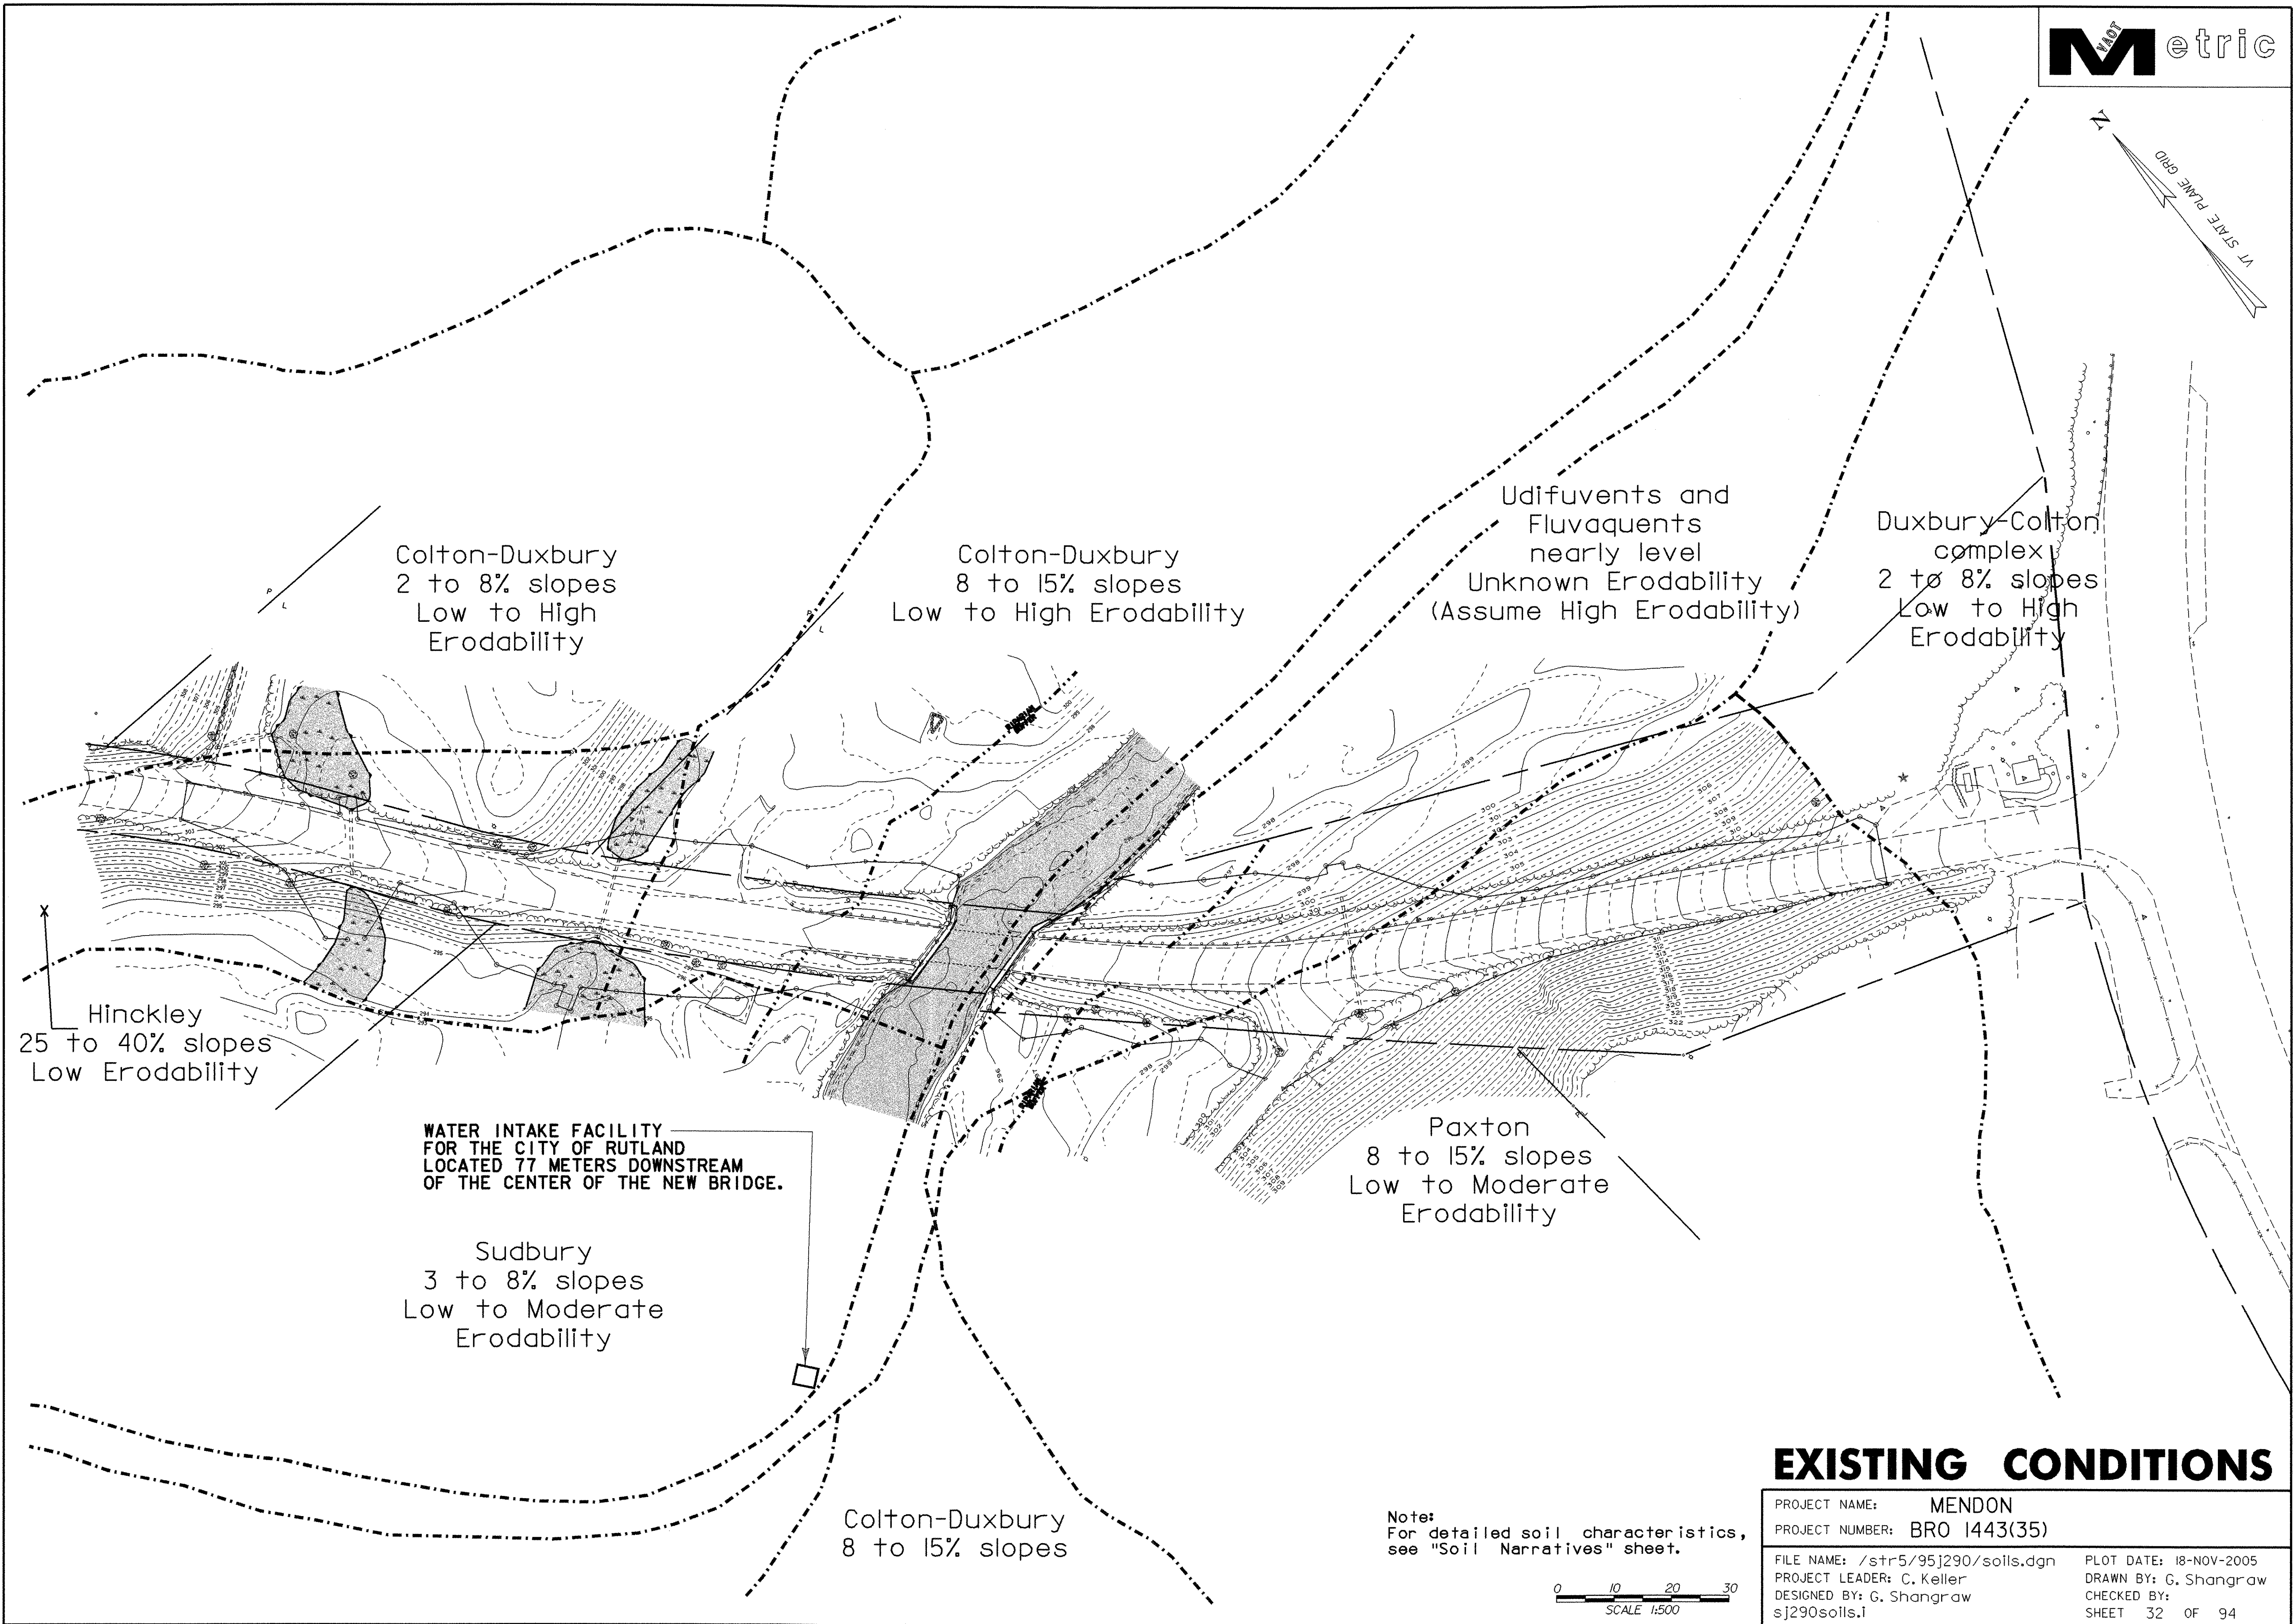
Colton-Duxbury
2 to 8% slopes
Low to High
Erodability

Colton-Duxbury
8 to 15% slopes
Low to High Erodability

Udifuvents and
Fluvaquents
nearly level
Unknown Erodability
(Assume High Erodability)

Duxbury-Colton
complex
2 to 8% slopes
Low to High
Erodability

Hinckley
25 to 40% slopes
Low Erodability

WATER INTAKE FACILITY
FOR THE CITY OF RUTLAND
LOCATED 77 METERS DOWNSTREAM
OF THE CENTER OF THE NEW BRIDGE.

Sudbury
3 to 8% slopes
Low to Moderate
Erodability

Paxton
8 to 15% slopes
Low to Moderate
Erodability

Colton-Duxbury
8 to 15% slopes
